ACCIDENT

Aircraft Type and Registration:	Boeing 737-800, EI-DLV	
No & Type of Engines:	2 CFM56-7B26 turbofan engines	
Year of Manufacture:	2006 (Serial no: 33,598)	
Date & Time (UTC):	15 September 2017 at 0807 hrs	
Location:	London Stansted Airport	
Type of Flight:	Commercial Air Transport (Passenger)	
Persons on Board:	Crew - 6	Passengers - 184
Injuries:	Crew - None	Passengers - None
Nature of Damage:	Failure of left nose landing gear axle and separation of left nosewheel	
Commander's Licence:	Airline Transport Pilot's Licence	
Commander's Age:	33 years	
Commander's Flying Experience:	4,500 hours (of which 4,300 were on type) Last 90 days - 255 hours Last 28 days - 85 hours	
Information Source:	AAIB Field Investigation

Synopsis

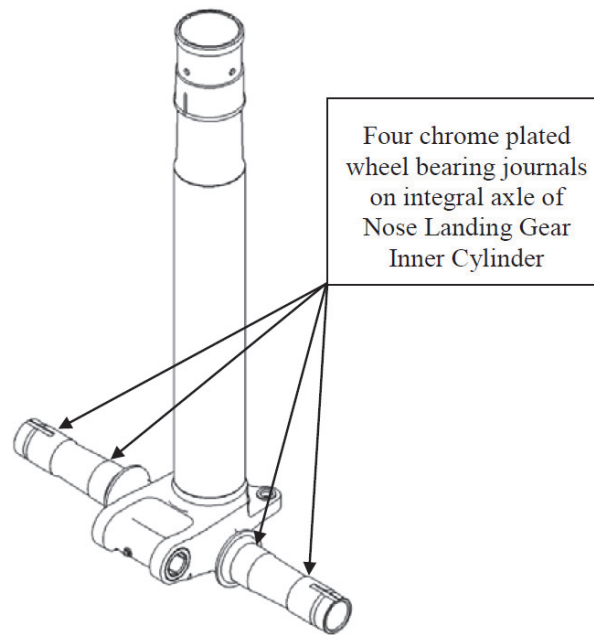
Figure 3

The nosewheel axles are integral parts of the NLG inner cylinder (Figure 3). Each axle has an inboard and an outboard journal onto which the two bearings from each nosewheel are fitted. The axles are made of a high strength steel alloy and the journals are chrome plated with a minimum chrome thickness of 0.003 inches. The highest stressed area of the axle is at the 6 o'clock position and the highest stress occurs during landing when the nosewheels touch down and load the axles upwards.

NLG inner cylinder with its four chrome plated wheel bearing journals
