ACCIDENT

Aircraft Type and Registration:	Piper PA-31, N250AC	
No & Type of Engines:	2 Lycoming TIO-540-A2C piston engines	
Year of Manufacture:	1976 (Serial no: 31-7612040)	
Date & Time (UTC):	6 September 2017 at 1723 hrs	
Location:	Caernarfon Airport, Gwynedd	
Type of Flight:	Private	
Persons on Board:	Crew - 1	Passengers - None
Injuries:	Crew - 1 (Fatal)	Passengers - N/A
Nature of Damage:	Aircraft destroyed	
Commander's Licence:	Commercial Pilot's Licence	
Commander's Age:	62 years	
Commander's Flying Experience¹:	Over 4,000 hours (with experience on type) Last 90 days - unknown Last 28 days - unknown	
Information Source:	AAIB Field Investigation

Synopsis

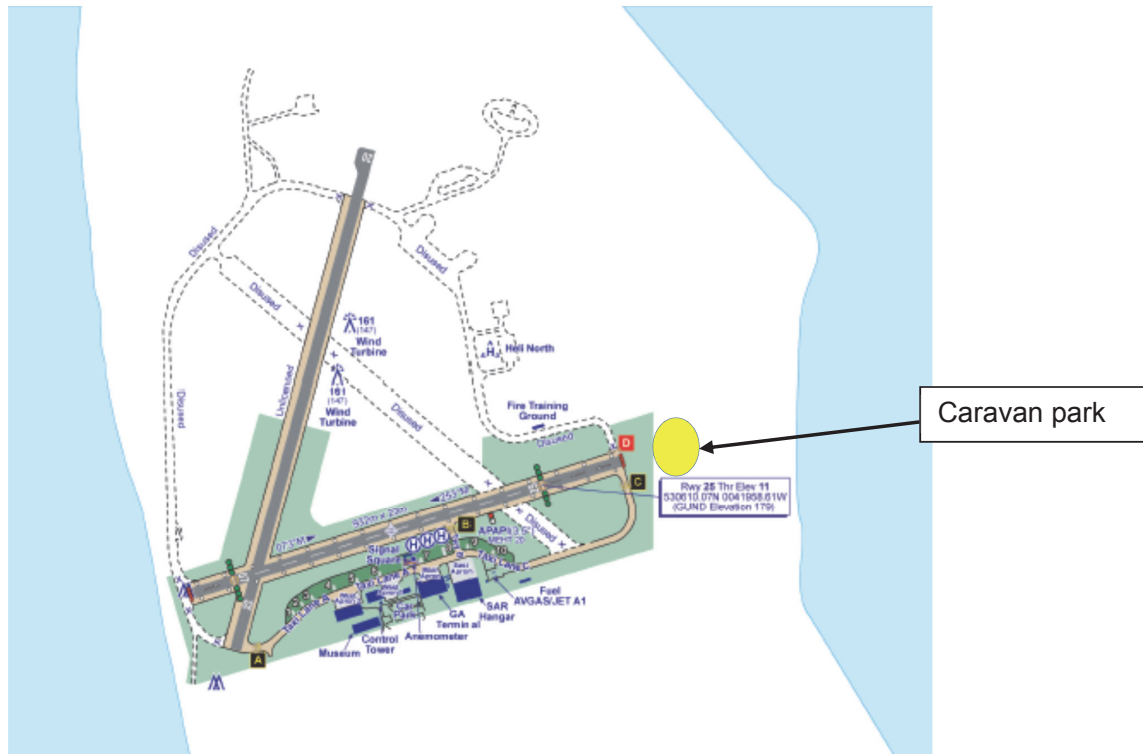
Figure 1

Caernarfon's operational runway is 932 m long and orientated 070°/250° (Figure 1). The airport's published summer operating hours were from 0800 to 1700 hrs.

Caernarfon Airport and location of caravan park

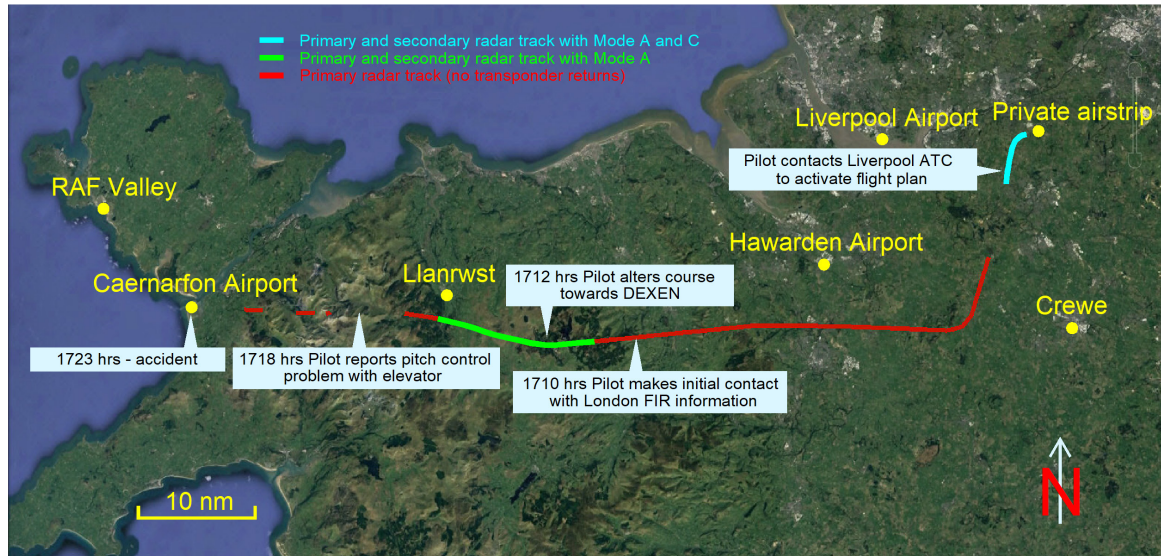
Recorded radar information (primary and secondary Mode A and C⁹) was available from ground-based sites located at Manchester Airport and St Anne's (near Blackpool). The radar data provided an almost complete record of the accident flight, starting shortly after the aircraft had taken off and ending when the aircraft was about 4 nm east of Caernarfon Airport. Figure 2 provides a plot of the aircraft radar track.

Radar track of N250AC

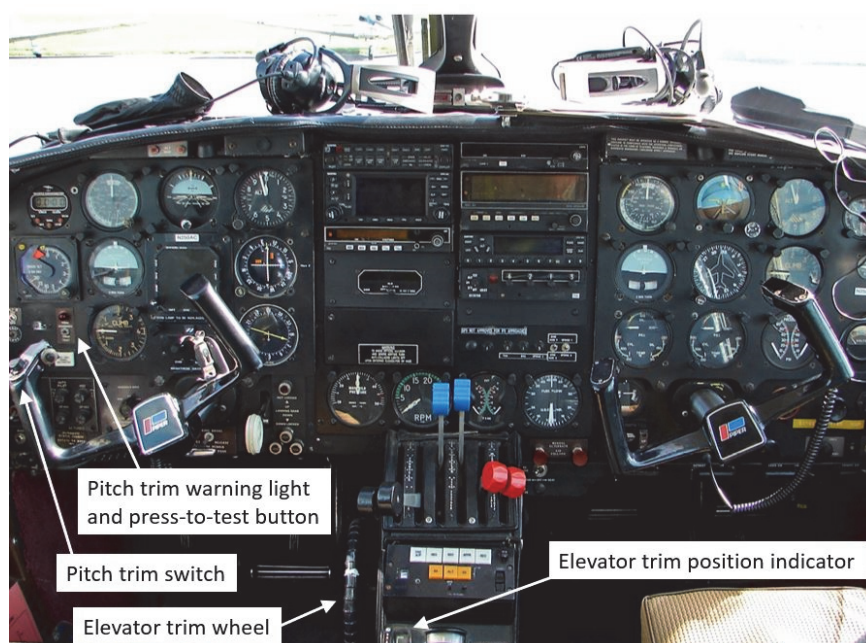
Figure 3

N250AC cockpit, showing trim controls (image used with permission)
