ACCIDENT

Aircraft Type and Registration:	Auster AOP.9, G-BXON	
No & Type of Engines:	1 Bombardier Cirrus 20801 piston engine	
Year of Manufacture:	1955 (Serial no: AUS/10/60)	
Date & Time (UTC):	18 June 2017 at 1135 hrs	
Location:	Spanhoe Airfield, Northamptonshire	
Type of Flight:	Private	
Persons on Board:	Crew - 1	Passengers - 1
Injuries:	Crew - 1 (Fatal)	Passengers - 1 (Serious)
Nature of Damage:	Aircraft destroyed	
Commander's Licence:	Private Pilot's Licence	
Commander's Age:	49 years	
Commander's Flying Experience:	409 hours (of which 0.5 hours were on type) Last 90 days - 2.0 hours Last 28 days - 0.5 hours	
Information Source:	AAIB Field Investigation

Synopsis

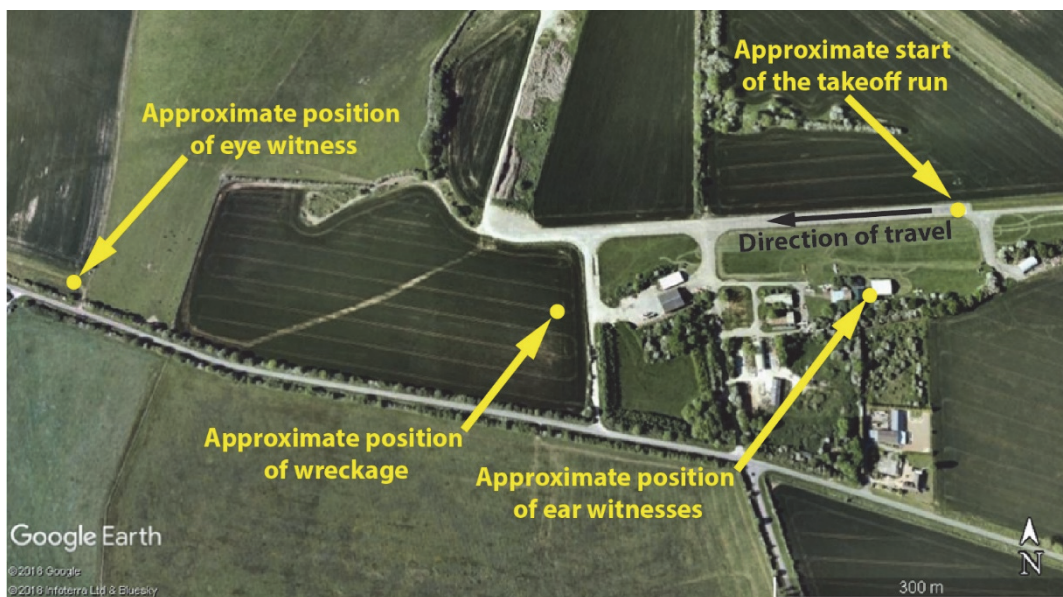
A horse rider had stopped at a position around 430 m from the end of the runway to watch the aircraft depart. She stated that the takeoff initially seemed normal but, soon after, the aircraft rocked slightly; first right then left. There was a short pause before the aircraft rolled left into a steep descent and struck the ground to the left of the runway. The engine noise sounded constant up until the impact. Figure 1 shows the location of the various witnesses.

Spanhoe Airfield and location of witnesses
