AAIB Bulletin

10/2018

AS350 B3e Ecureuil	G-MATH	05-May-17	3
--------------------	--------	-----------	---

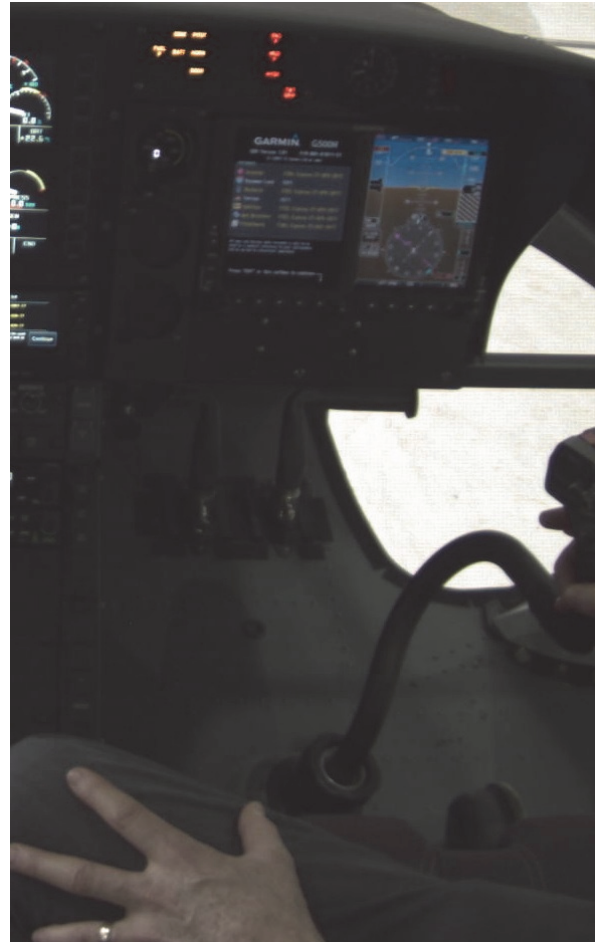
Figure 10

During the final stages of the flight, only the right-seat pilot's cyclic was visible as the instructor had changed his hand position, obscuring the Vision 1000 view of his controls. The video imagery showed that at 0832:58 hrs and a left AOB of 62° (3.5 seconds prior to impact), the right-seat pilot's cyclic was positioned in the furthest right position which is shown in Figure 9. This figure also shows how his grip had tightened on the cyclic. While the exact cyclic position could not be established, when comparing to the 'full and free' check performed on the test helicopter, it shows that the cyclic had not reached its right limit (Figure 10).

View from exemplar helicopter Vision 1000 showing full right cyclic in mid fore-aft position

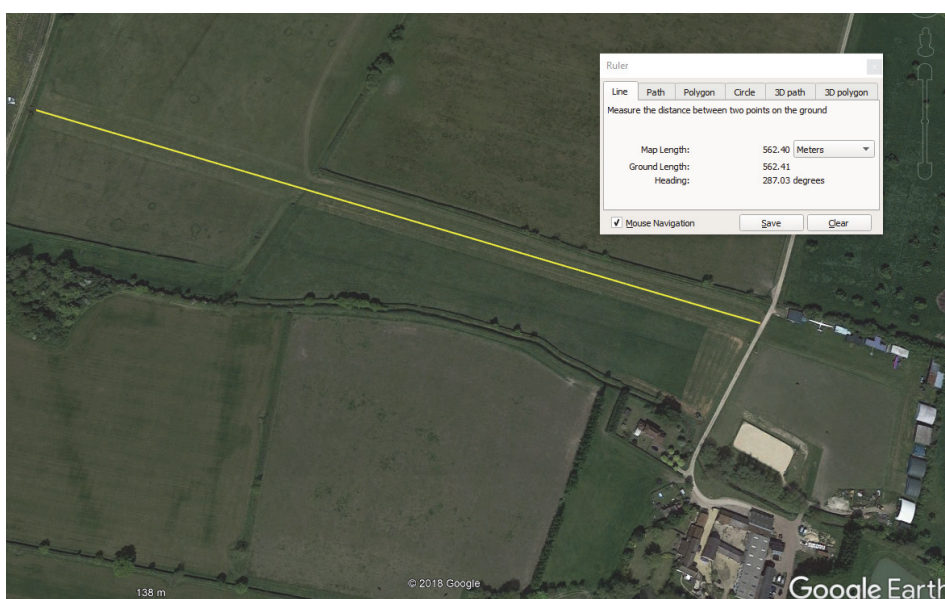
Figure 2

The runway is orientated 29/11 and has a grass surface. Its condition was reported as dry and newly rolled. The farm's website states the runway length is 600 yards (549 m). The pilot reported that he had measured the strip and found it to be 615 m long. Measurements taken from aerial imagery of the airfield more closely match the length stated on the farm's website. Adjacent to the Runway 29 threshold and under the approach path are a parking area and hangars, (Figure 2).

View of Eaton Bray Farm Airfield indicating runway length
