# ***AAIB Bulletin***

***11/2018***

Published 8 November 2018

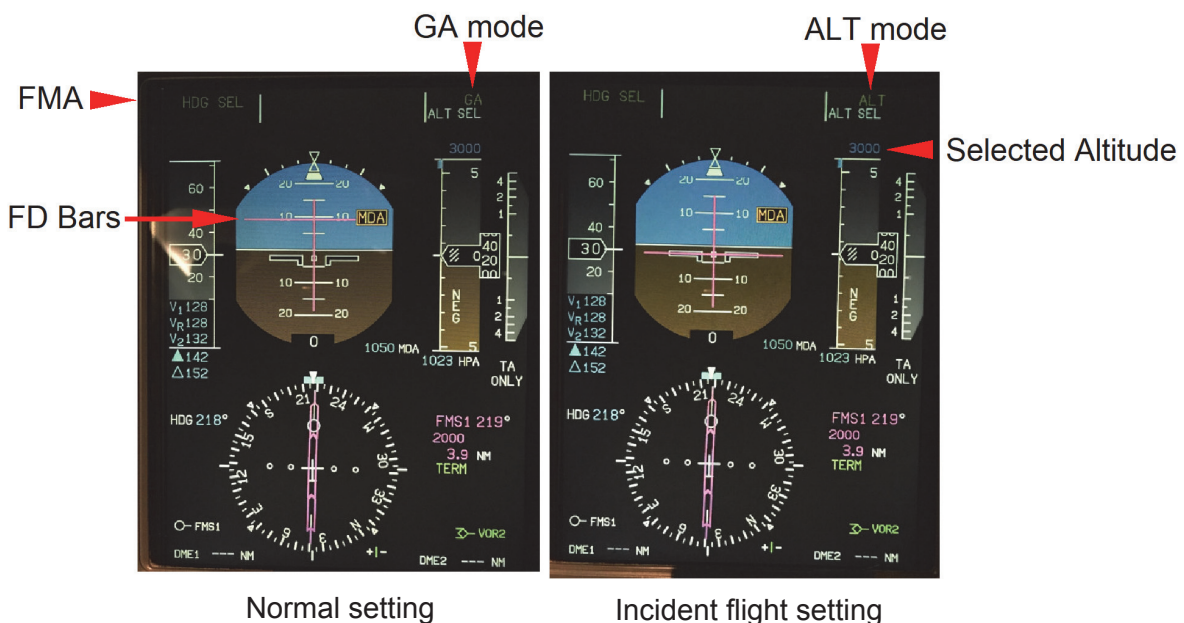
**Figure 2**

Figure 2 shows the FMA and FD vertical bar positions displayed on the PFD when the FD modes are selected in accordance with the operator's procedures prior to takeoff (GA, HDG and ALT SEL) and those selected during the incident takeoff (HDG, ALT SEL and ALT). Other than the FMA indicating that the ALT mode has been armed on the ground, there are no other indications to identify that the target altitude has been set to the airfield elevation amsl.

PFD indications when GA, HDG and ALT SEL (left PFD) and HDG, ALT SEL and ALT (right PFD) are selected for takeoff

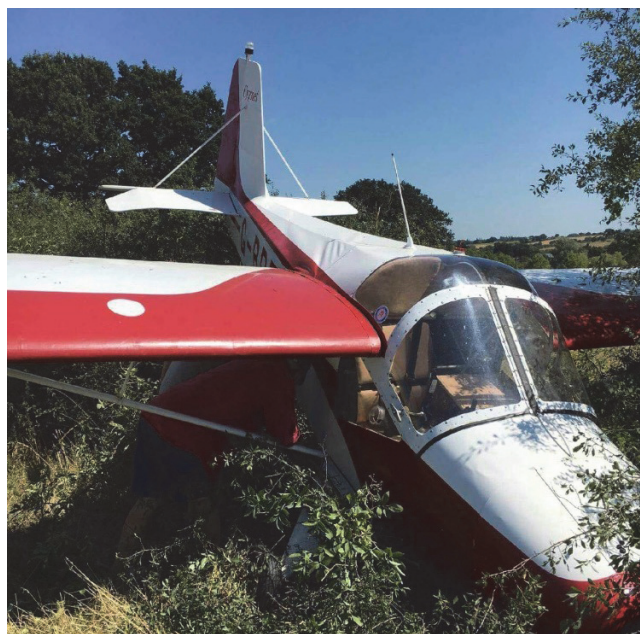
**Figure 1**

On short final, at approximately 140 ft above the ground, as the throttle was advanced the engine abruptly stopped. The pilot attempted to restart the engine by engaging the electric starter and the engine ran for a few seconds before stopping again as the throttle was advanced. By this time the aircraft had descended below the level of the trees on the approach and the pilot determined that he could not clear them, nor land in the available area before the trees. He turned right approximately 20°, flew beneath a set of power lines and aimed for a low hedge to cushion the impact. The aircraft came to rest in the hedge, Figure 1. The pilot, who was wearing a four-point harness, sustained a minor leg injury in the accident but was able to vacate the aircraft using the cockpit door. The aircraft sustained substantial damage to the wings, landing gear, fuselage and tailplane.

Accident site

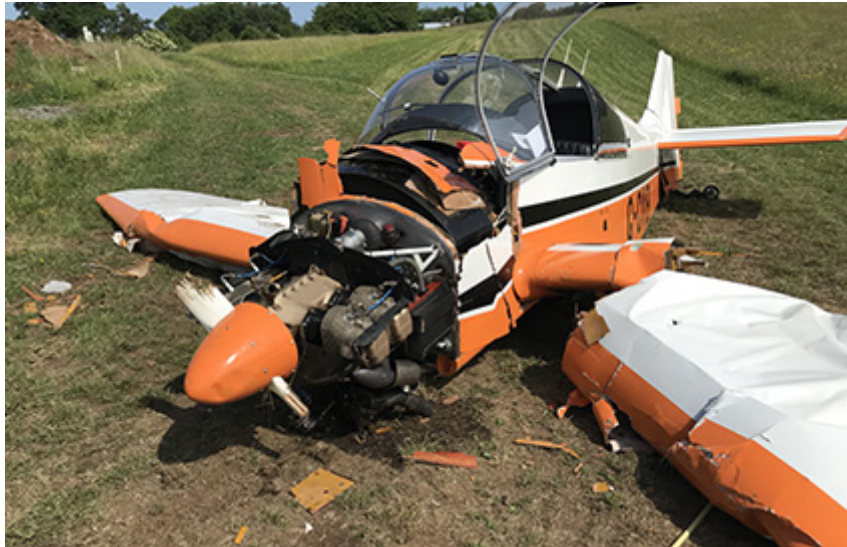
**Figure 1**

The pilot approached Runway 36 at his private airstrip, having estimated the wind strength as 5 kt, from a variable direction. No turbulence was apparent during the approach but, as the aircraft neared the boundary hedge, it suddenly encountered sinking air and the pilot was unable to prevent the left main landing gear from striking the hedge. He lost control and the aircraft struck the ground and travelled along the runway for a few metres. When the aircraft came to rest it had rotated left through approximately 180°, the landing gear had collapsed, the left wing had detached and the right wing and forward fuselage were extensively damaged (Figure 1). The occupants used the normal access doors to vacate the aircraft without assistance.

The aircraft was pointing back towards the threshold of Runway 36 when it came to rest. The uphill slope of the runway is apparent in the background

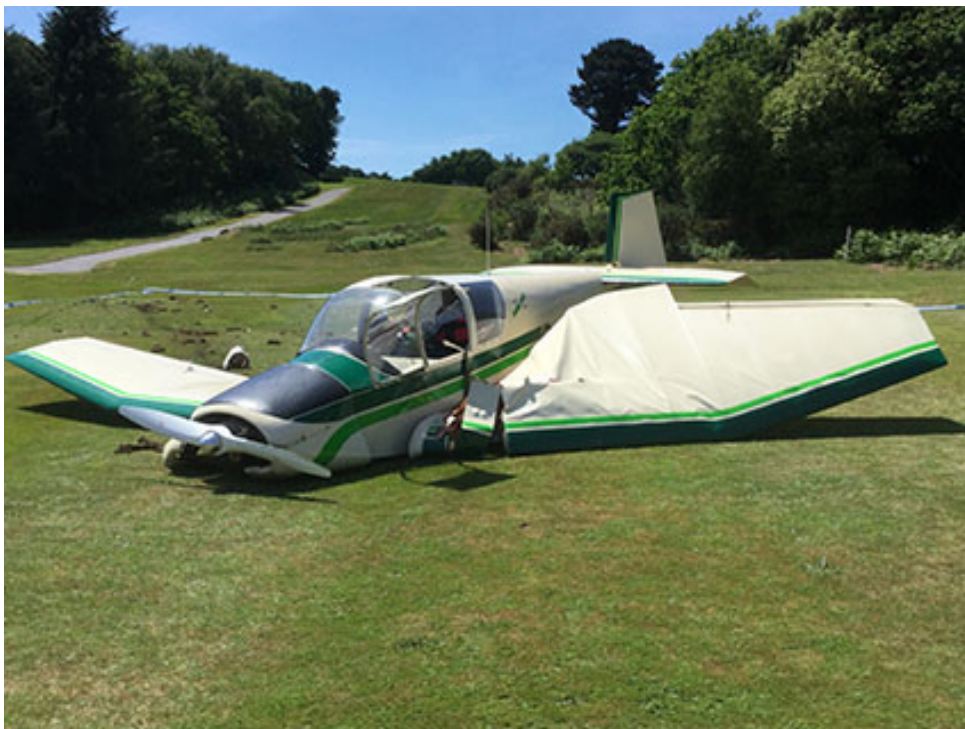
**Figure 2**

G-AVYV after the accident

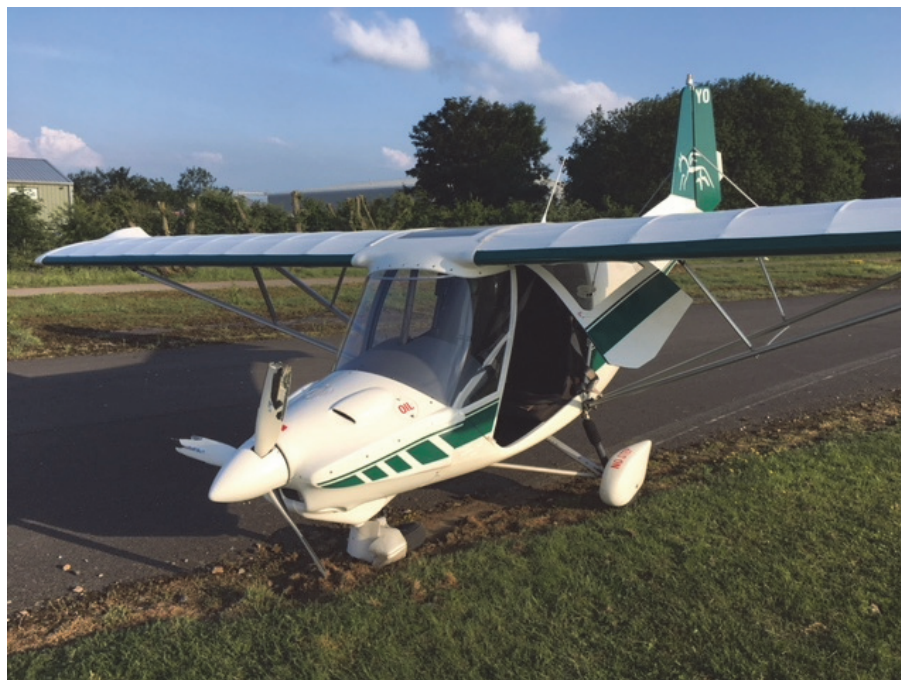
**Figure 1**

The pilot was returning from a local flight to land on Runway 05 at Membury Airfield. The weather was CAVOK, wind northerly at 5 kt and temperature 25°C. The pilot reported that he was slightly higher and faster than normal on approach. Another aircraft was waiting to depart at the holding point so the pilot of G-CDYO planned to land half way down the runway to allow plenty of space between the two aircraft. On landing, G-CDYO bounced twice and on the third touchdown the nosewheel collapsed and the propeller struck the runway. The aircraft came to a halt on the left-hand edge of the runway (Figure 1).

G-CDYO with collapsed nosewheel and propeller damage

After the accident the pilot reflected that he should have gone around when he realised he was high and fast on the approach and was not going to land at the start of the runway or after the first or second touchdown.
