AAIB Bulletin

12/2018

BAE Systems (Operations) Ltd ATP	SE-MHF	14-Dec-17	3
BAE Systems (Operations) Ltd ATP	SE-MHE	14-Feb-18	15

Piper PA-28-161 Cherokee Warrior III	G-WAVS	08-Jan-18	34
--------------------------------------	--------	-----------	----

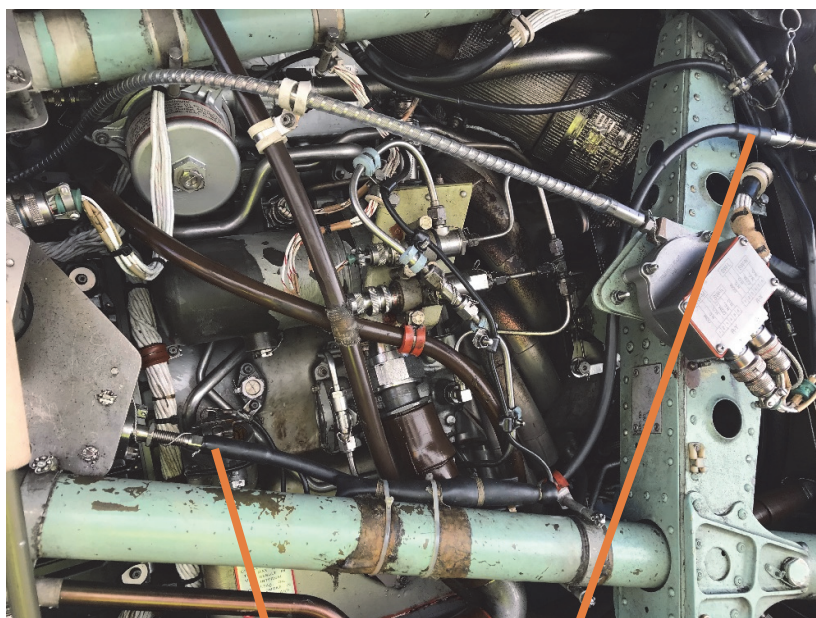
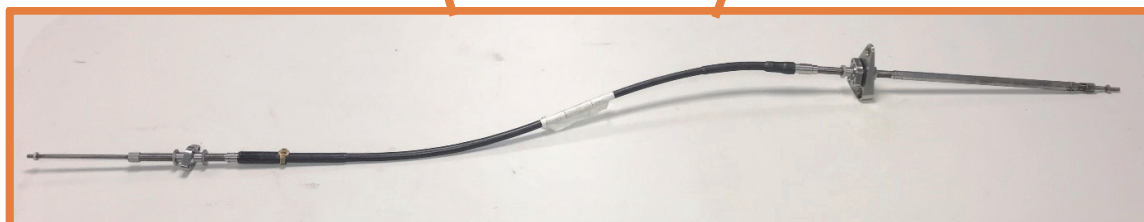
Figure 7

Between 2014 and 2018, the operator recorded six events on their ATP fleet where pilots reported 'restricted', 'stiff / notchy' or 'frozen' power levers. There was no confirmed link between the events but the engine power 'Bowdenflex' control cables were cited as a possible cause because of their apparent susceptibility to moisture ingress and freezing; the control cables are under the engine cowls (Figure 7).

Bowdenflex cable

In December 2017, the manufacturer introduced an electronic Service Information Leaflet (eSIL) 76-ATP-800-1, recommending operators to periodically purge moisture from the cables using low pressure nitrogen or air. The manufacturer recommended a periodicity of 150 flights but stated that operators should amend the frequency based on their in-service experience and operational environment.

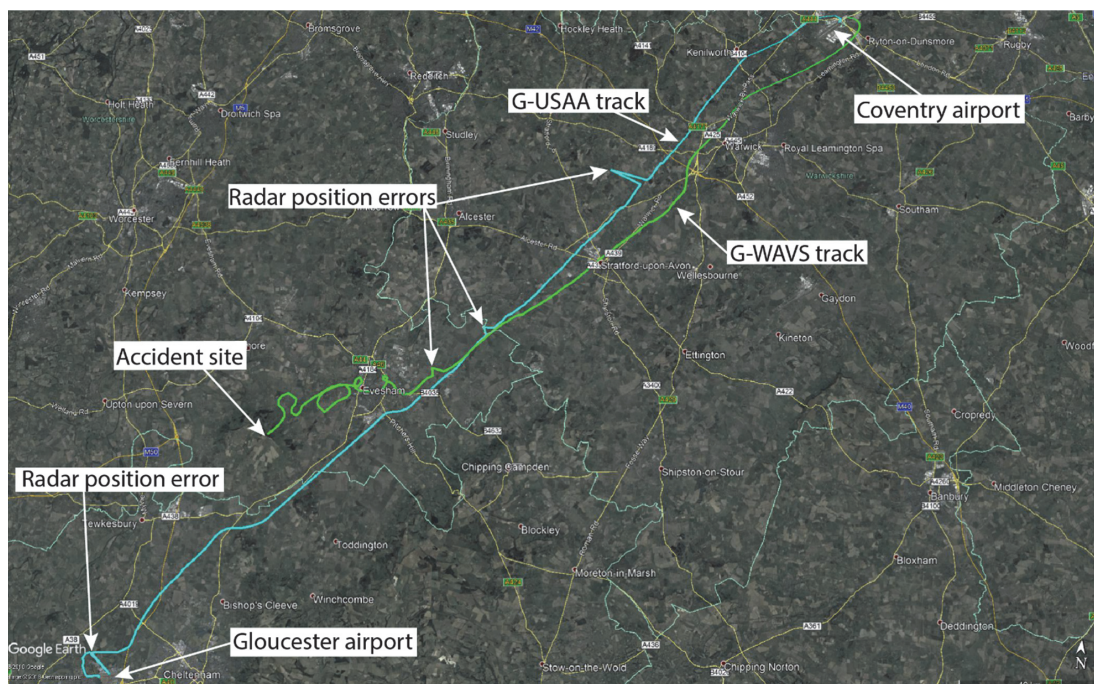
Radar tracks were obtained for both G-WAVS and G-USAA. These covered both aircraft from initial climb from Coventry until G-USAA was on final approach to Gloucester, and for G-WAVS until the last radar return 200 m from the accident site. Figure 3 shows an overview of both tracks.

Radar tracks of G-WAVS & G-USAA

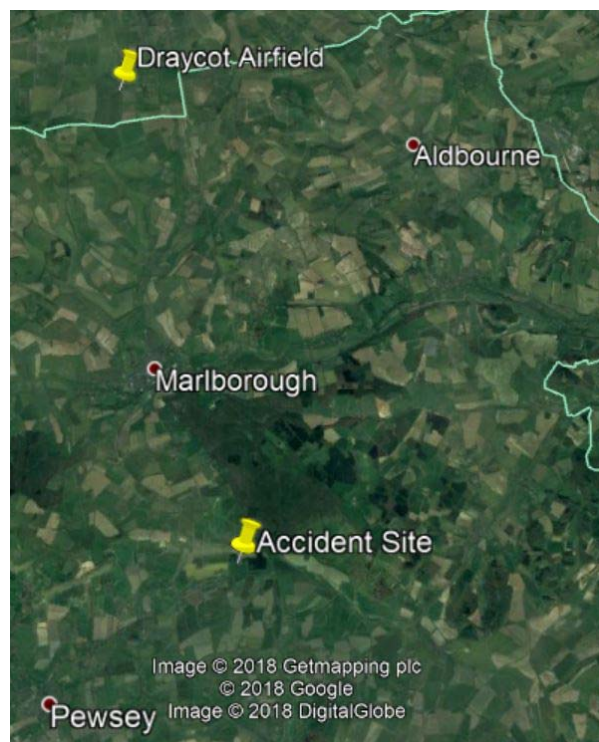
Another witness described the aircraft as “spinning around one wing and looked very nose-down” before his view was obscured by trees. The accident site was surrounded by tall trees on three sides and none of the witnesses saw the aircraft hit the ground. The accident site was located approximately 7 miles from Draycot (Figure 1).

Figure 1
Accident geography

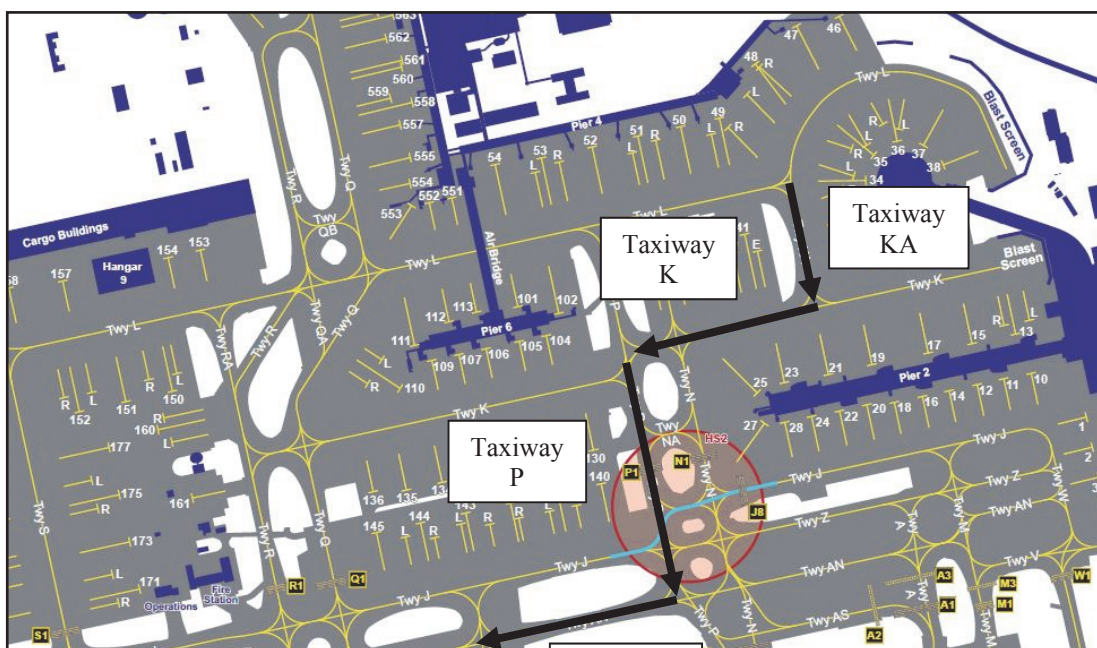
At 2137 hrs, the aircraft pushed back from its stand at LGW. The aircraft taxied out for Runway 26R via Taxiways KA, K to hold at Holding Point P1. At 2156 hrs, the aircraft was given a conditional clearance to line up on Runway 26R after a landing A320. At 2158 hrs the aircraft crossed the holding point at P1 and taxied via P and AN to the runway. Whilst on Taxiway AN, before entering the runway, the crew received their takeoff clearance. Figure 1 shows the taxi routing taken by G-CKWC.

G-CKWC taxiway routing at LGW

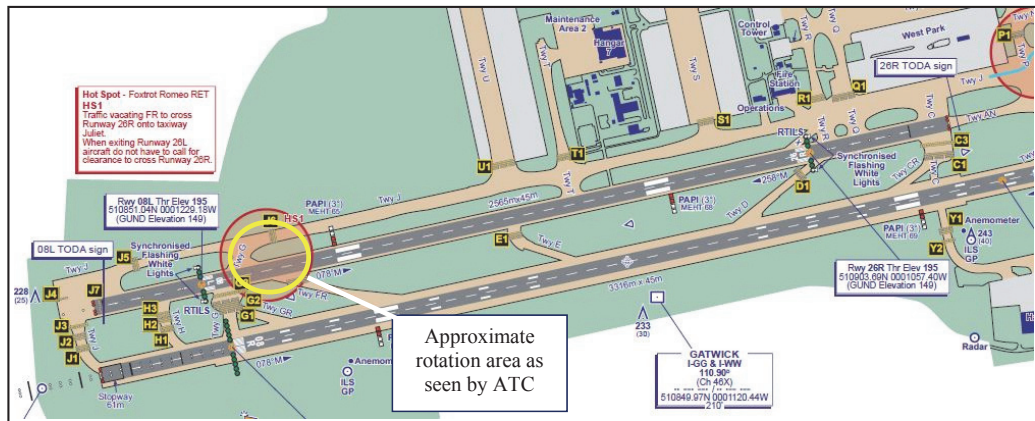
Figure 2

The crew elected to perform a rolling takeoff. The tower controller noted that the aircraft did not appear to put on power or accelerate until at the Runway 26R landing threshold. The controller also saw that the aircraft did not appear to rotate until approximately abeam Taxiway FR as shown in Figure 2. The crew later recalled that there was not much runway remaining at lift-off.

Full length of Runway 26R

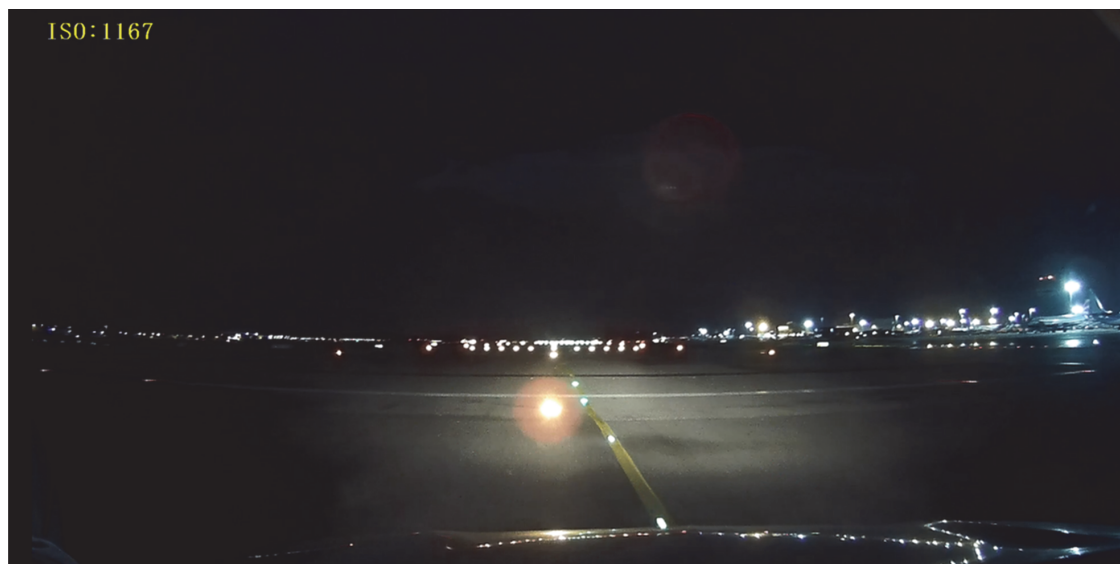
Figure 6

Start of Runway 26R at night
(Photo courtesy of Gatwick Airport Limited)

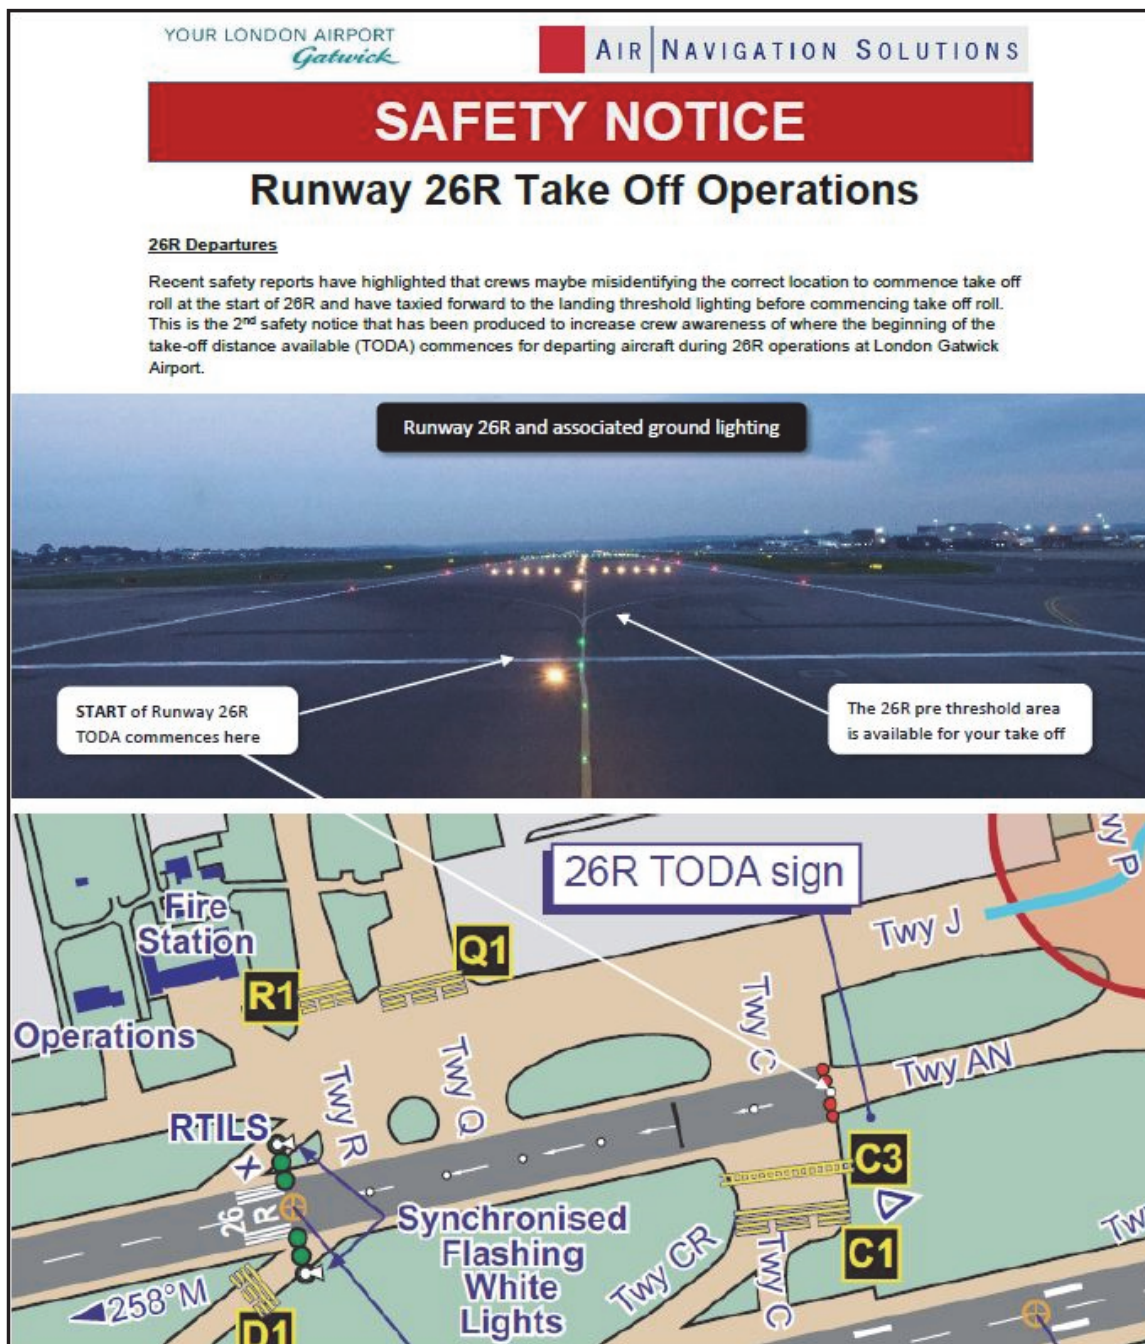
Figure 7

Safety Notice issued by Gatwick and the ANSP

Following this serious incident, the airport operator and ANSP introduced further measures to reduce the likelihood that aircraft would begin their takeoff from the incorrect point on Runway 26R. These measures, which are described in detail later in the report, included a Safety Notice (Figure 7) and revised runway markings between the beginning of the TORA and the displaced threshold (Figure 8).

- A Safety Notice was published on 13 April 2018 to provide further information for pilots on the location on Runway 26R from where they can commence their takeoff. This Safety Notice was subsequently amended and reissued to include a photograph with the airfield lighting illuminated. This amended notice is shown at Figure 7.
