AAIB Bulletin

2/2019

Published 14 February 2019

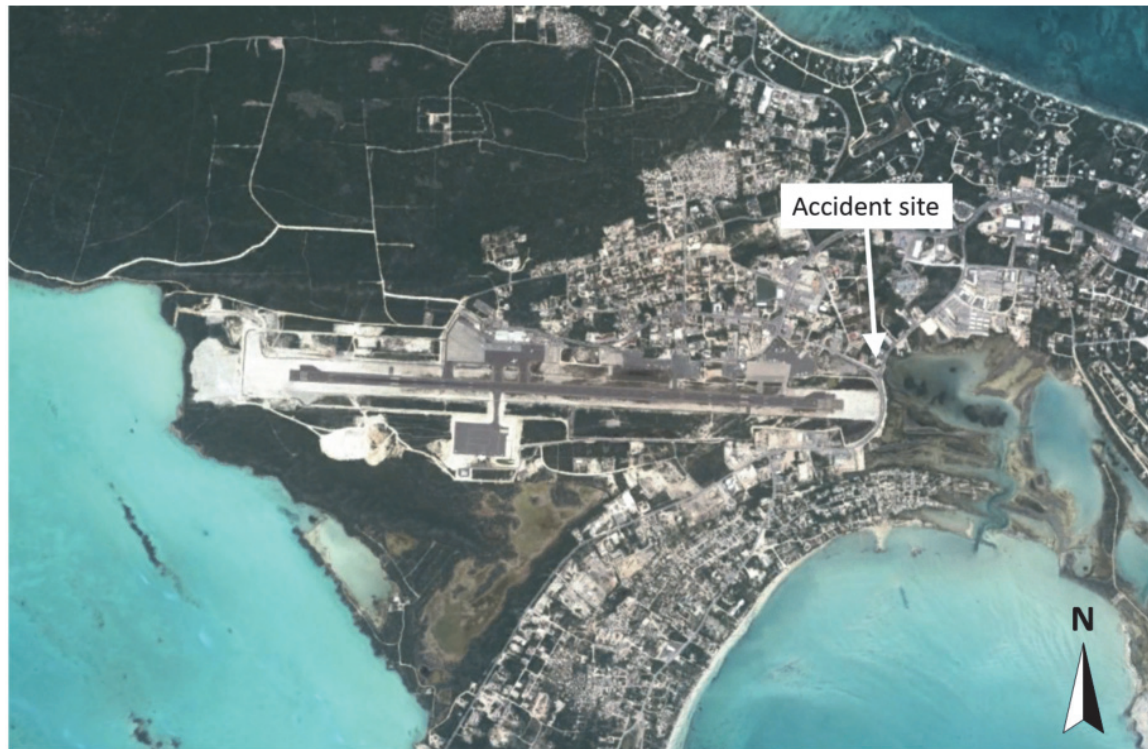
Figure 6

The aircraft had struck the ground to the north of the airport and outside the perimeter fence (Figure 6). The accident site was a corner piece of undeveloped land bordered by roads and next to a petrol station. Police and fire services arrived at the scene quickly but a fierce fire had taken hold. The aircraft occupants were fatally injured. Post-mortem investigations showed that it is highly likely both occupants died instantly due to the initial impact.

General area around the airport © Google Earth

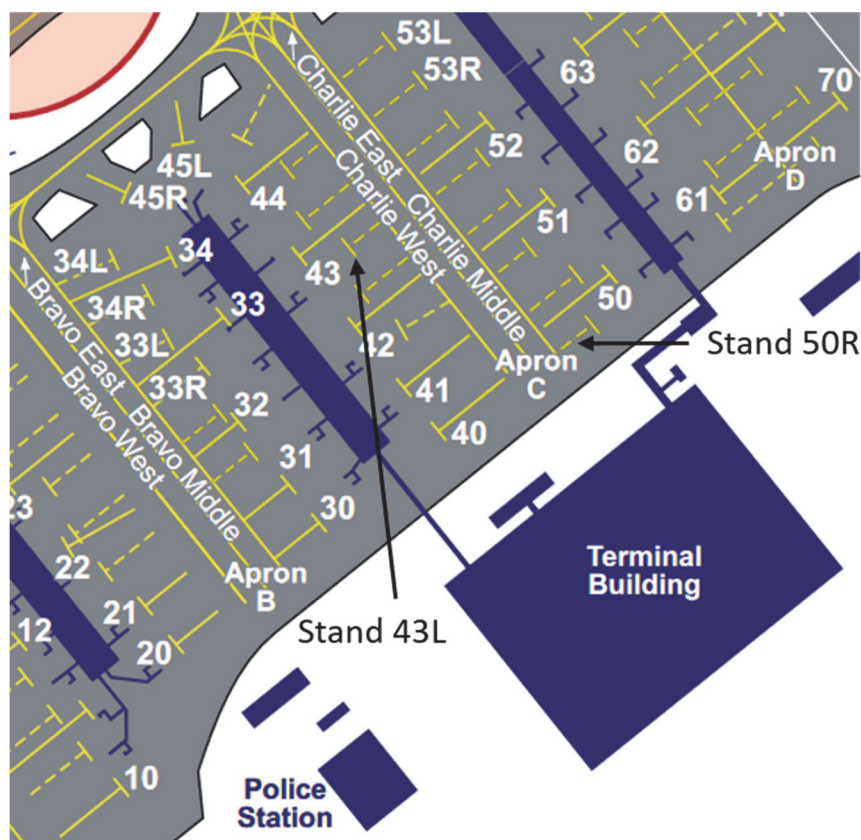
Figure 1

The aircraft was parked on stand C43L with the headset operator on the right side of the aircraft, in communication with the flight deck and the tug driver in his driving position. The weather was described as poor visibility with strong winds and heavy rain causing standing water, reflecting the airport lights and making the ground markings difficult to see. The intended stands and taxi lines are shown at Figure 1.

Parking stands and taxi lines with 50R being closest to the blast fence.

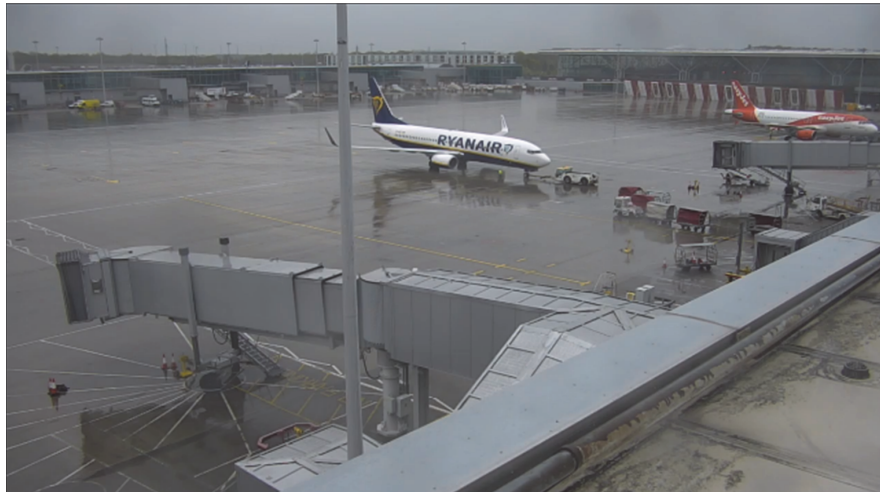
Figure 2

Closed-circuit Television (CCTV) of the event showed that the aircraft was pushed back but moved slightly from side to side as the tug driver attempted to locate and follow the taxi line. When the tail of the aircraft contacted the blast fence, the tug stopped and then reversed a short distance before becoming stationary. The images in Figures 2 to 6 were taken from the CCTV recording.

Initial pushback from the Stand 43L

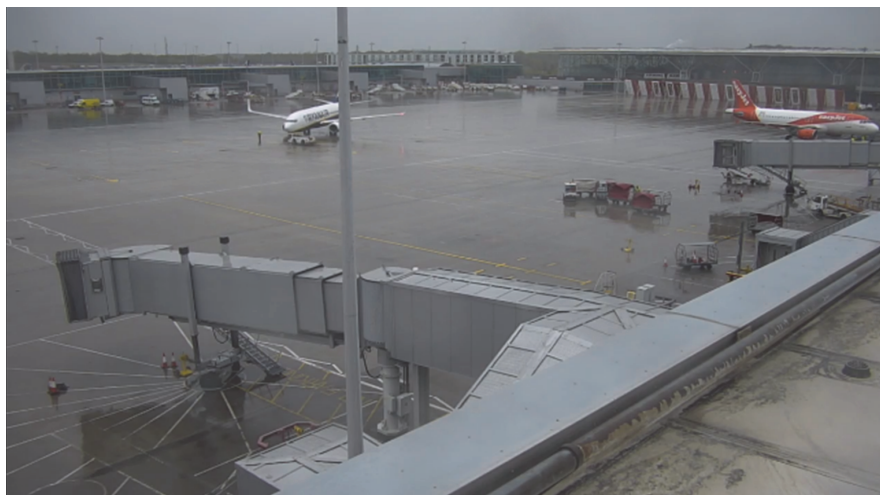
Figure 3

The aircraft approaching the taxi line with the headset person on the right side of the aircraft

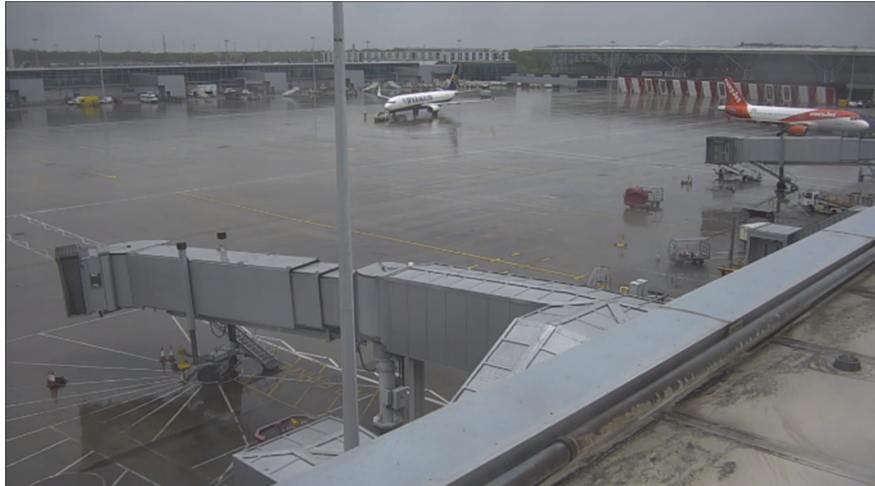
Figure 4
The aircraft established on the taxi line

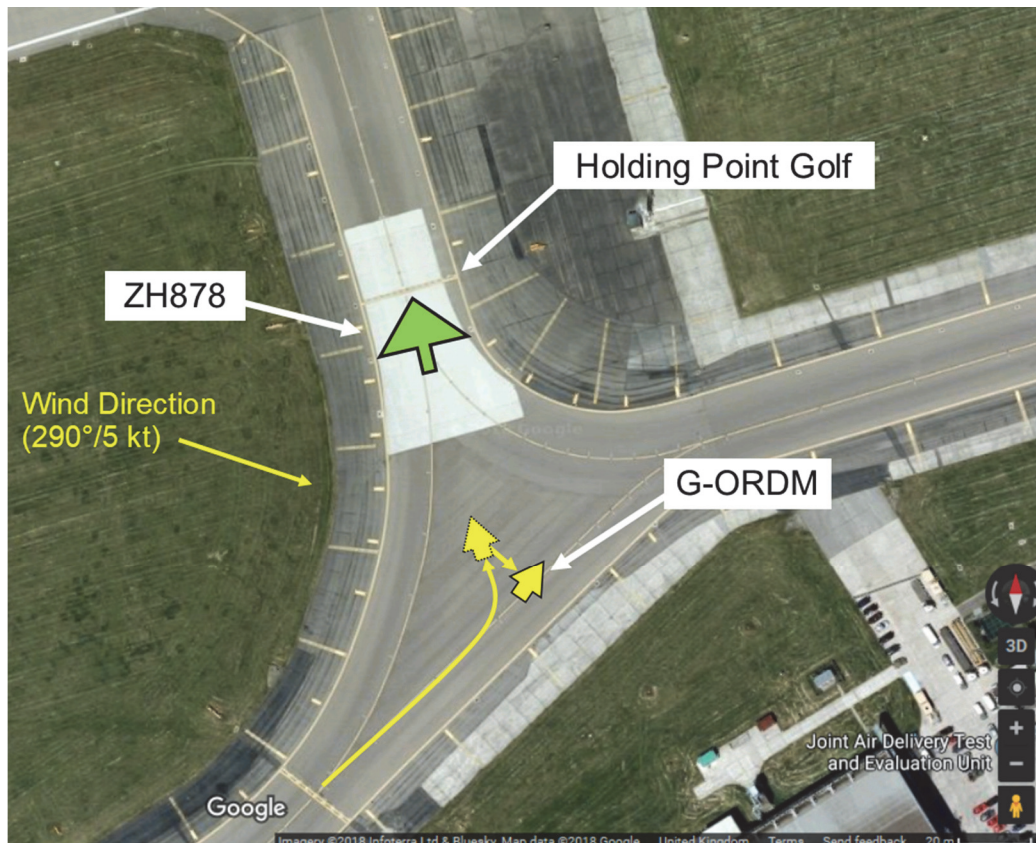
Figure 1

G-ORDM had taxied behind ZH878 to Holding Point G (Golf) at RAF Brize Norton, with the pilot maintaining, what he assessed to be, 50 to 100 m separation behind the C-130J. He did not encounter any adverse propwash effects while taxiing to the holding point. On arrival at Golf, he began to turn his aircraft into wind to conduct engine power-up checks. At this point, ZH878 was stationary while the crew completed their Pre-Take Off checks unaware that G-ORDM was behind them (Figure 1). The last item in those checks was the Propeller Overspeed Check which required an increase in engine power from Ground to Flight Idle.

Relative positions of the aircraft at Golf and approximate ground track of G-ORDM
