AAIB Bulletin

3/2019

Aircraft Type and Registration:	Piper PA-31, N250AC	
No & Type of Engines:	2 Lycoming TIO-540-A2C piston engines	
Year of Manufacture:	1976 (Serial no: 31-7612040)	
Date & Time (UTC):	6 September 2017 at 1723 hrs	
Location:	Caernarfon Airport, Gwynedd	
Type of Flight:	Private	
Persons on Board:	Crew - 1	Passengers - None
Injuries:	Crew - 1 (Fatal)	Passengers - N/A
Nature of Damage:	Aircraft destroyed	
Commander's Licence:	Commercial Pilot's Licence	
Commander's Age:	62 years	
Commander's Flying Experience¹:	Over 4,000 hours (with experience on type) Last 90 days - unknown Last 28 days - unknown	
Information Source:	AAIB Field Investigation

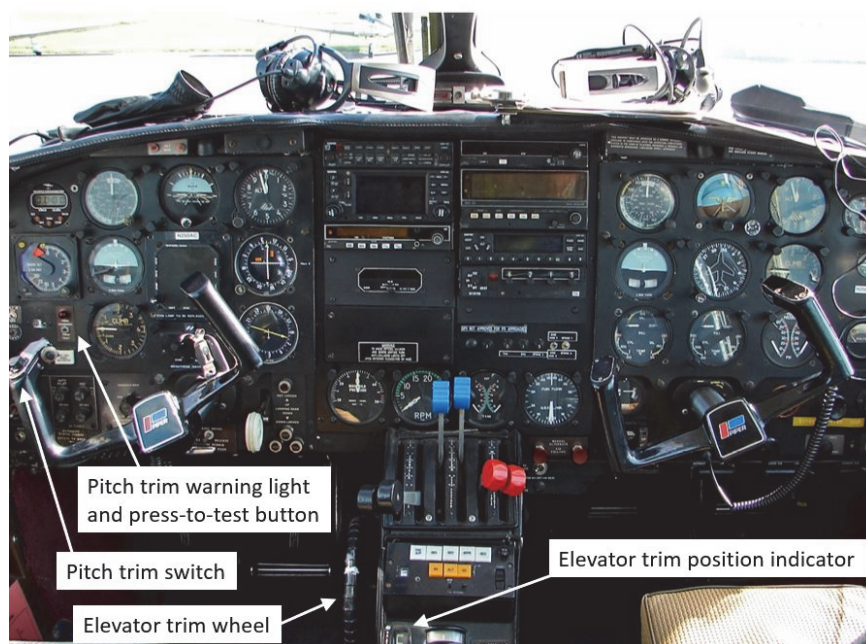
Figure 3

N250AC cockpit, showing trim controls (image used with permission)

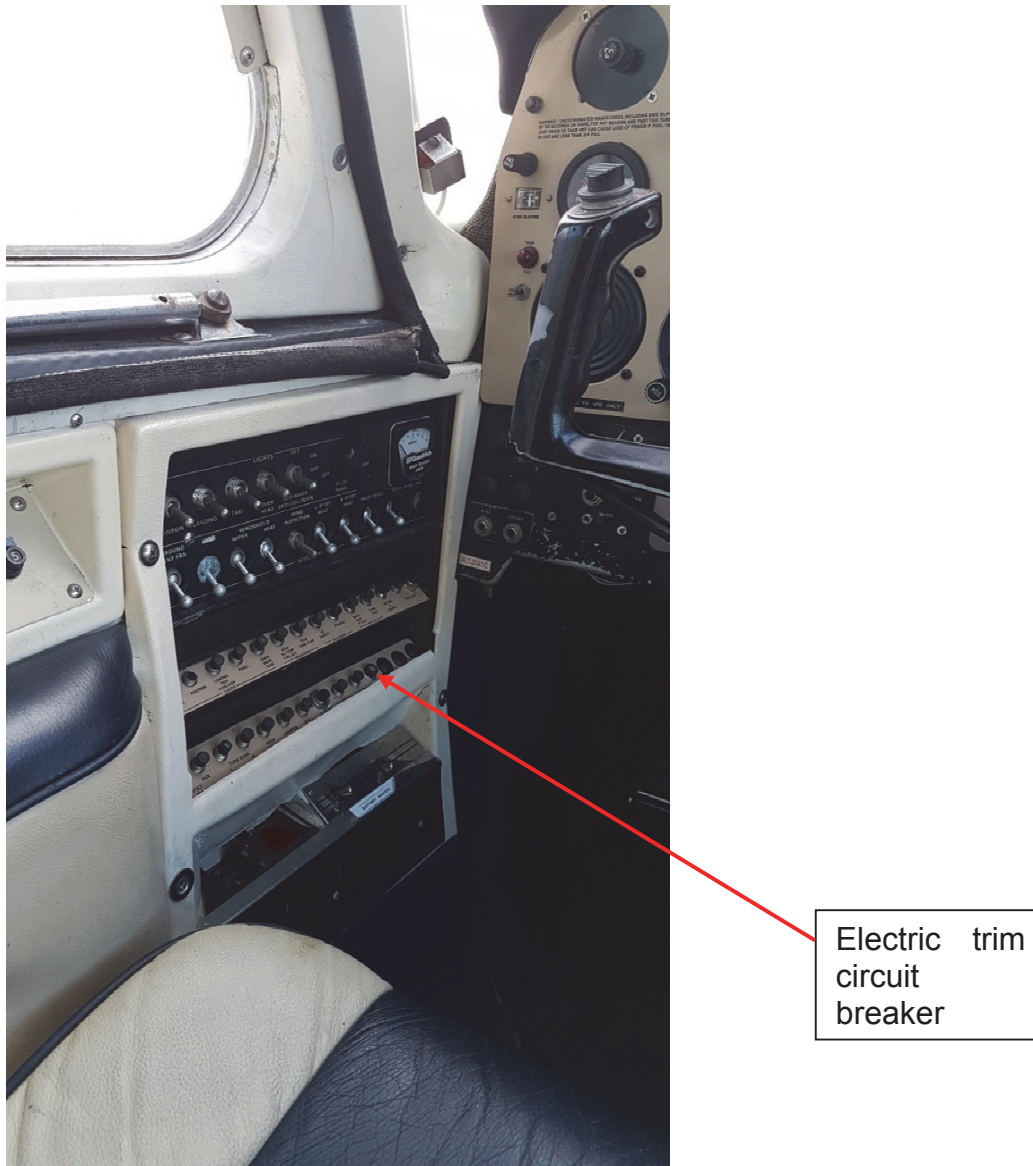
Figure 4

Electrical switches for the aircraft's systems, including the master switch, are located on the circuit breaker panel on the left cockpit sidewall (Figure 4). Circuit breakers are provided that automatically open each electric circuit should an overload occur. The pitch trim servo has a dedicated circuit breaker located on this circuit breaker panel. It is possible to manually open the circuit breakers by pulling their reset buttons outwards, which disconnects the selected circuit from electrical power.

Circuit breaker panel in a representative PA-31

The damage from the post-impact fire had destroyed the upper fuselage structure and much of the cockpit area. Hence most of the wiring and electrical components in the cockpit, including the circuit breaker panel and the pitch trim switch were not available for inspection.

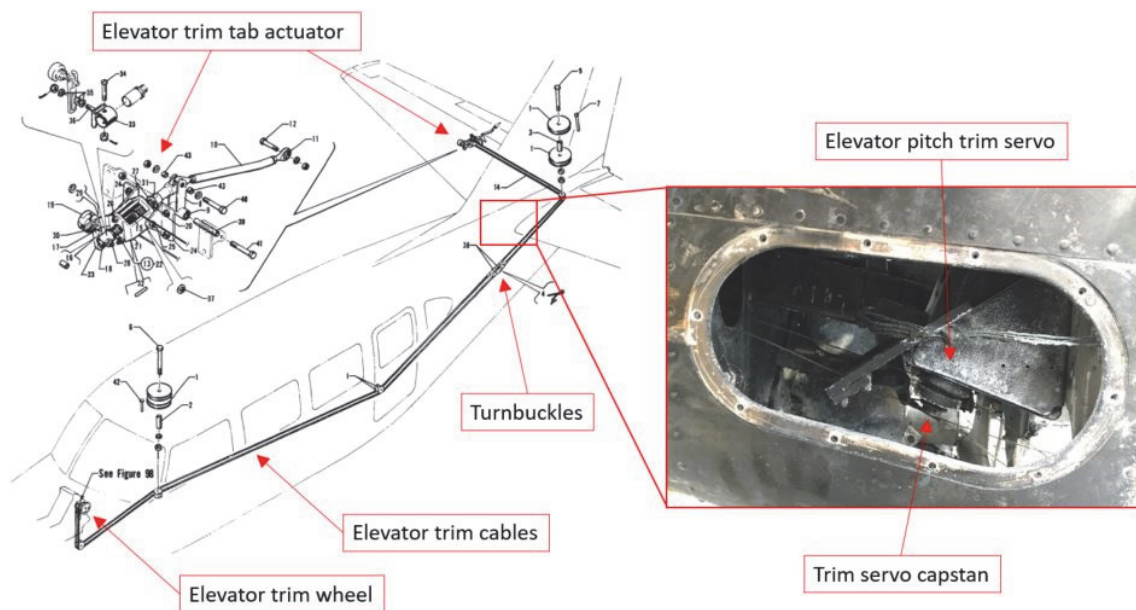
Figure 9

The elevator trim system cables were identified in the aircraft wreckage and found to be continuous from the elevator trim wheel in the cockpit to the elevator trim tab actuator in the right tailplane (Figure 9). Both adjustment turnbuckles within the elevator trim cable system were correctly assembled and wire-locked. The elevator trim cable was correctly wrapped around the pitch trim servo capstan and idler pulley assembly, and the pitch trim servo was securely attached to the airframe within its mounting bracket. Fire damage prevented any electrical wiring or functional checks of the pitch trim servo.

Elevator trim system

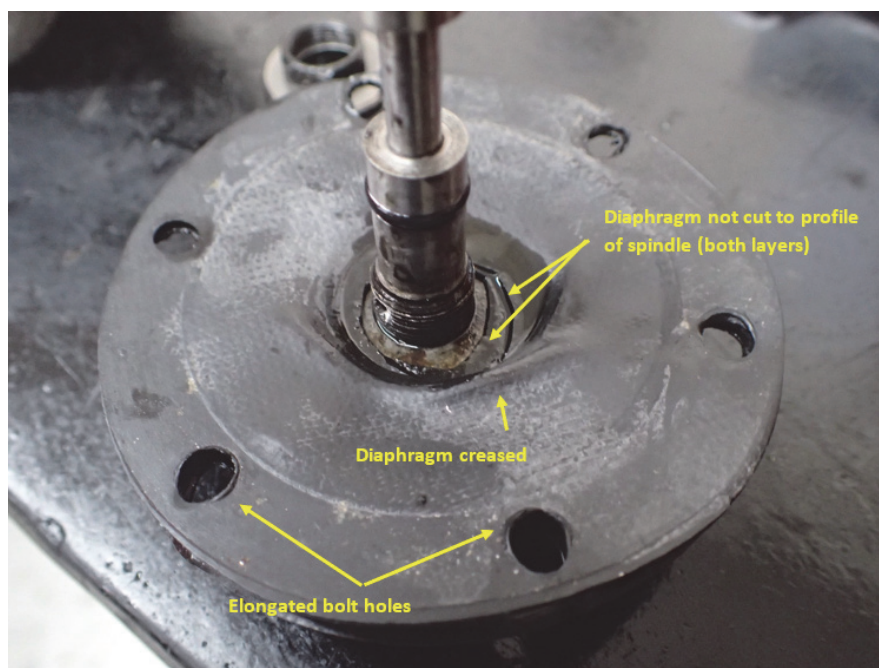
Figure 4

Disassembly revealed that on both pumps the clamping nut at the base of the central spindle was loose, resulting in the internal diaphragm not being adequately clamped. Additionally, the diaphragms did not have the appearance of having been professionally fitted and cut to size, exhibiting stretching and creasing, elongated bolt holes and a crudely-cut central hole (Figure 4). Oil had leaked to the fuel side of the diaphragm, indicating that the diaphragm did not form an effective seal between the fuel and oil (atmospheric) side of the pump. One effect of this is that fuel could escape through the centre of the diaphragm into the oil side of the pump and exit a fuel drain in the upper part of the pump body; this would result in reduced suction.

View showing oil side of diaphragm from right mechanical fuel pump

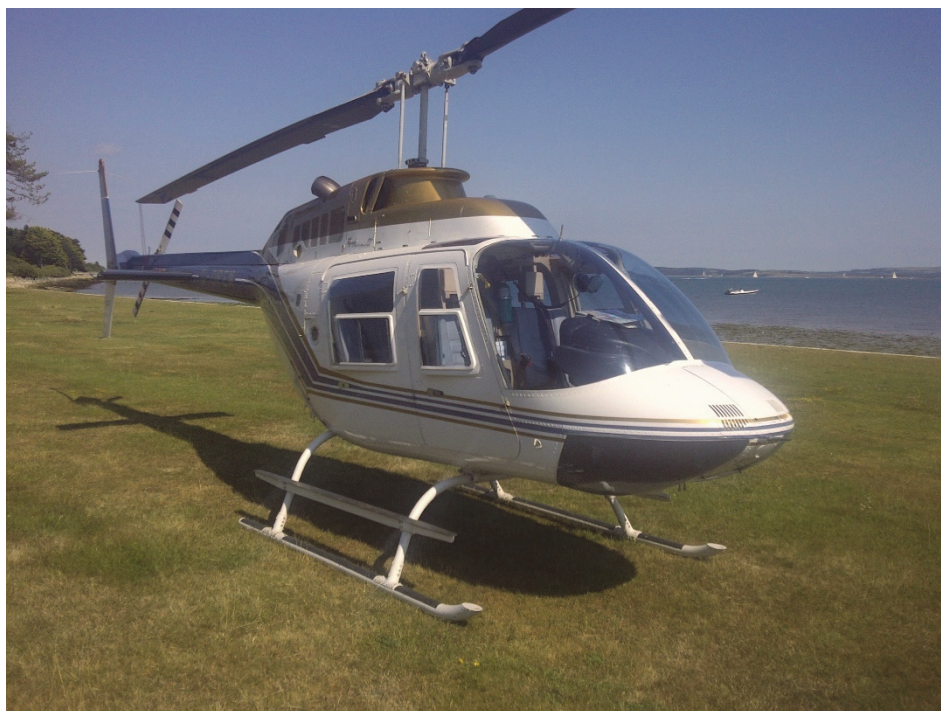
Figure 3

G-OPEN (Figure 3) was a Bell 206B3, a single-engine light helicopter, powered by a Rolls-Royce (Allison) 250-C20J reverse-flow gas turbine engine, driving a two-bladed main rotor system through the main gearbox (MGB).

G-OPEN

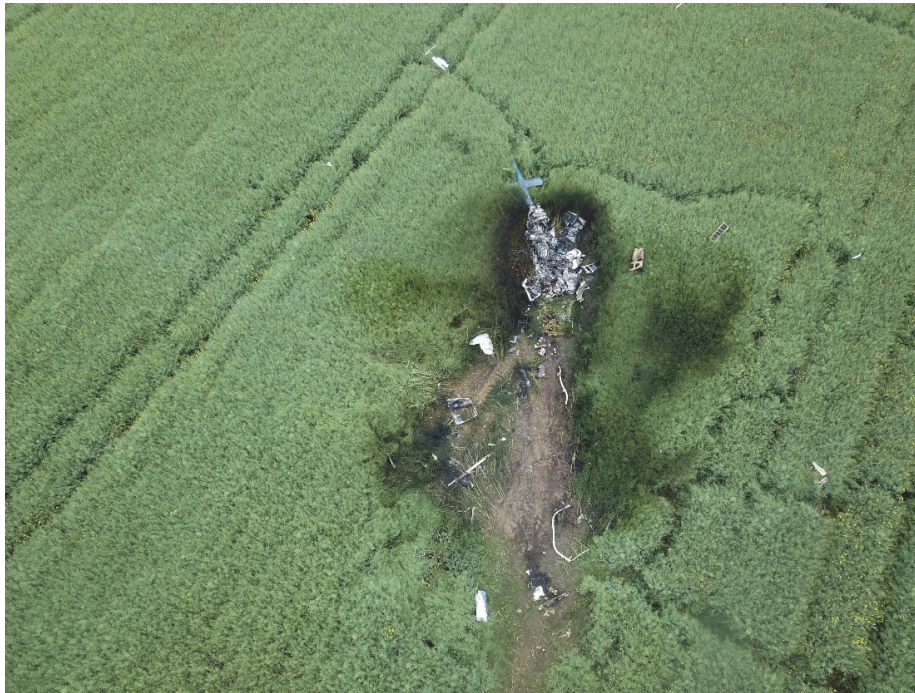
Figure 4

The helicopter had come down in an approximately level attitude on flat ground in a crop field, on an heading of about 270°, striking the ground with a high vertical rate of descent and some forward speed (Figure 4). The distribution of wreckage and ground marks indicated that the tail was the first part of the helicopter to strike the ground, followed by the landing gear and main rotor. The helicopter became inverted and caught fire.

Aerial view of the accident site

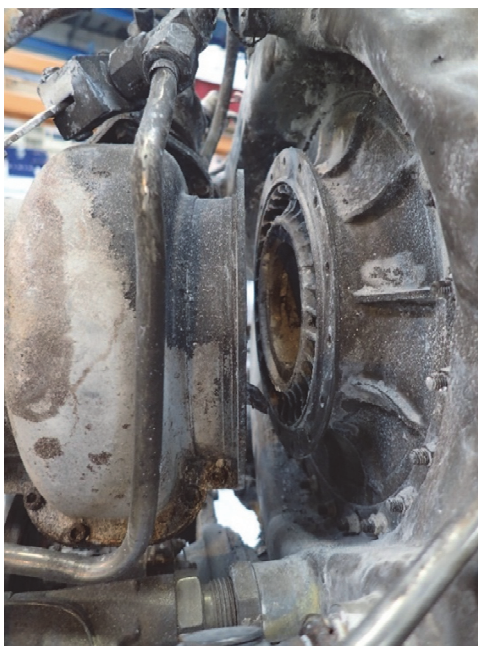
Figure 5

The compressor front support exhibited crushing damage and the axial portion of the compressor had separated from the centrifugal impeller shroud, remaining attached to the engine only by the oil and anti-ice supply and scavenge lines (Figure 5). None of the 16 attachment bolts were found at the accident site or recovered from the wreckage.

Axial compressor detached from impeller shroud

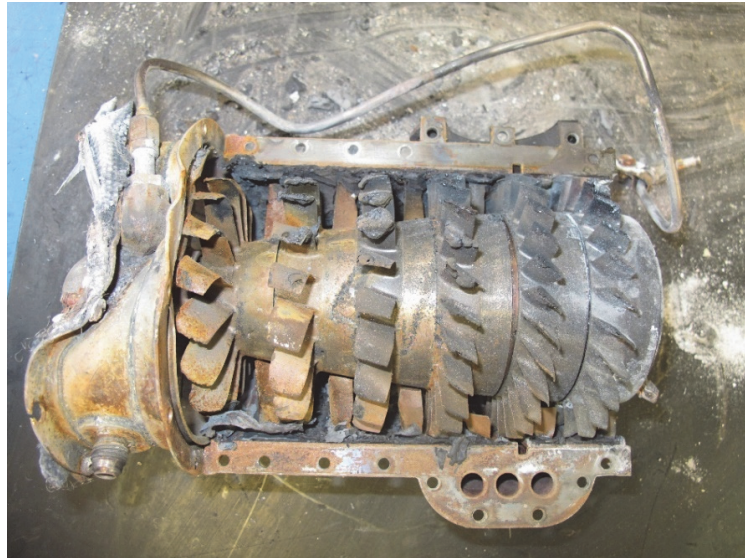
Figure 6

Axial compressor rotor blades

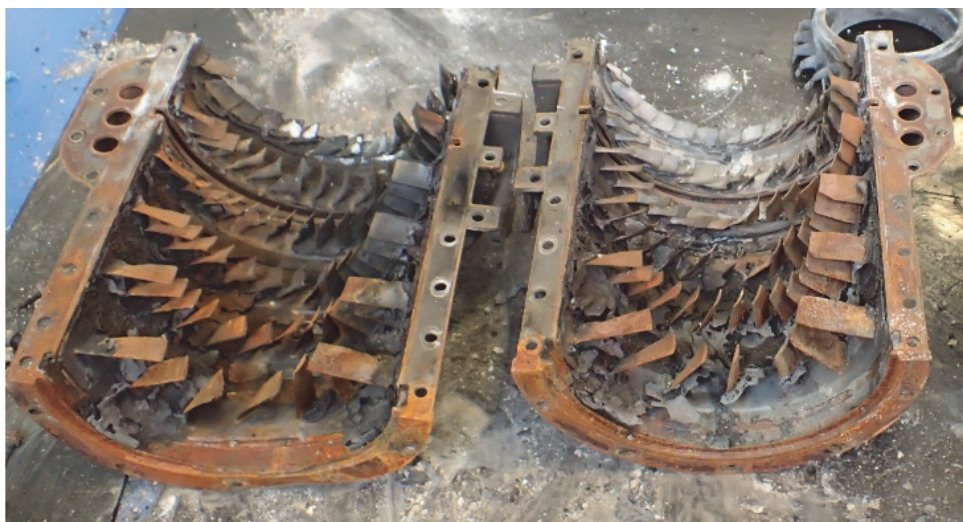
Figure 7

Axial compressor case halves and stator vanes

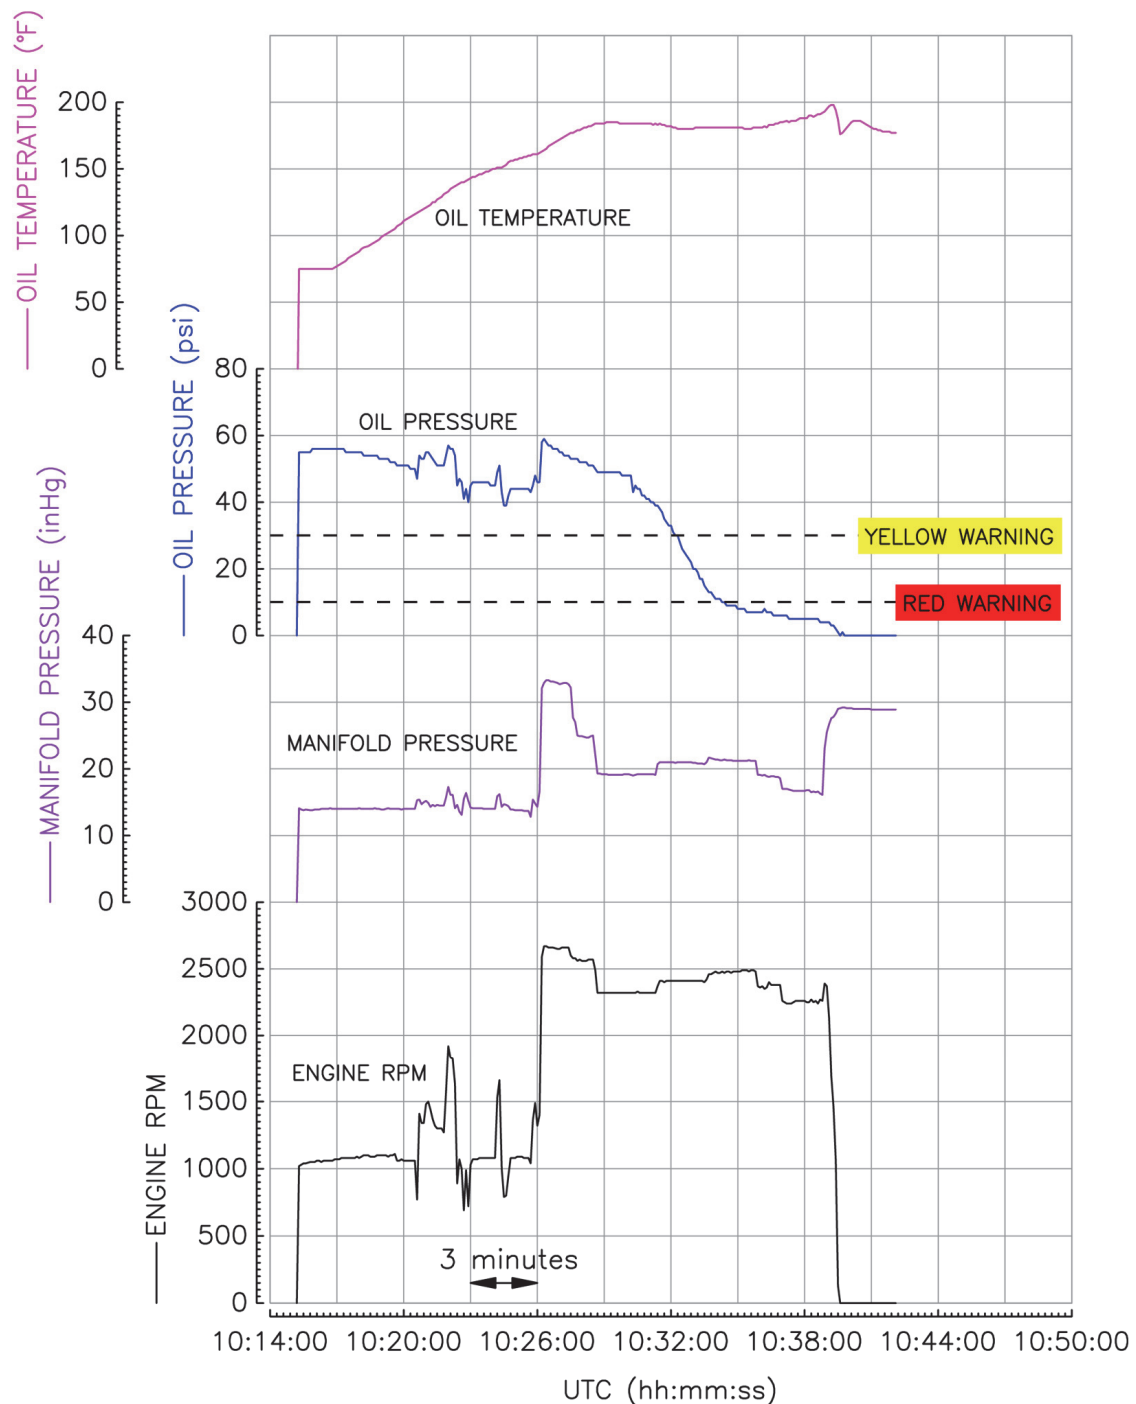
The engine data for the accident flight is plotted in Figure 7. The data shows that the engine had been running for 11 minutes before the rpm and MAP increased for takeoff. During this period the oil temperature rose progressively to 162°F and the oil pressure reduced to approximately 45 psi before peaking at 58 psi as the engine speed was increased to 2,670 rpm. Over the next 13 minutes, the oil temperature continued to increase, peaking at 198°F. Approximately 6 minutes after the start of the takeoff run, the oil pressure reduced to 30 psi (yellow warning) and 2 minutes later reduced to 10 psi (red warning). The engine stopped rotating approximately 13 minutes after the takeoff run commenced. During the flight the CHTs peaked at 346°F, and the EGTs at 1,436°F.

Figure 7
Engine data from accident flight

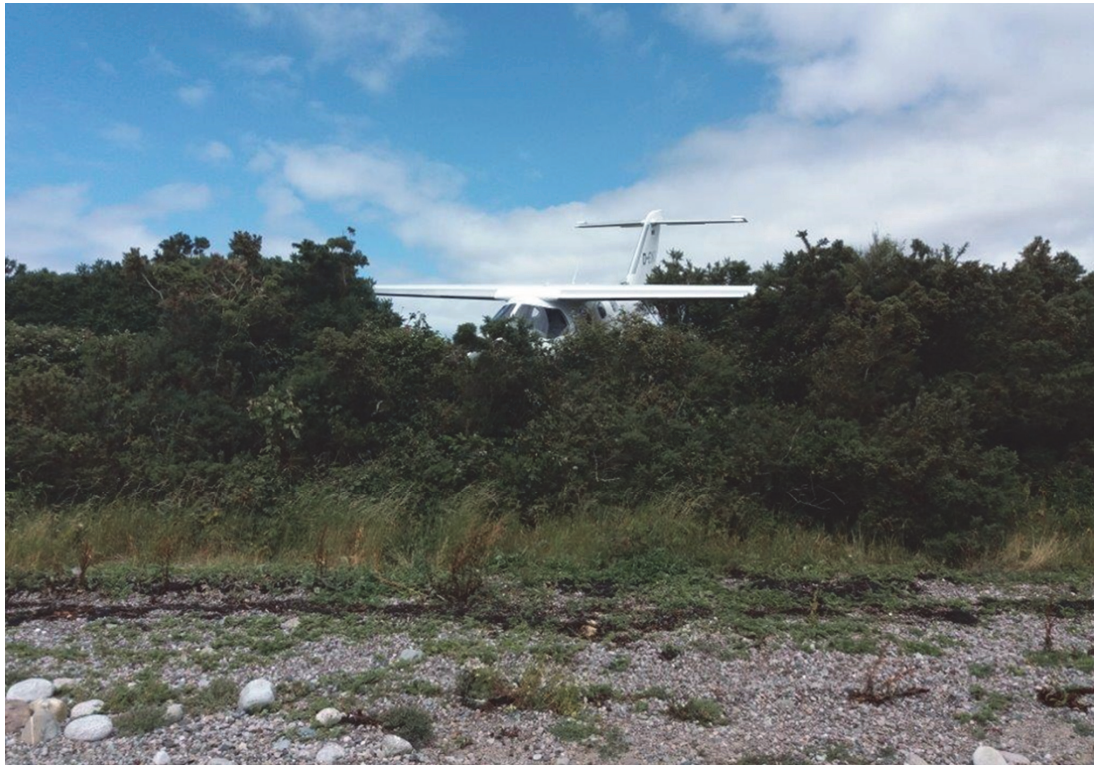
The pilot was cognisant of the fact that locking the wheels would radically reduce braking performance and tried to avoid this while still applying significant braking effort. However, the aircraft failed to stop by the end of the paved surface, overran the runway and struck the airfield boundary fence before coming to a stop in an area of bushes just prior to the shoreline (Figure 1).

Figure 1
Aircraft on the Shoreline

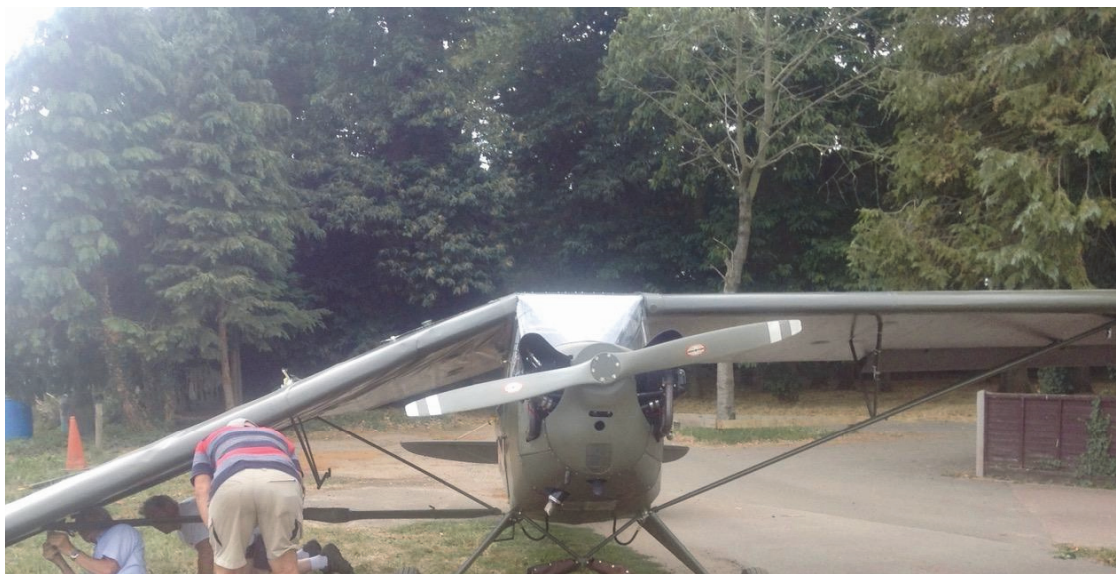
Figure 1
G-BSXT after the accident

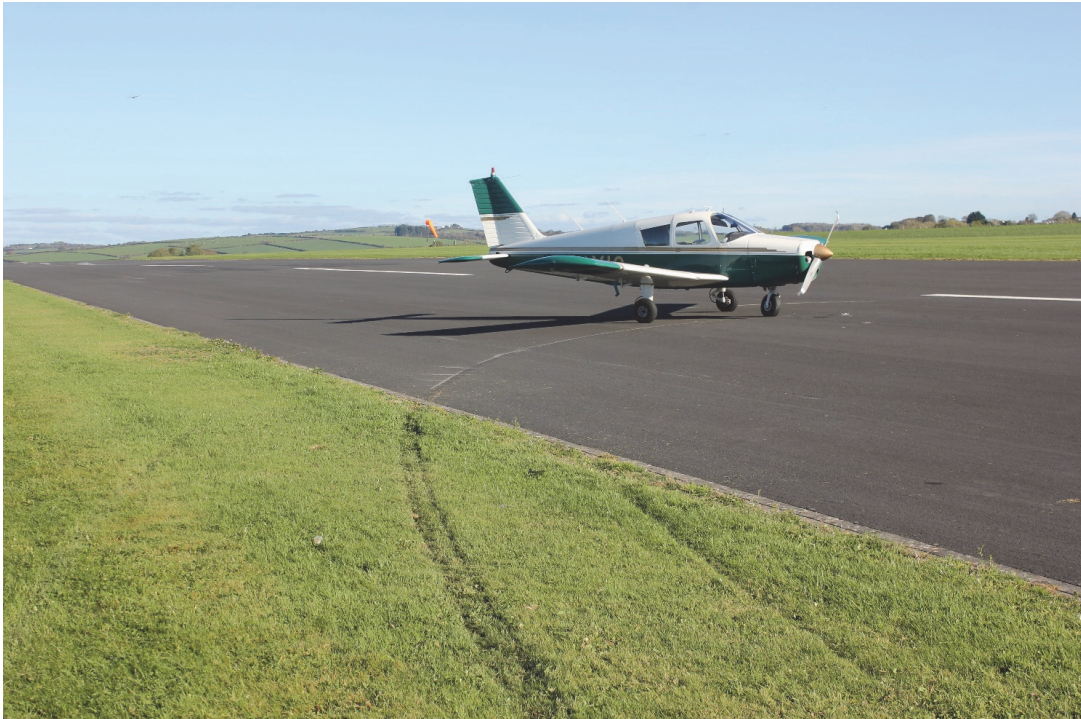
Figure 1

The pilot was completing his third circuit and planned to execute a practice forced landing (PFL) on Runway 07 from mid-way along the downwind leg. There was some right drift on short final on the previous landings, so he offset the PFL approach to the left of the runway extended centreline. The expected right drift did not occur, so the pilot rolled the aircraft to the right to regain the centreline. The aircraft's response was greater than expected, possibly due to the northerly crosswind lifting the left wing, causing the right wing, and the propeller to contact the runway surface. The aircraft slewed across the runway, departing the left side. It skidded left as it rotated to the right, returning to the runway as it did so. The left wing then contacted the runway surface before the aircraft came to rest (Figure 1).

G-AYIG once it had come to rest (note the ground marks showing the path of travel)

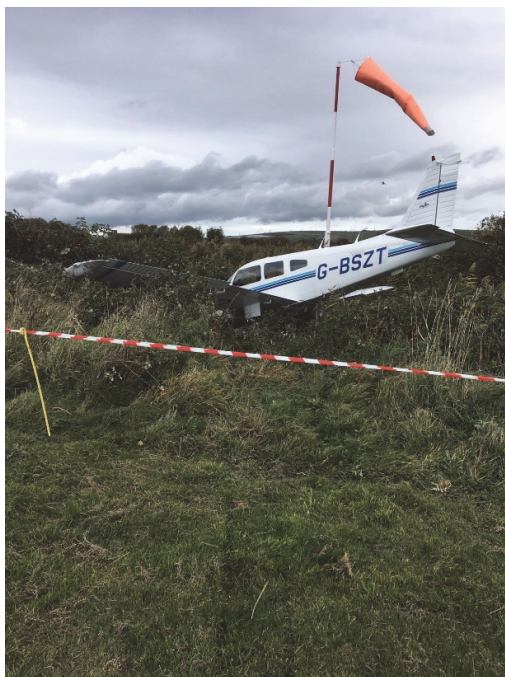
Figure 1

to yaw to the left. The pilot attempted to put the nosewheel back onto the runway by pushing on the control column, but the aircraft departed the runway to the left. Witnesses reported seeing the aircraft bounce across the grass, possibly becoming airborne momentarily due to the rough surface. They also noted that the aircraft seemed to continue at high speed for some time with no apparent reduction in power. Eventually the aircraft was seen to slow but the pilot found it difficult to stop the aircraft before it struck undergrowth. The aircraft then ran into a ditch at slow speed as shown in Figures 1 and 2.

G-BSZT came to rest in a ditch

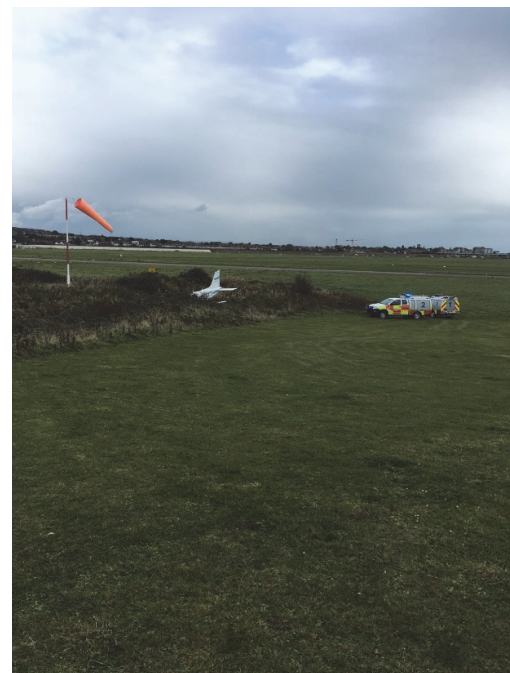
The pilot was unable to keep the aircraft on the runway during the final stages of the takeoff roll. With showers in the vicinity of the airfield, he may have encountered a gust of wind unexpectedly which combined with the crosswind from the left and caused the aircraft to yaw to the left and leave the runway. With the wheels on the grass, the pilot was unable to stop the aircraft before it struck undergrowth and came to rest in a ditch.

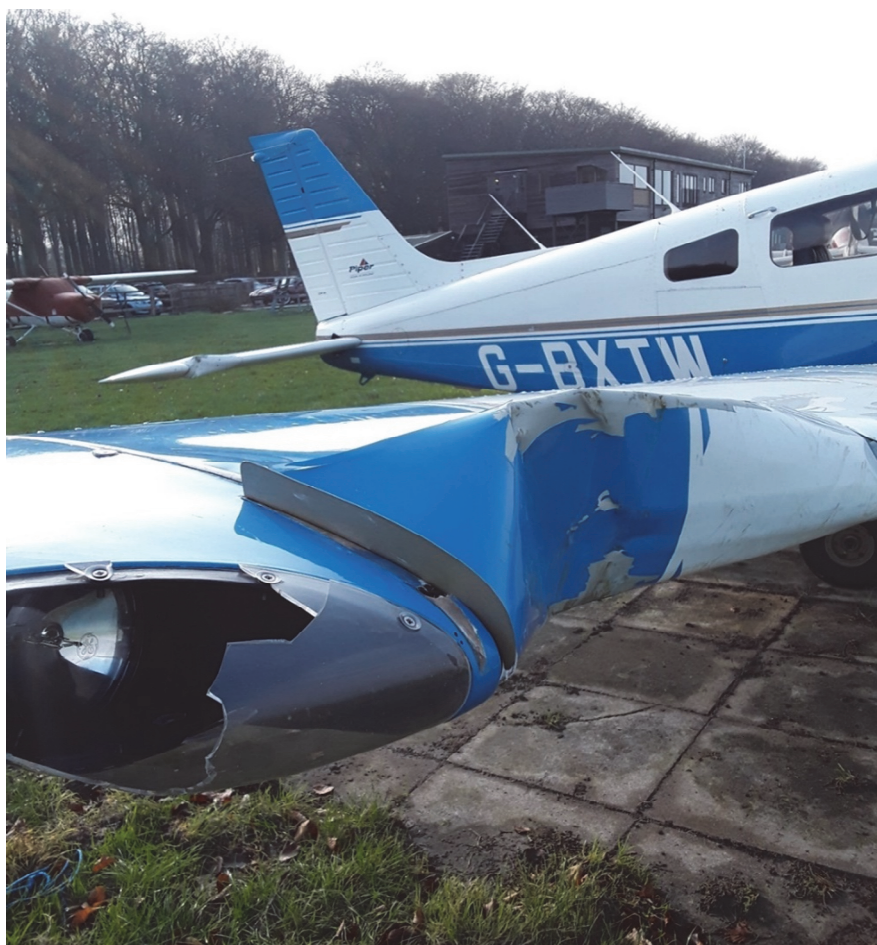
Figure 1

The pilot reported that he thought the approach was "normal" until he heard a bang and realised he had hit the top of trees located to the right and below the approach path. He applied power and left bank to return to the correct path. The aircraft landed normally. Damage was found to the leading edge and tip of the right wing, and to the tailplane (Figure 1).

G-BXTW after the accident showing damage to right wing and tailplane

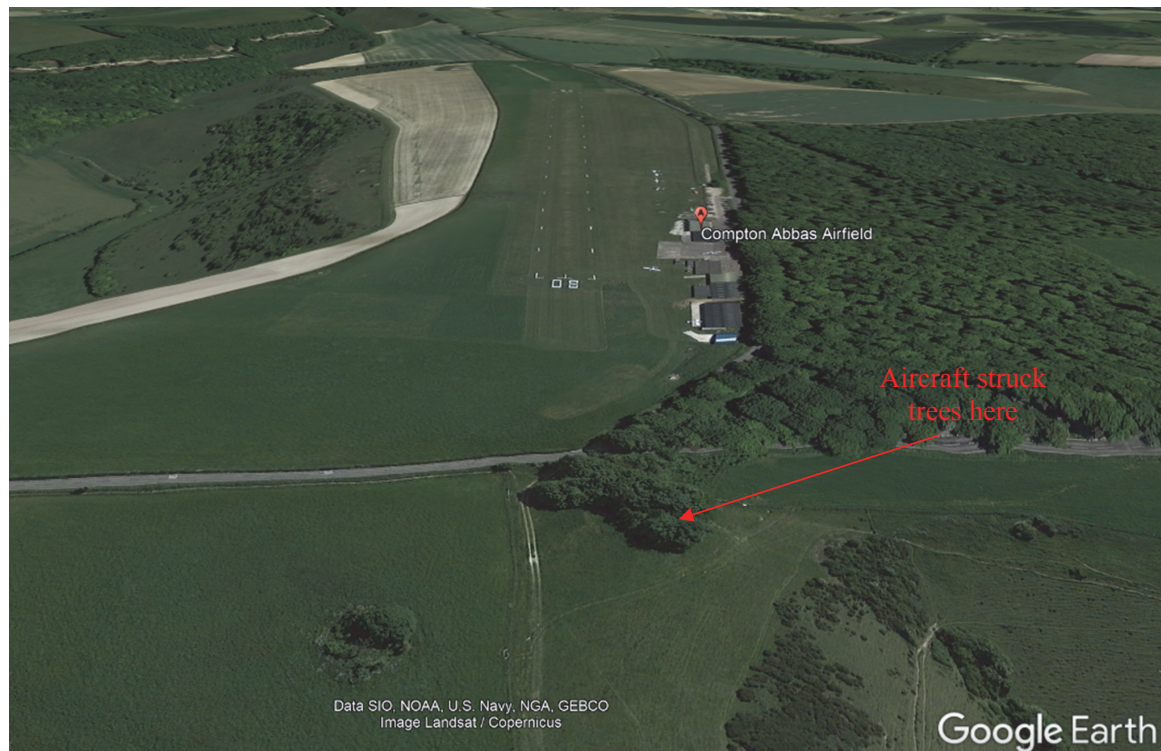
Figure 2

The trees the aircraft struck are located to the right of the approach path (Figure 2). The airfield operator reported that aircraft normally clear these trees by approximately 100 ft to 150 ft and that they are located approximately 100 m to the right of the straight-in approach to Runway 08.

Compton Abbas Airfield (viewed from the east)

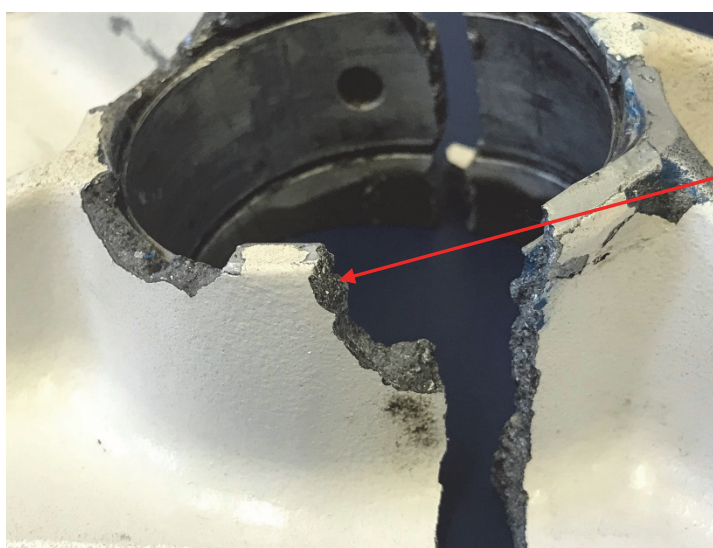
**Figure 3**

Examination of the fracture faces showed that most of the fracture surfaces had suffered from mechanical damage but appeared to show the characteristics of failure in overload. One area was identified which showed the characteristics of crack propagation in fatigue (Figure 3) although damage to the fracture face prevented the identification of the crack initiation site. This area was associated with the area of missing material.

Area of missing material from trunnion

The fracture faces of the failed trunnion showed evidence of failure in overload together with one area which showed the characteristics of crack progression in fatigue. The initiation of the fatigue crack could not be identified due to mechanical damage of the fracture surface.

The PA-28R landing gear was designed to allow the type to operate from unpaved airfields. It is therefore probable that the initiation of the fatigue crack within the trunnion was the result of an unreported abnormal event, such as a heavy landing or rapid taxiing across uneven ground.

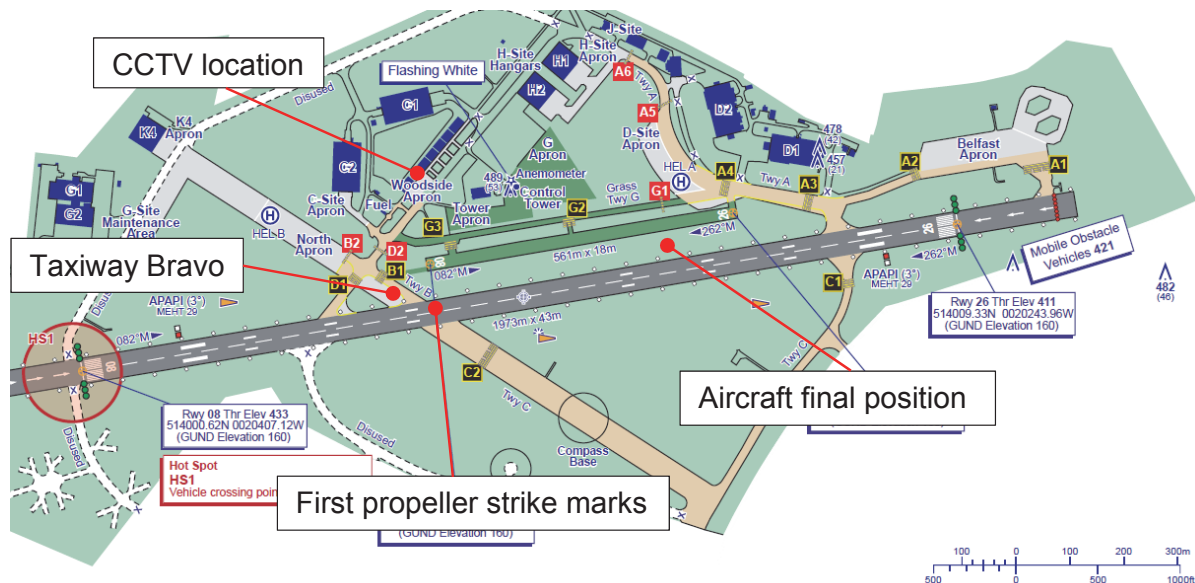
Figure 1
Cotswold Airport

Examination of the runway showed impact marks from the left propeller after the aircraft had passed the intersection with Taxiway Bravo (Figure 1). There were 15 strike marks and the spacing was consistent with an aircraft speed of 70-80 kt. Further along the runway there were more strike marks along with scraping from the left wing and aileron and the aft fuselage. The aircraft halted facing north-west on the grass between the tarmac and grass runways.

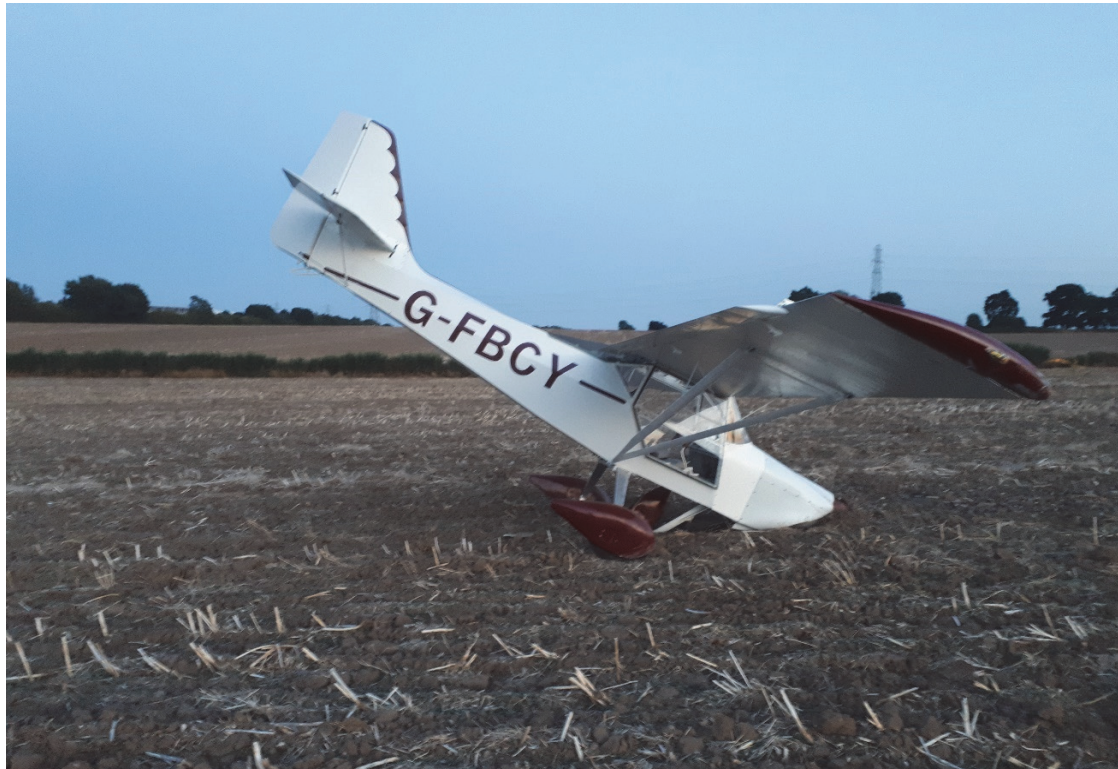
Figure 1
G-FBCY after landing

and had a slight uphill gradient. After touching down, the nosewheel collapsed and the propeller struck the ground (Figure 1). The pilot and his passenger suffered only minor injuries and were able to exit the aircraft unaided.

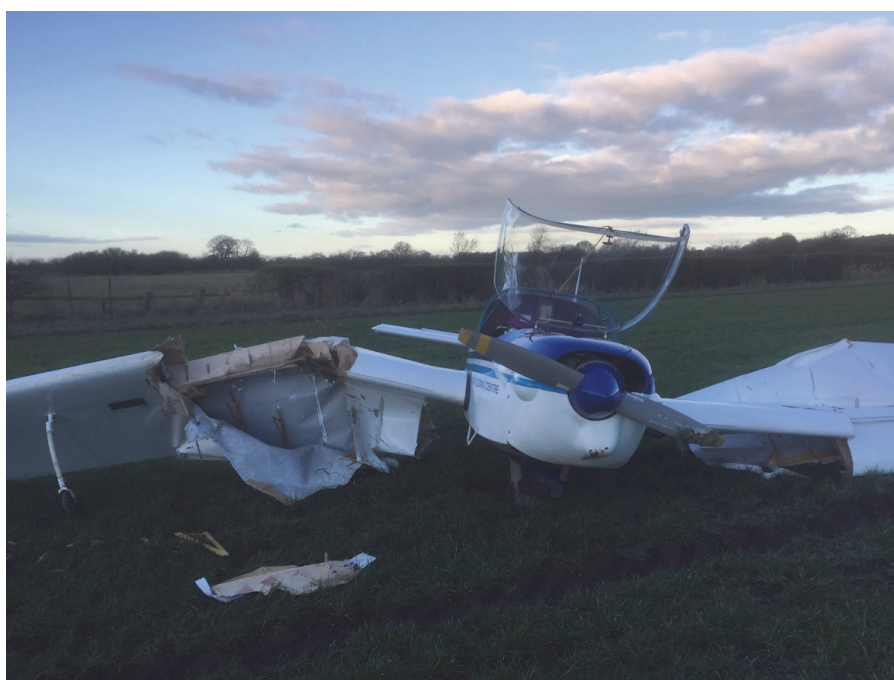
**Figure 2**

G-BUGT after the accident

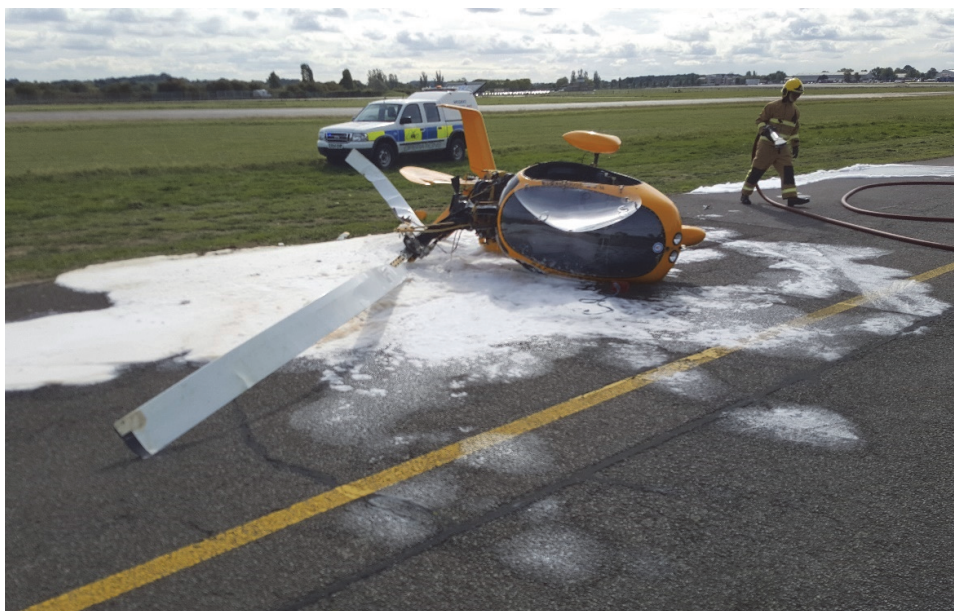
Figure 2
G-BXDE after the accident

The pilot examined the gyroplane after the accident and found the gust lock was not engaged (Figure 3). However, it could not be determined if the gust lock had disengaged during the accident sequence.
