# ***AAIB Bulletin***

***4/2019***

S1/2019 - Piper PA-46-310P Malibu	N264DB	21-Jan-19	3
-----------------------------------	--------	-----------	---

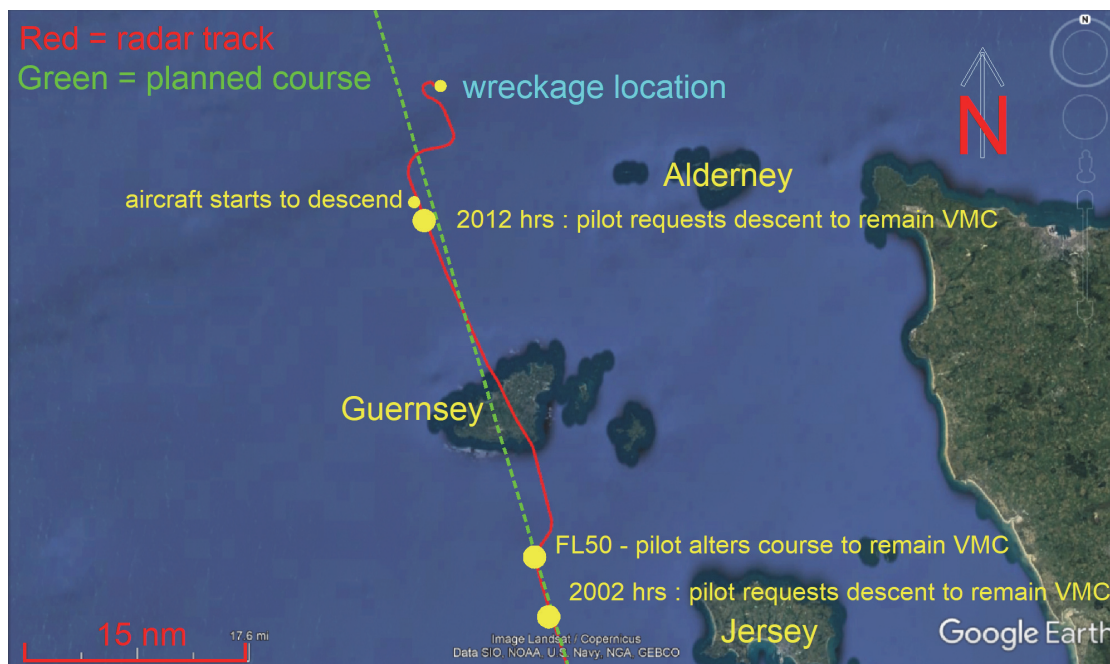
**Figure 3**

Aircraft track in the vicinity of Guernsey

At 2002:10 hrs, N264DB was about 11 nm west of Jersey and 13 nm south of Guernsey when the pilot requested clearance to descend to “MAINTAIN VMC” (Figure 3). The aircraft was cleared to FL50, with the instruction to advise ATC if a further descent was required. Shortly afterwards, the aircraft began to descend whilst also making a right turn followed by a left turn. This positioned the aircraft overhead Guernsey, about 1.5 nm parallel to the planned track. The controller then inquired if N264DB required a further descent, to which the pilot responded: “NEGATIVE, JUST AVOIDED A PATCH THERE, BUT BACK ON HEADING FIVE THOUSAND FEET”.

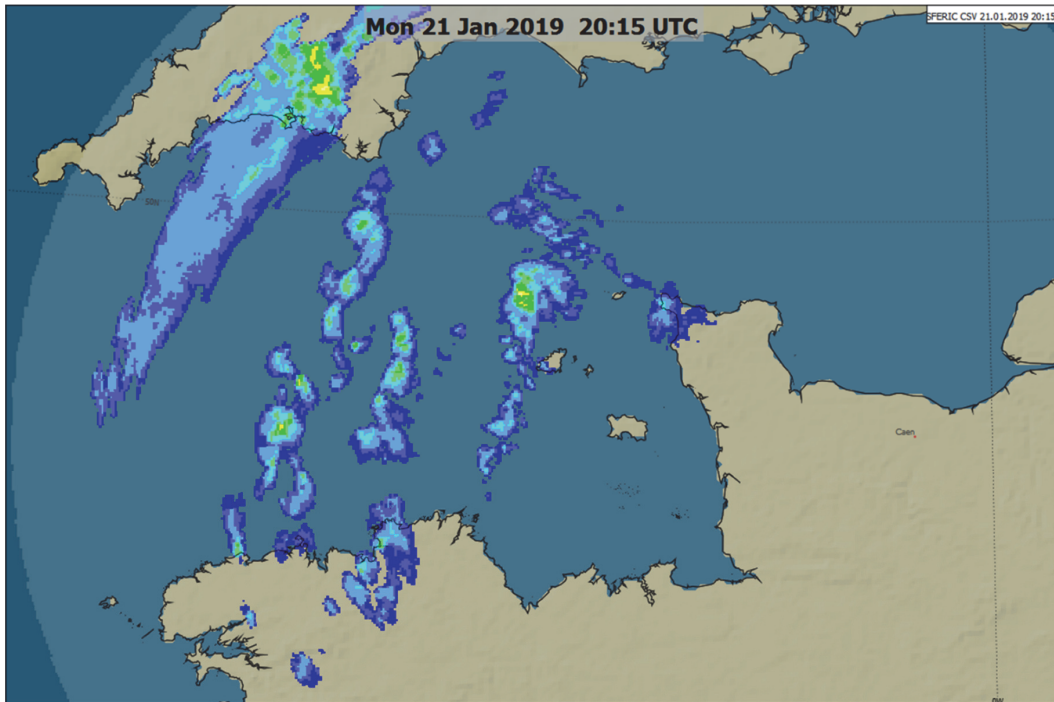
**Figure 4**

The rainfall radar picture at 2015 hrs showed a band of showers, some heavy, passing through the area of flight as shown in Figure 4.

Rainfall radar for 2015 hrs

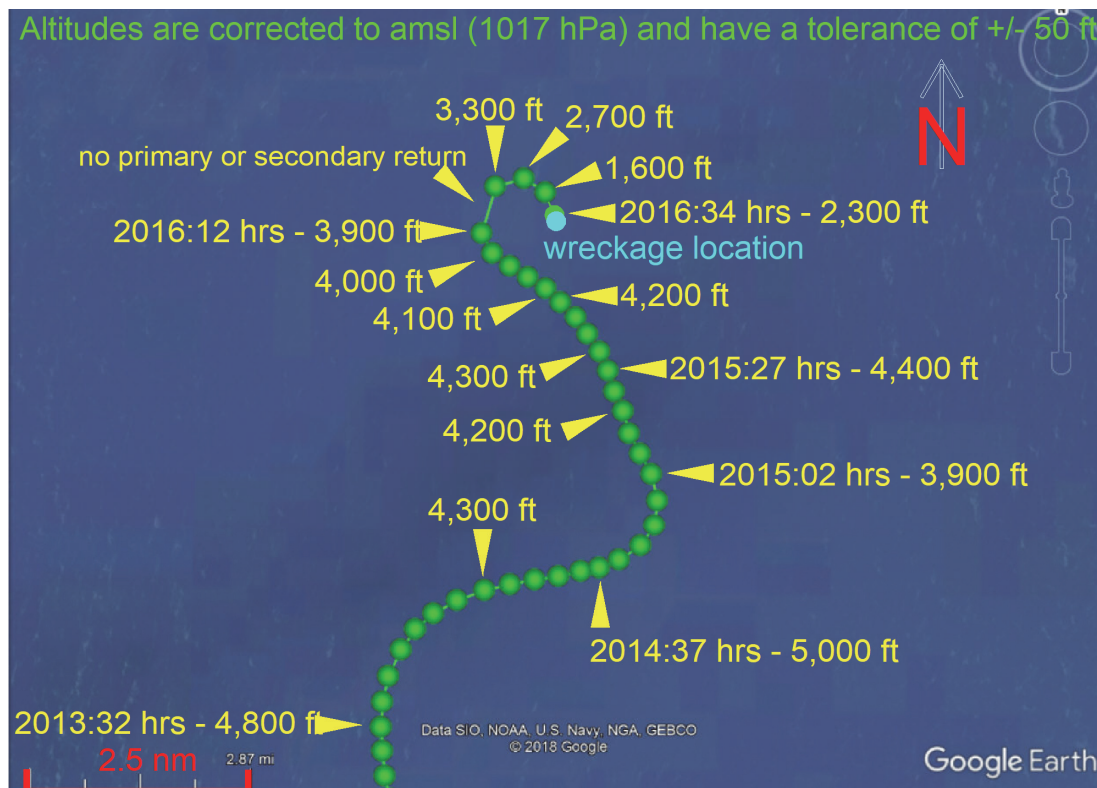
**Figure 10**

N264DB started to descend gradually and turned onto a track of about 060°T (Figure 10). Approximately 30 seconds later the aircraft turned left onto about 305°T. During this sequence of turns the aircraft descended from about 4,800 ft to 4,300 ft, climbed to about 5,000 ft, and then descended again to about 3,900 ft. The aircraft then proceeded to climb to about 4,200 ft on a track that was nearly parallel with the planned course of 343°T. Its average groundspeed was about 175 kt.

Radar track of final section of flight  
(created from a combination of data from Jersey (Les Platons) and Guernsey radars)

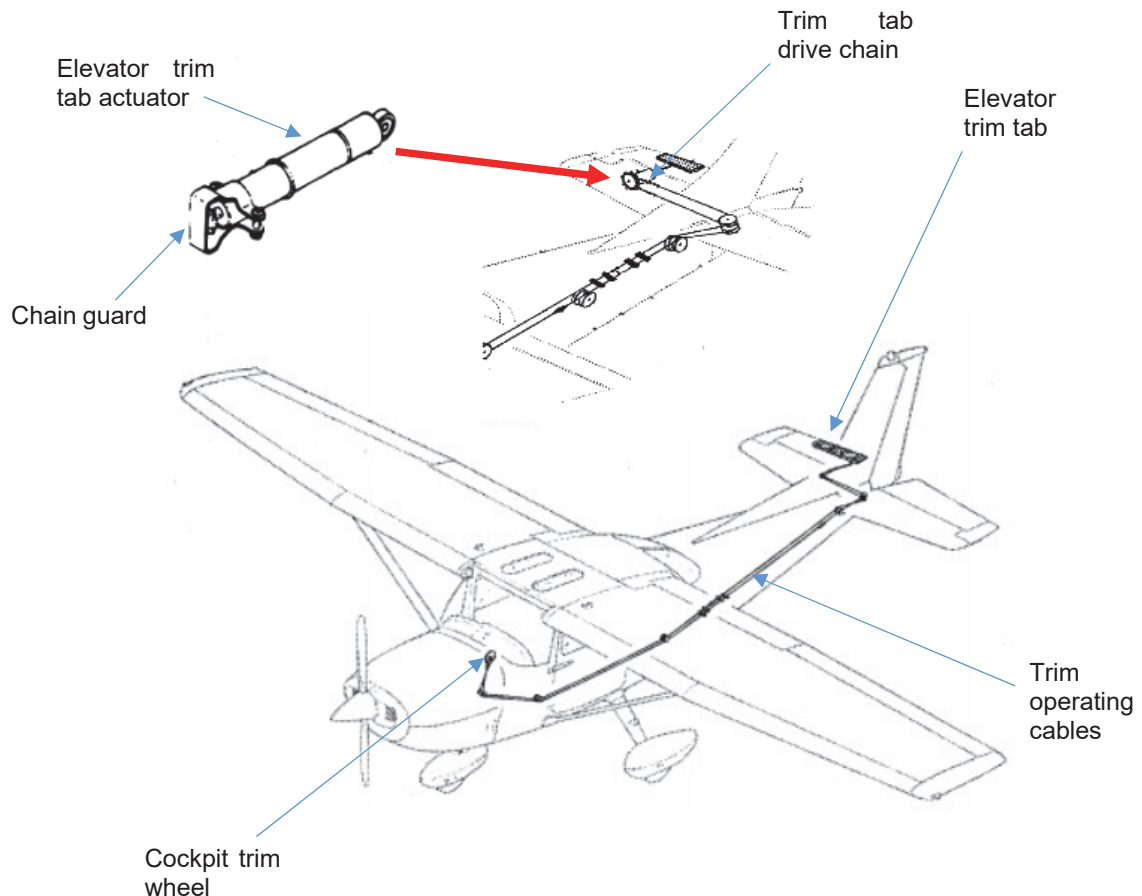
**Figure 2**

The Cessna 172 is fitted with a moveable trim tab on the right elevator. The trim tab is used to 'trim' the aircraft and allow it to be flown at various attitudes with minimal pilot control force. The elevator trim system consists of a cockpit-mounted wheel and position indicator connected to a pair of cables which extend, through a series of pulleys, to the elevator trim tab actuator (Figure 2). The two cables are connected at the elevator by a length of chain which is looped around a sprocket on the trim tab actuator. A chain guard ensures that the chain remains engaged with the sprocket.

Rotation of the trim wheel moves the drive chain on the actuator sprocket, extending or retracting the actuator which in turn moves the trim tab. When the cockpit control wheel is turned, the position indicator moves to indicate the direction of trim wheel movement, either NOSE UP or NOSE DOWN. Movement of the trim wheel in a NOSE UP direction results in the elevator trim tab moving downwards in relation to the elevator and movement of the trim wheel in a NOSE DOWN direction results in the elevator trim tab moving up. Prior to takeoff, to ensure that adequate pitch control is available, the elevator trim tab is set to the neutral position, identified by the TAKEOFF position marked on the trim position indicator.

Cessna 172 pitch trim system

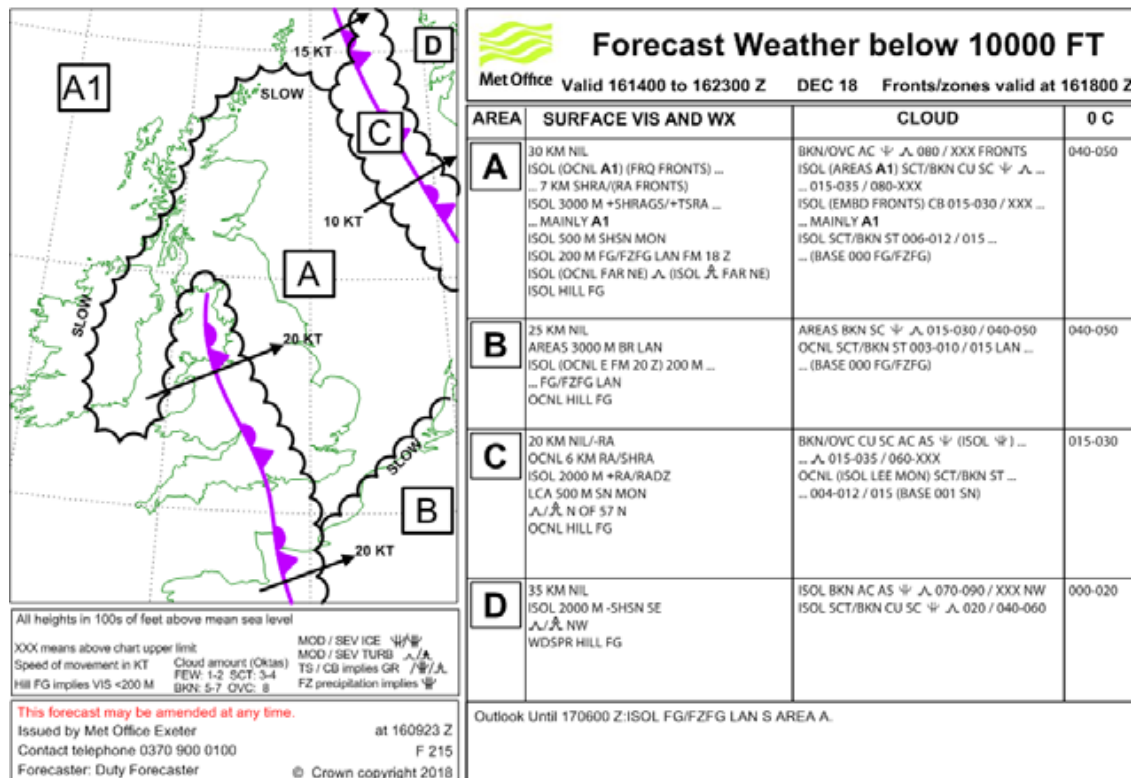
Figure 1

The Met Office forecast for the date and time of the incident is shown in Figure 1. Moderate icing was forecast from between 4,000 ft and 5,000 ft to the upper limit of the chart (10,000 ft). Severe icing was forecast within isolated cumulonimbus cloud embedded within the occluded front.

Met Office forecast for 16 December 2018
