AAIB Bulletin

5/2019

Published 9 May 2019

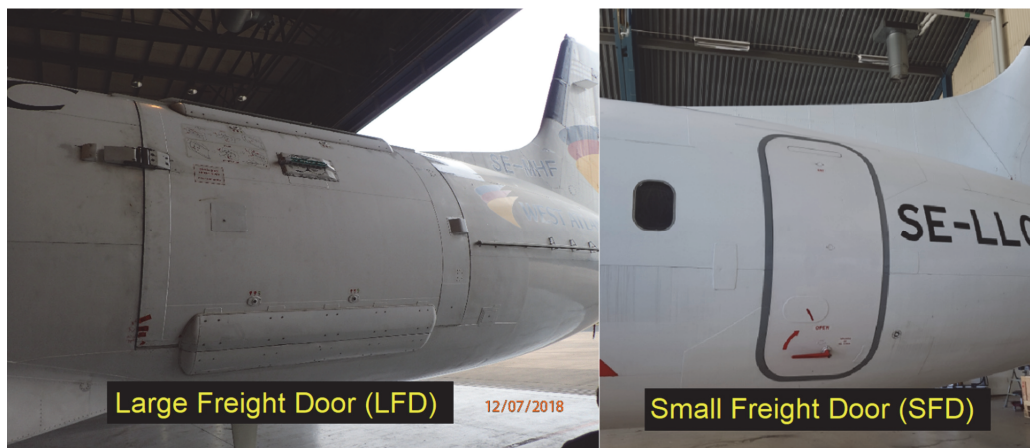
Figure 11

A total of 20 BAe ATP aircraft had been modified to cargo transport with the installation of the LFD that replaced the rear passenger door. Of these LFD aircraft, the operator of SE-MHF had operated 16. It had also operated a further 13 BAe ATP aircraft that used the rear passenger door for cargo loading (Figure 11), referred to as Small Freight Door (SFD) aircraft in this report.

LFD and SFD cargo doors

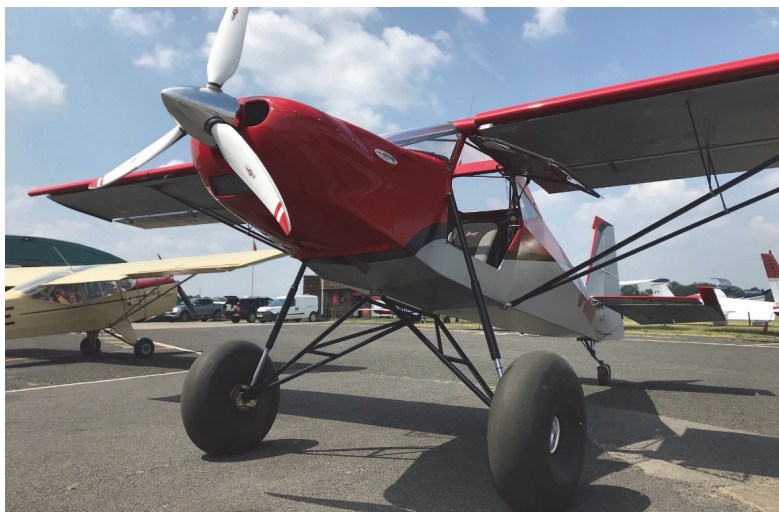
Figure 1

Accident aircraft

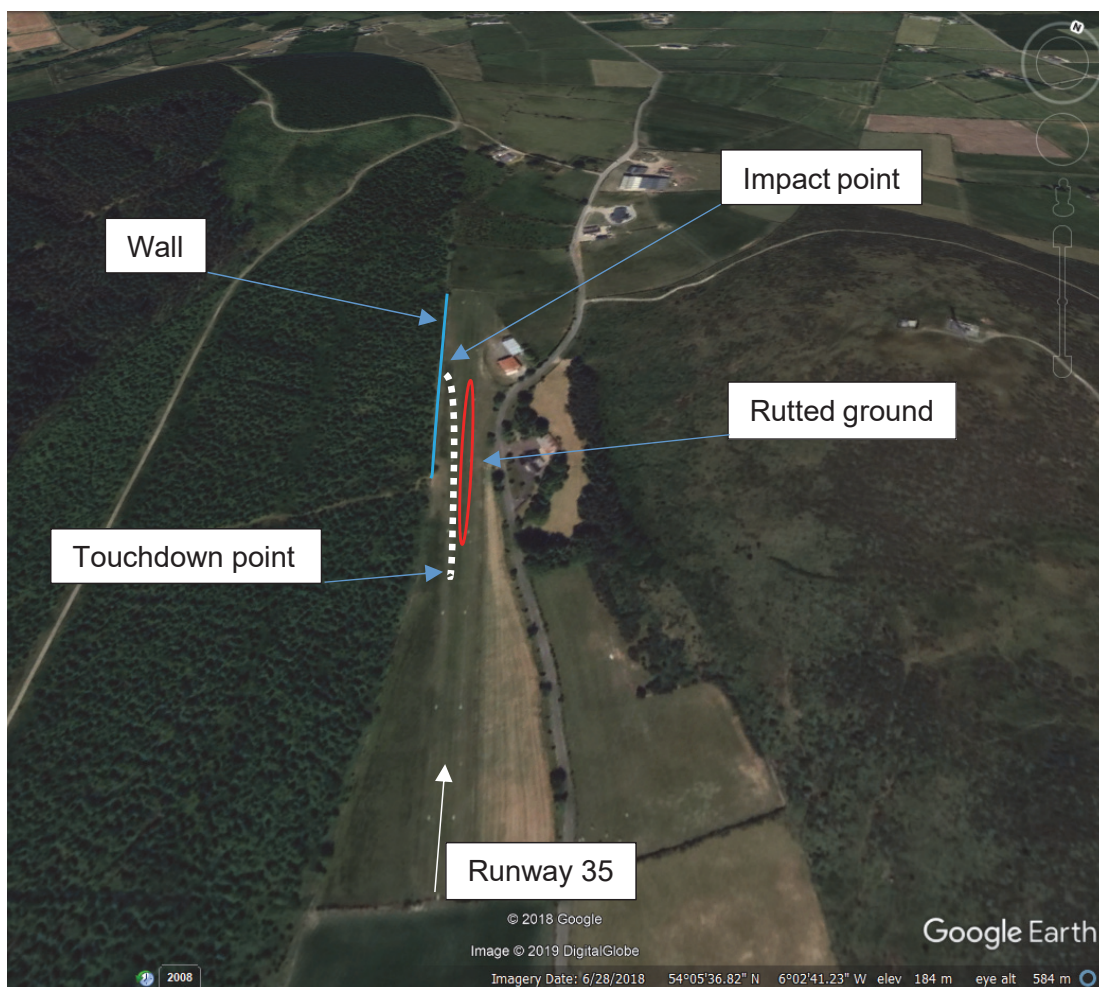
Figure 1
Aughrim airfield

The pilot was returning to a private airstrip at Aughrim, near Kilkeel, County Down, having flown two previous flights that day to Newtownards and Kernan Flying Club. The grass airstrip at Aughrim has a pronounced slope along the runway and departures are usually from Runway 17 (downslope) and landings on Runway 35 (upslope). When the pilot departed earlier in the day he noticed that the left side of Runway 17 was "badly rutted"; therefore as he approached Runway 35 to land he positioned to the left of the centreline (Figure 1).

The surface was soft and wet from melted overnight frost and as the aircraft touched down the pilot maintained some power to compensate for the upslope and to keep the nosewheel lightly loaded and prevent it from digging in. As the landing roll continued, the ground to the left side of the runway started to slope away. The pilot noticed the aircraft veering to the left and responded by lowering the nose to increase steering authority and applying full right rudder. It was at this point that the left main landing gear wheel may have caught a rut or depression, which caused the aircraft to swing rapidly to the left. This motion caused the pilot to inadvertently increase the engine power, increasing the rate of turn. By now the aircraft was fully off the runway where it struck a wall and sank into a ditch (Figure 2). The damage to the wing struts, propeller and other structural damage were all sustained from the impact with the wall. Both the pilot and passenger were able to exit the aircraft unaided and without injury.

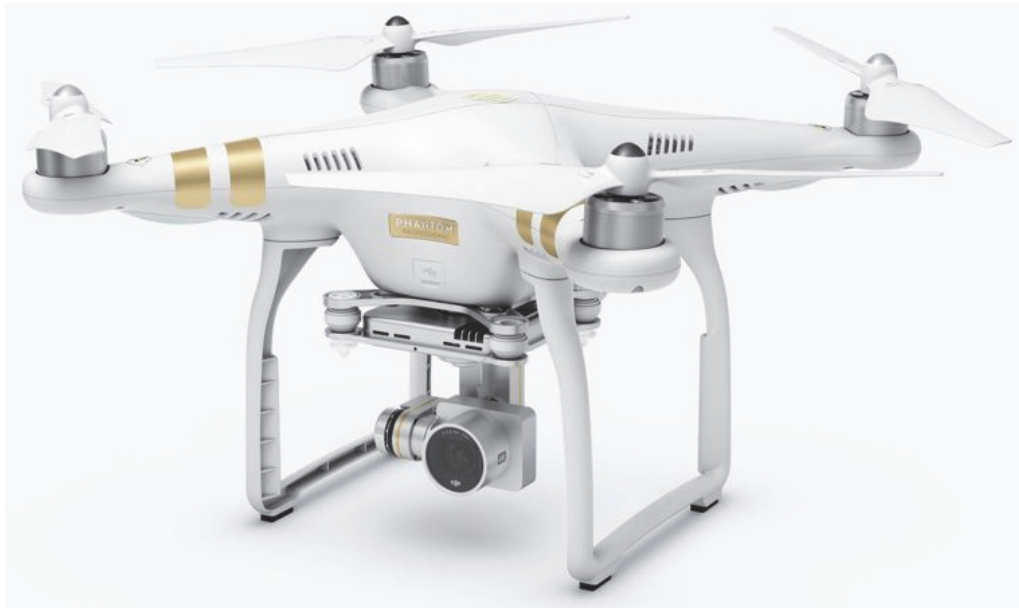
Figure 1

The pilot completed his pre-flight checks of inspecting the structure and propellers for signs of damage and proceeded with an uneventful takeoff. As the UA reached a height of approximately 10-15 ft the pilot heard an unusual sound which he took to be wind noise. Seconds later he heard the same noise and the UA descended rapidly before ground impact. During the impact the battery and camera separated from the UA and came to rest approximately two metres away. Upon inspection, one motor complete with mounting screws and propeller, was missing and despite a search of the area it was

not found. The UA was extensively damaged but there were no injuries or third-party damage.

DJI Phantom 3 Pro with gimbal mounted camera
