AAIB Bulletin

6/2019

Published 13 June 2019

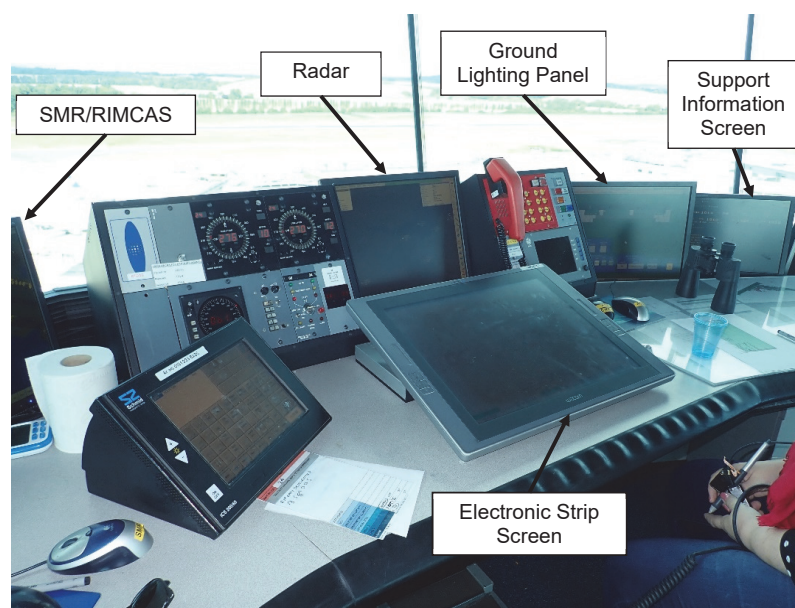
Figure 8

The tower control workstation is the middle of the three workstations. It has an unobstructed view of the runway and the approaches at both ends. This workstation is shown at Figure 8. In front of the controller, mounted on the desk, is an interactive screen which displays information about the flights, both on the ground and on approach to the airport. Each flight has a 'strip' which contains details of the flight and the controller amends the strip as the flight progresses through a departure or an arrival. Mounted vertically in front of the controller is a screen showing the radar picture of the arriving and departing traffic. This allows the controller to see the sequence and spacing of the aircraft on the approach (see Figure 3 earlier in this report).

Tower controller's workstation at Edinburgh as viewed from the OJT's approximate position

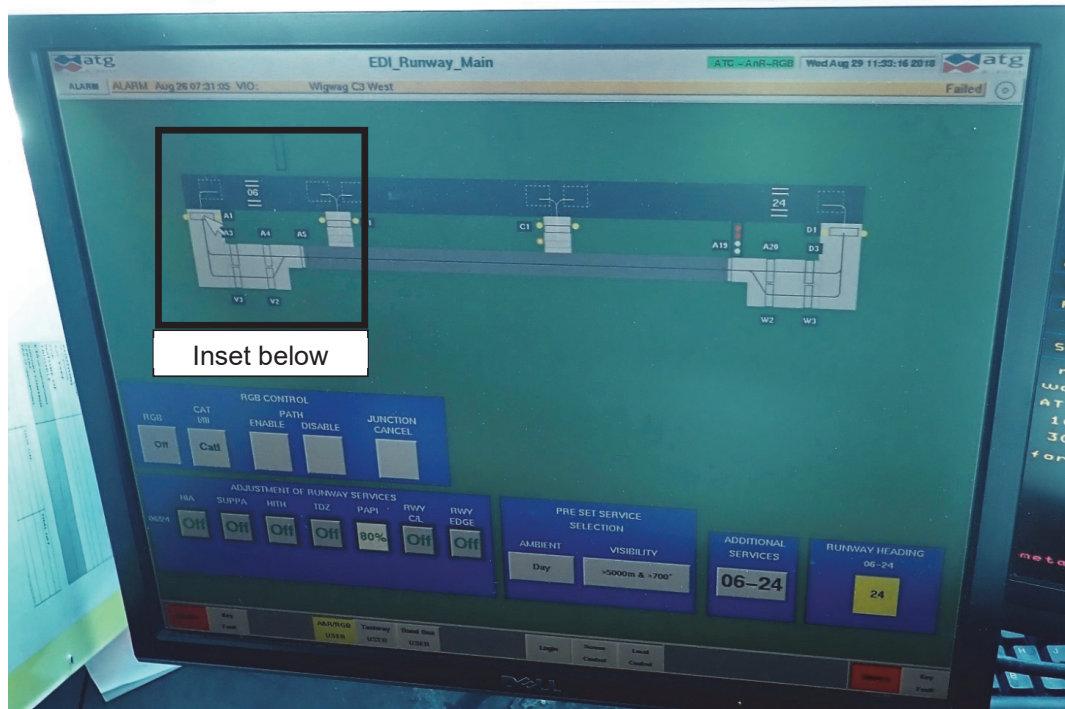
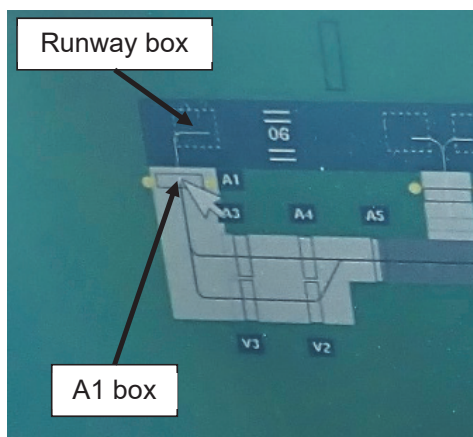
Figure 11

The lighting control panel is interactive. The controller selects different boxes on the screen using a mouse to turn on and off lights and change the intensity of some. Turning off the Stop Bar for the holding point A1 for Runway 06 requires the controller to click accurately inside the A1 box followed by a click in the box at the start of the runway.

Lighting control panel

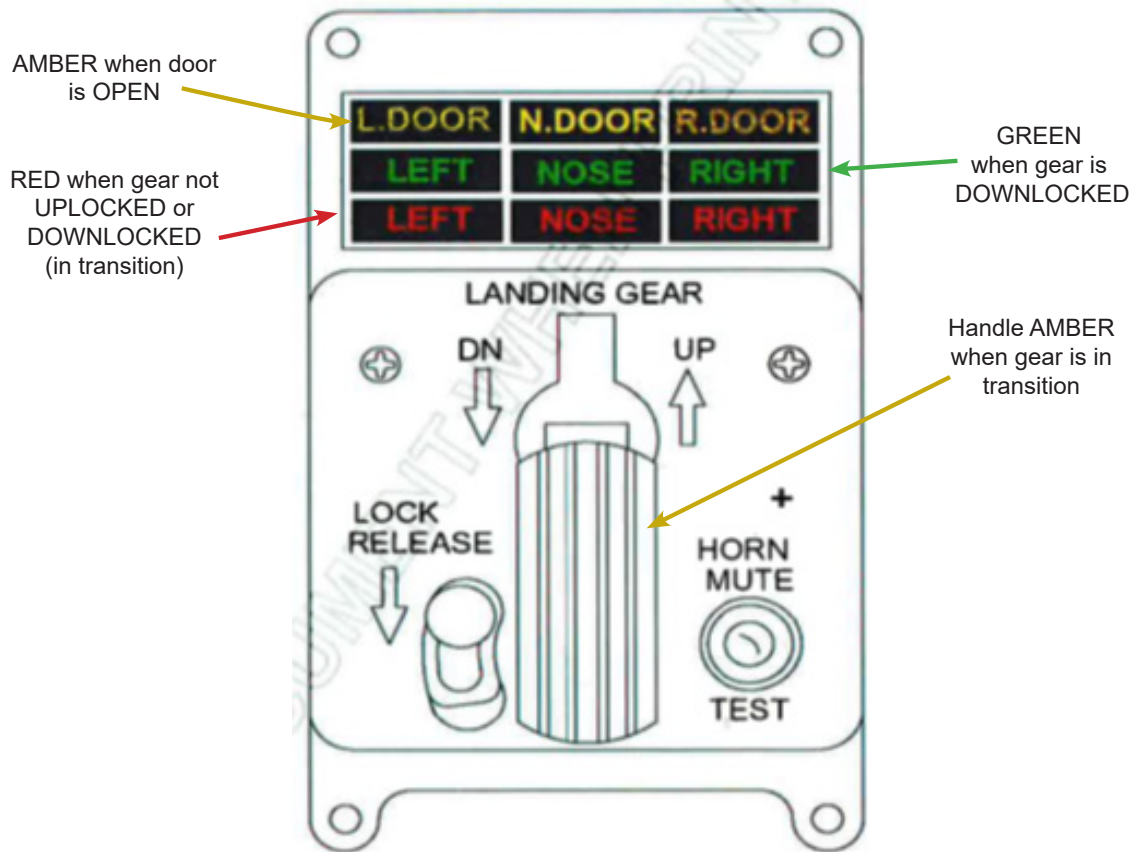
Figure 6

Shortly after takeoff, the landing gear selector lever was selected to the UP position. On the Landing Gear Control and Indication Panel (LGCIP), which is shown in Figure 6, the crew observed that the landing gear green lights extinguished, the three red lights and the amber landing gear door lights as well as the amber light in the landing gear selector lever all illuminated. After a short time, all three red lights extinguished, the left and right DOOR lights extinguished but the nose door light and the light in the landing gear selector lever remained illuminated. The crew kept the airspeed below the 185 kt landing gear limit speed and climbed to 4,000 feet, routing to waypoint Magee to take up the hold whilst they assessed the problem. The aircraft entered the hold at 1132 hrs and the total fuel onboard was 2,800 kg.

Dash 8 Q400 landing gear control and indication panel

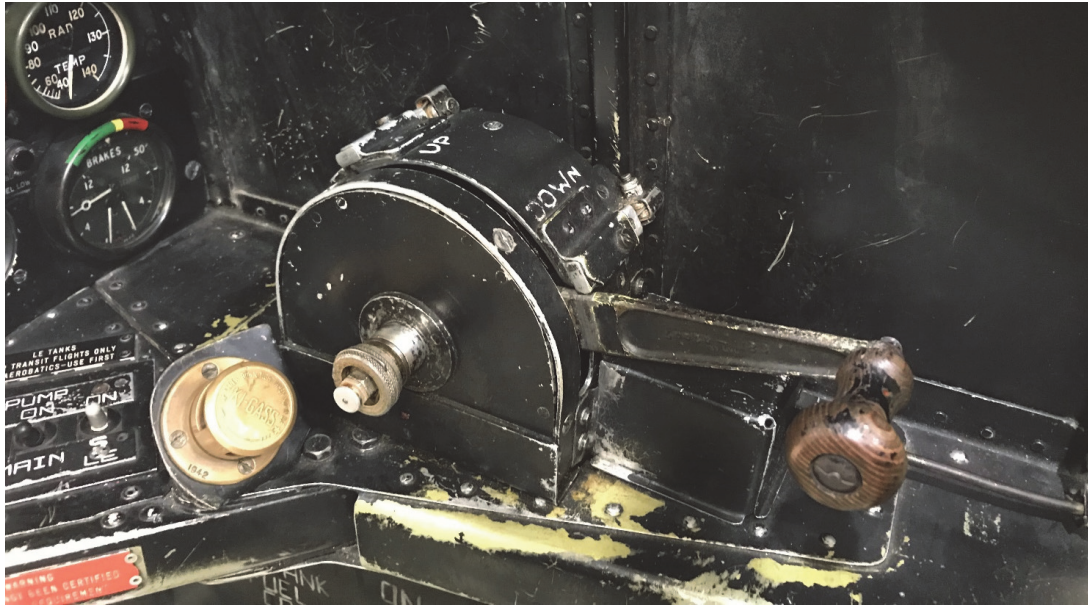
Figure 1
Undercarriage control lever

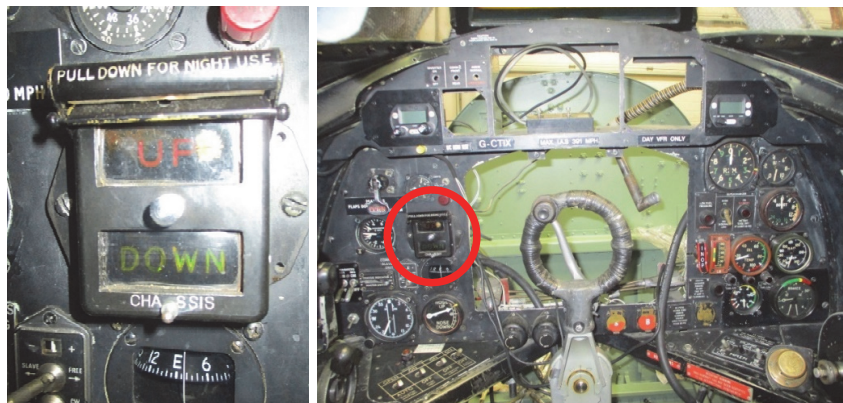
Figure 2
Undercarriage position indicator

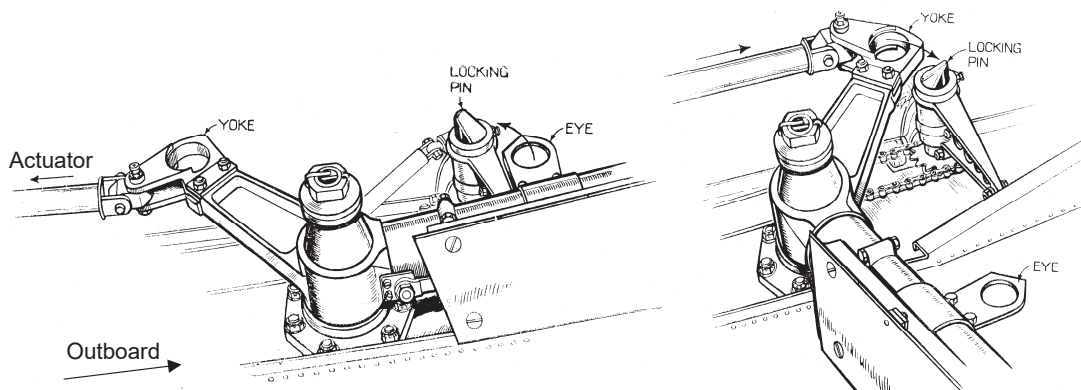
Figure 3

To extend the undercarriage the control lever is moved to the left out of a retaining gate and rotated aft by approximately 130°. During this motion the UP side of the hydraulic system is powered to take the weight of the undercarriage off the undercarriage locking pin (Figure 3) so that it can be rotated to the DOWN position. The locking pin is rotated by a series of pulleys, cables and chains connected to the control lever and is sprung loaded so that it can retract and allow either the yoke or eye to disengage or engage as required. A combination of gravity and the DOWN side of the hydraulic system powers the legs until the yoke engages with the locking pin. Once fully down, the hydraulic system pressure increases until a cut-off plunger in the control unit is activated and system pressure is diverted through a bypass circuit and IDLE is indicated on the control lever unit.

Undercarriage locking pin

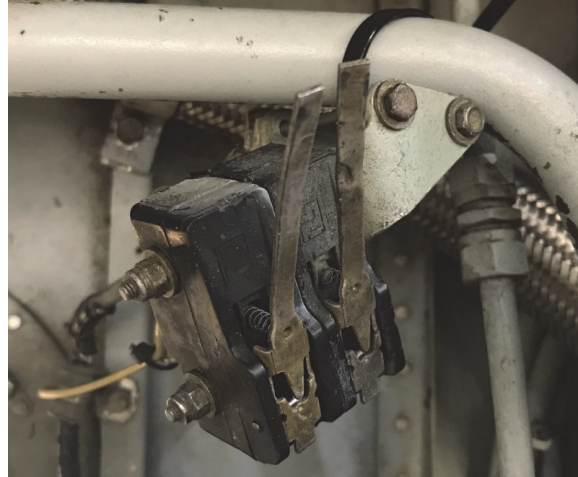
Figure 4

There are several switches in the undercarriage bay which are used to indicate to the pilot the undercarriage position. There is a single switch fitted to each locking pin which indicates if the pin is in the fully locked position. Further switches are mechanically activated when the undercarriage leg is either in the fully UP or fully DOWN position (Figure 4). To illuminate the UP caption in the cockpit, the locking pin must be fully engaged and the UP position switch made. Consequently, for the DOWN caption to be illuminated the locking pin must be engaged and DOWN position switch made. When these conditions are not met (ie during undercarriage retraction or extension) no captions will be lit. Each caption is lit by two bulbs in case of bulb failure.

DOWN position and undercarriage warning horn switches (partially disassembled)

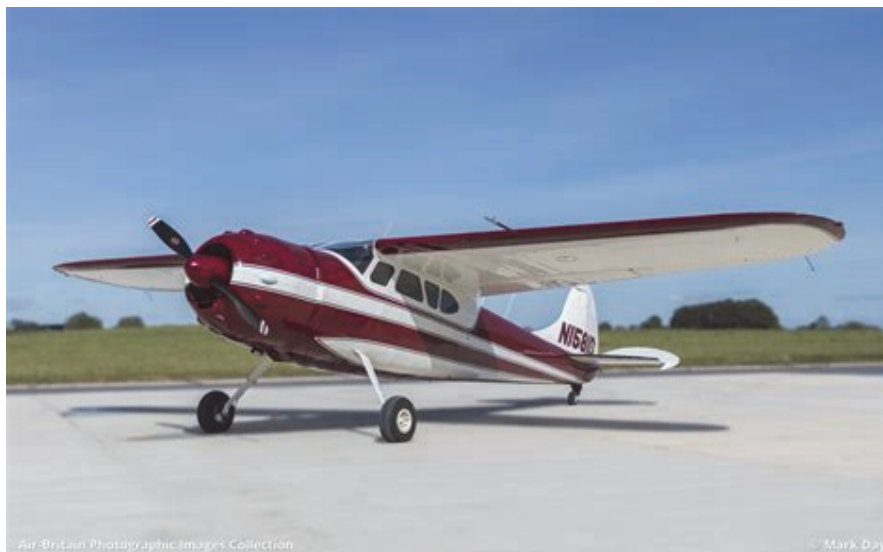
The aircraft was being flown from Dunkeswell Airfield to Branscombe Airfield in Devon in good weather with the wind calm, CAVOK and QNH 1004 hPa. Shortly after departure, the engine began to lose power from which it recovered briefly before suffering a total power loss at a position where turning back to the airfield was not an option. The pilot flew towards the lower ground to the west and checked the mixture, throttle and fuel pumps. He moved the fuel tank selector to the left, right and then both tanks in turn and recycled both magnetos, all to no effect. He made an approach to a large field, touching down briefly on the soft ground before allowing the aircraft to fly down the gentle slope and touch down again on a gentle upslope. The wheels began to dig in and, on crossing some slightly firmer ground, the pilot thought that the tail was lowering normally. However, the wheels dug in heavily and the aircraft nosed over onto its back. The pilot was uninjured and able to exit the aircraft through the normal door. No cause for the engine problem was identified. The aircraft is shown at Figure 1.

Figure 1
Cessna 195, N1581D with tail wheel configuration
