AAIB Bulletin

7/2019

Published 11 July 2019

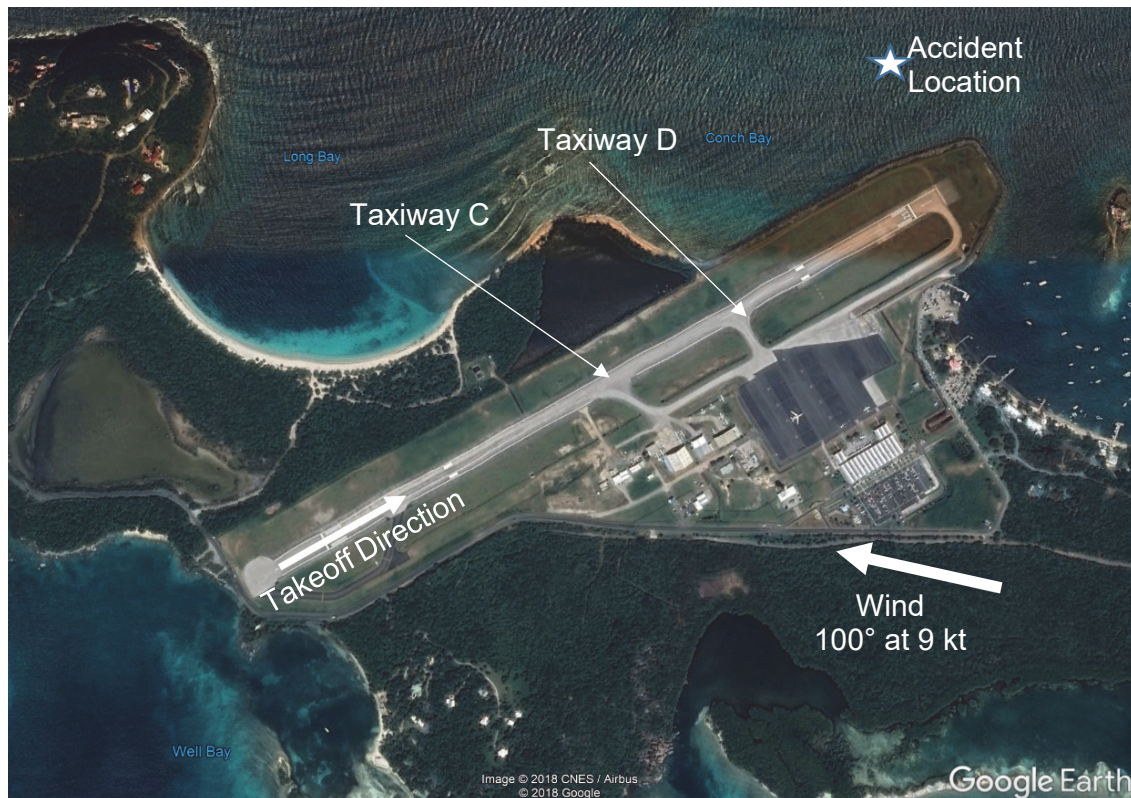
Figure 2

The pilot of N66778 started his takeoff roll from the start of Runway 07. The pilot of another aircraft, who was holding on Taxiway C, reported seeing N66778's rear fuselage touch the runway as the aircraft rotated. He described seeing the aircraft then climb with slight oscillations in pitch. He reported that the aircraft was at approximately 50 ft when it passed Taxiway C and the flaps were up¹ (Figure 2).

Terrance B. Lettsome International Airport (Beef Island) showing the accident location

The aircraft had come to rest in approximately 5 m of water, 250 m north of the Runway 25 threshold (Figure 2). The wreckage was recovered to shore by local salvage personnel on the day of the accident; this was overseen by representatives of the BVIAA. It was raised to the surface using floatation bags before being pulled to the shore and loaded onto a truck by crane. The wreckage was moved to a secure location within the airport grounds where detailed examination of the wreckage could be carried out.

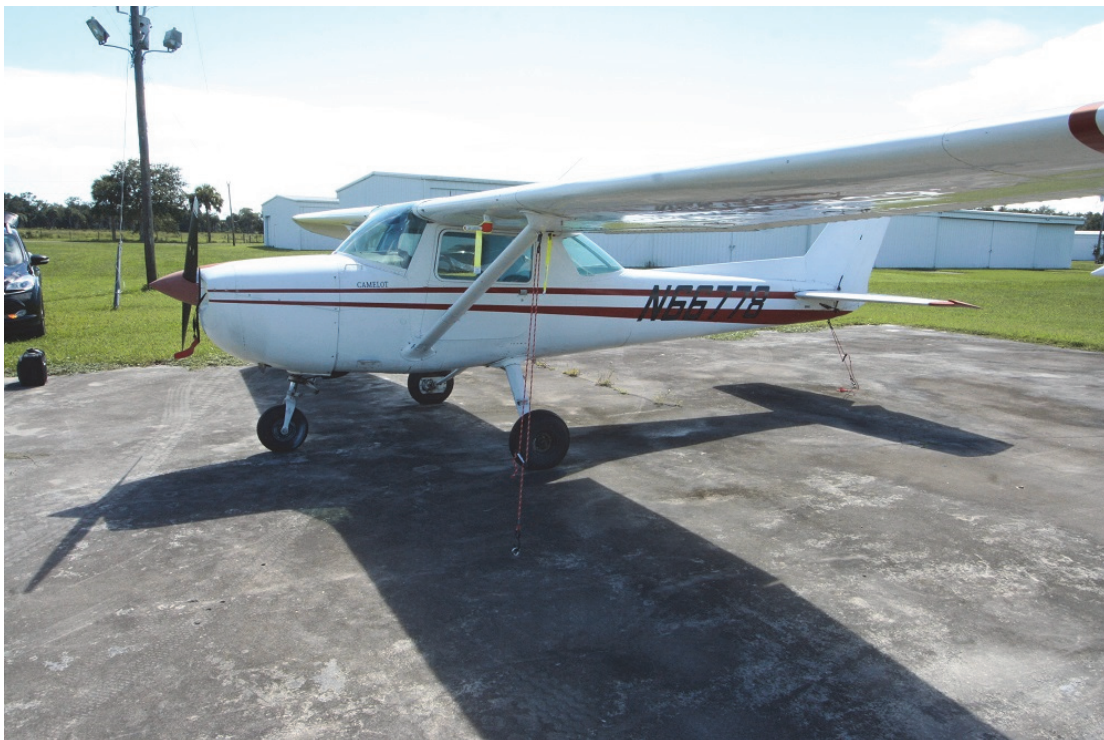
Figure 3

N66778 (pictured in Figure 3) held a valid Export Certificate of Airworthiness (ECofA) issued by the FAA on 13 February 2018. When the ECofA was issued, the aircraft had accumulated 2,556.1 flying hours, as had both the engine and propeller. The aircraft and engine log books were not recovered during the investigation, so an accurate indication of the aircraft accumulated hours at the time of the accident could not be determined. The ECofA referred to three major repairs and alterations, these were for the installation of wingtip fairings, a voltage controller and tinted sun visors. There were no records made available to the investigation indicating the approval of fitment of any other repairs, alterations or additions.

N66778 prior to the accident (image used with permission)

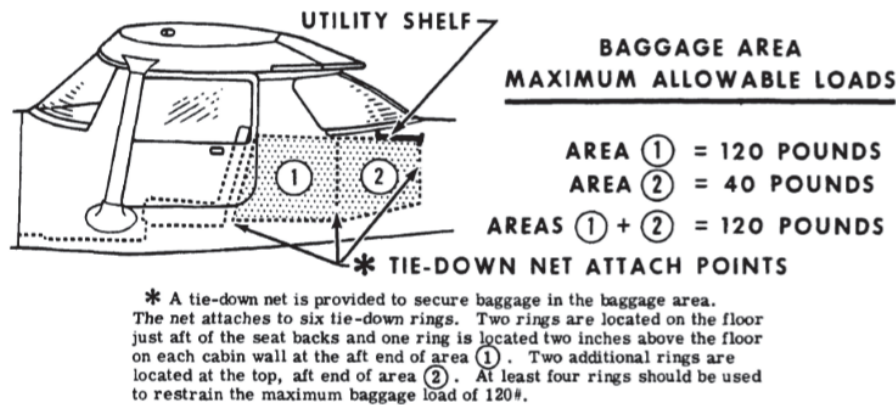
Figure 7

The Maximum Takeoff Weight for the Cessna 150M is 1,600 lbs. The calculation for N66778 was 4% above the maximum weight. The centre of gravity limits at Maximum Takeoff Weight for the Cessna 150M are 32.8 to 37.5 inches. The calculation for the centre of gravity position for N66778 was at least 1.39 inches beyond the aft limit. If some items had been loaded further aft or if items moved during the takeoff the centre of gravity could have been even further aft.

The baggage area behind the pilot's seat is divided into two areas for weight and balance calculations. The maximum load for the front area is 120 lbs, the maximum load for the aft area is 40 lbs, but the maximum total load for the whole baggage area is 120 lbs (Figure 7). Based on the witness reports that the auxiliary fuel tank, oil cans and the crate of water were stored behind the pilot's seat, N66778 had at least 158.8 lbs of weight in the baggage area.

Baggage Loading Restriction

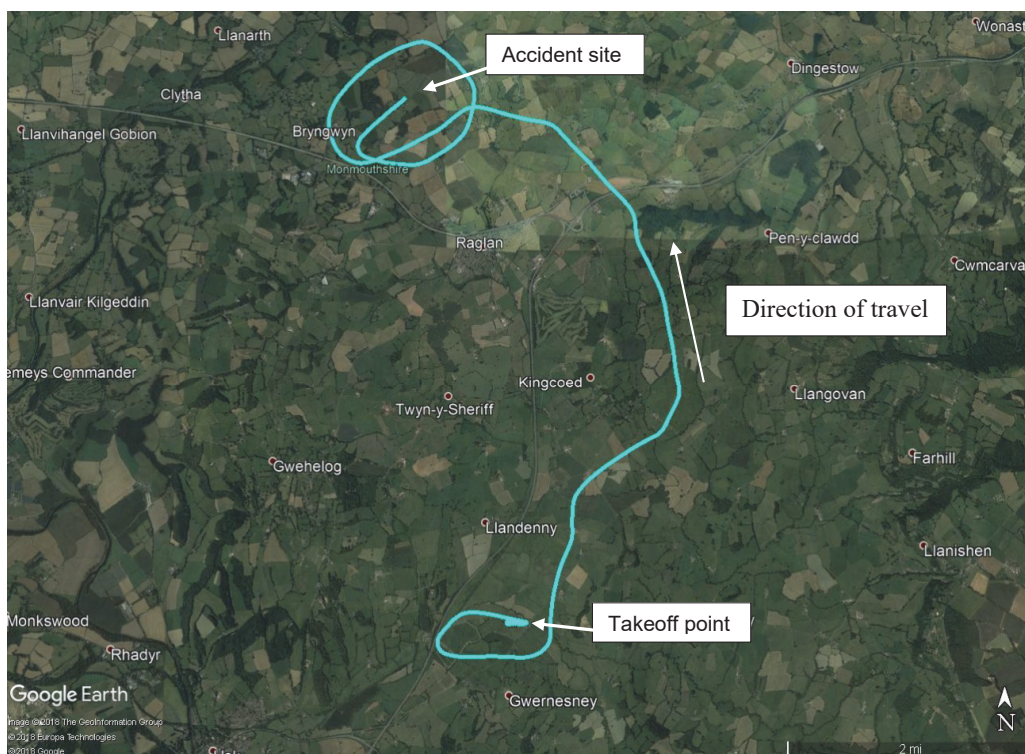
Figure 1

It is not known whether a brief took place or the details of the intended flight, but the TMG took off from Usk Airfield at about 0947 hrs with the instructor and student on board. Witnesses report seeing the aircraft shortly after this time near the town of Raglan, about 4 miles north of the airfield. Recovered flight data shows the aircraft flew an orbit over an area of fields approximately 1.5 miles to the north-west of the town, before commencing an apparent final approach for a practice force landing into a large field (Figure 1).

G-KHEH flight of 10 June 2018

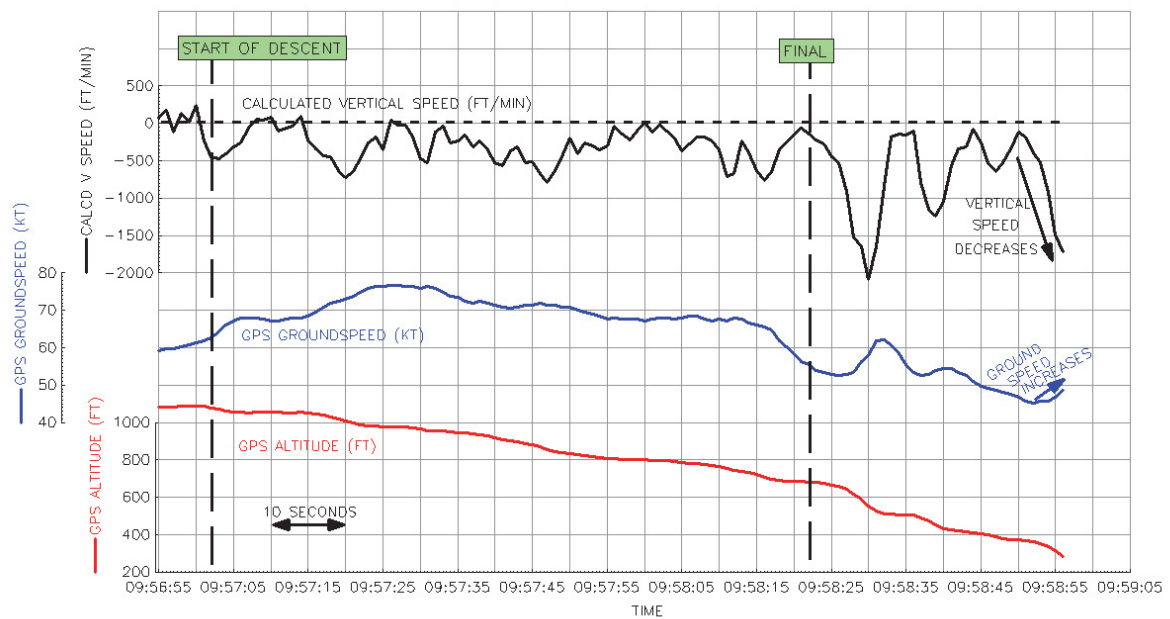
Figure 8

Between the start of the descent and the turn to the final approach track, vertical speed varied at between +100 to -790 ft/min, with the aircraft descending 400 ft over one minute 20 seconds (Figure 8). Ground track covered over this period was approximately 1.6 nm, equating to an average ratio of 1:24. Calculated groundspeed varied between 54 kt and 77 kt.

During the last four seconds, recorded data shows the aircraft in a descent with decreasing vertical speed and groundspeed increasing from 45 kt. The last recorded position was at 0958:56 hrs with the aircraft at 284 ft amsl (about 54 ft agl) located approximately 43 m before the tree.

G-KHEH flight data parameters for the final two minutes of flight

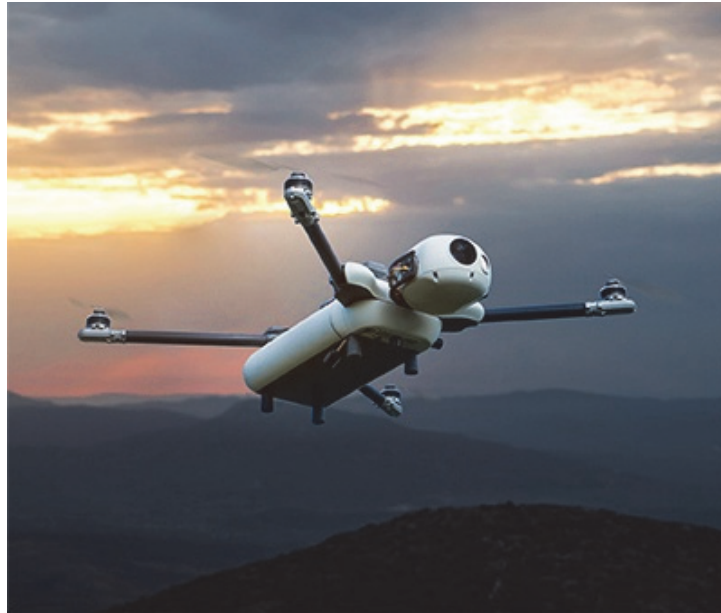
Figure 1

The pilot, who works for the UAS manufacturer, was operating the UAS on a demonstration flight. It was the first flight of the day and prior to taking off, the battery level indication had indicated a 100 % state of charge and a voltage of 25.2 V. The UAS took off at maximum takeoff mass and indicating an available flight time of 60 minutes. The pilot climbed the UAS to a height of 50 m where it maintained a stable hover. It had been flying for approximately 5 minutes when the pilot initiated a control input to rotate the UAS about its yaw axis. Whilst yawing, the UAS appeared to suffer a complete power failure; all four electric motors stopped and the UAS began descending rapidly. There were no associated warnings

displayed on the controller and the UAS did not respond to any control inputs by the pilot. It entered autorotation at approximately 10 - 15 m above the ground, but this was insufficient to arrest the rate of descent and it struck the ground hard. The onboard battery ignited and the UAS was destroyed in the ensuing fire.

Evolve Dynamics Sky Mantis
