Air Accidents Investigation Branch
Farnborough House
Berkshire Copse Road
Aldershot
Hants GU11 2HH

Published 8 August 2019

Beagle B121 Series 2 Pup	G-TSKY	12-Jul-18	3
Reims Cessna F172N Skyhawk	G-BGSV	10-Oct-18	16

AS350B2 Ecureuil	G-PLMH	13-Jun-18	31
------------------	--------	-----------	----

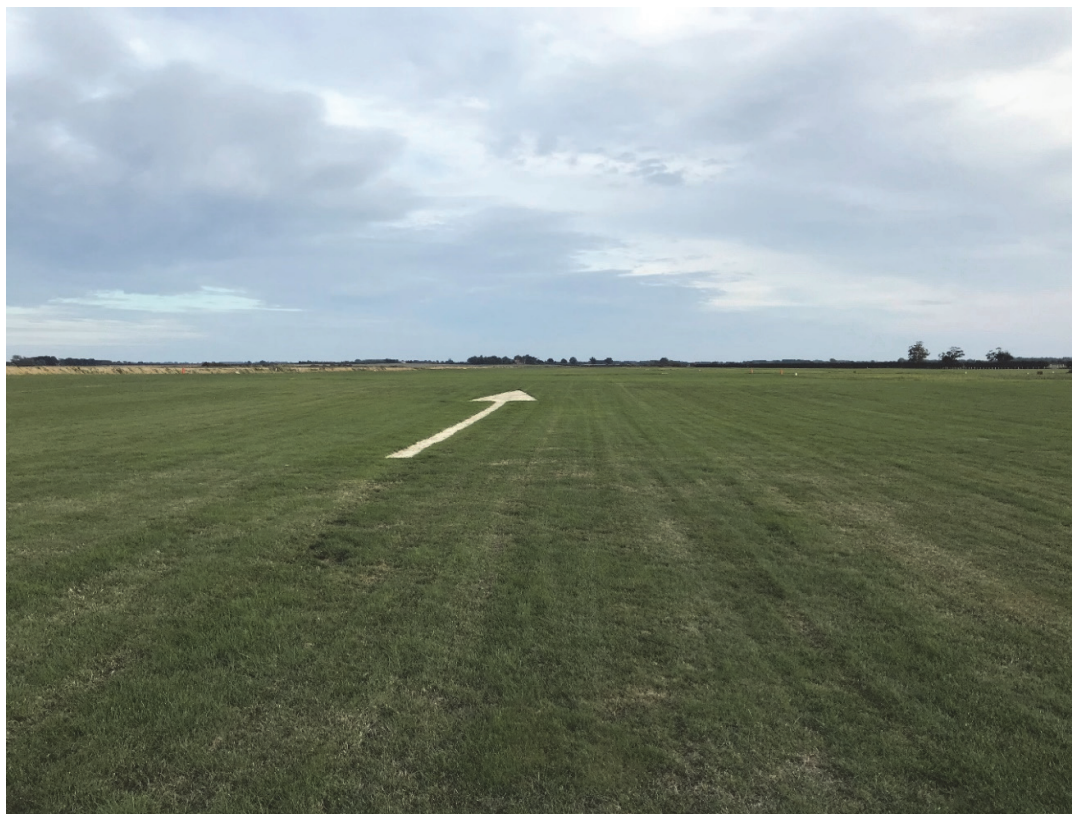
Figure 2

The club member friend arrived at the airfield soon afterwards and parked at the western end of Runway 12 with his headlights shining along the arrow indicating the threshold, Figure 2. He was not able to enter the clubhouse and turn the building lights on because, in the rush, he had left the keys at home. On arrival at the airfield, he tried to telephone the pilot again but did not make contact.

Displaced threshold area Runway 12

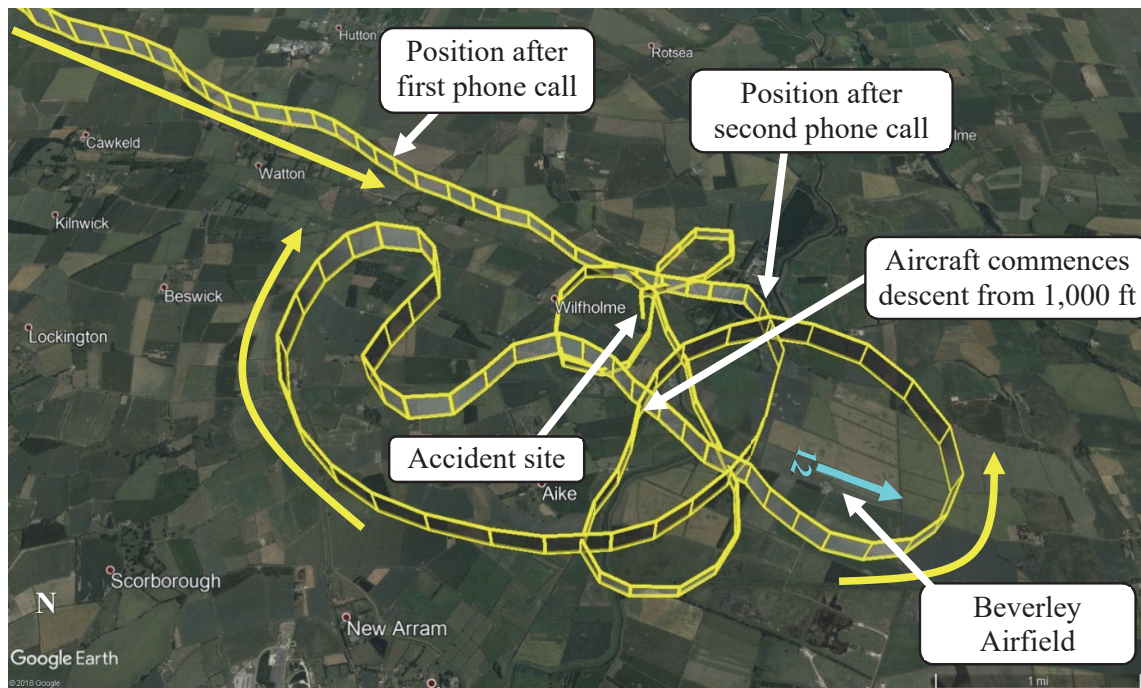
Mobile phone records were recovered for the pilot's phone which revealed at 1808:08 hrs, while 8.5 nm north-west of the airfield, the pilot made a phone call to a friend. The call was unanswered and went to the friend's voicemail. Figure 4 shows the radar track from 1809:30 hrs and when the phone call ended, the aircraft was 3 nm north-west of Beverley Airfield. A second call was made between 1812:45 and 1813:50 hrs; this was the answered call to the club member friend.

G-BGSV radar track showing arrival overhead Beverley Airfield

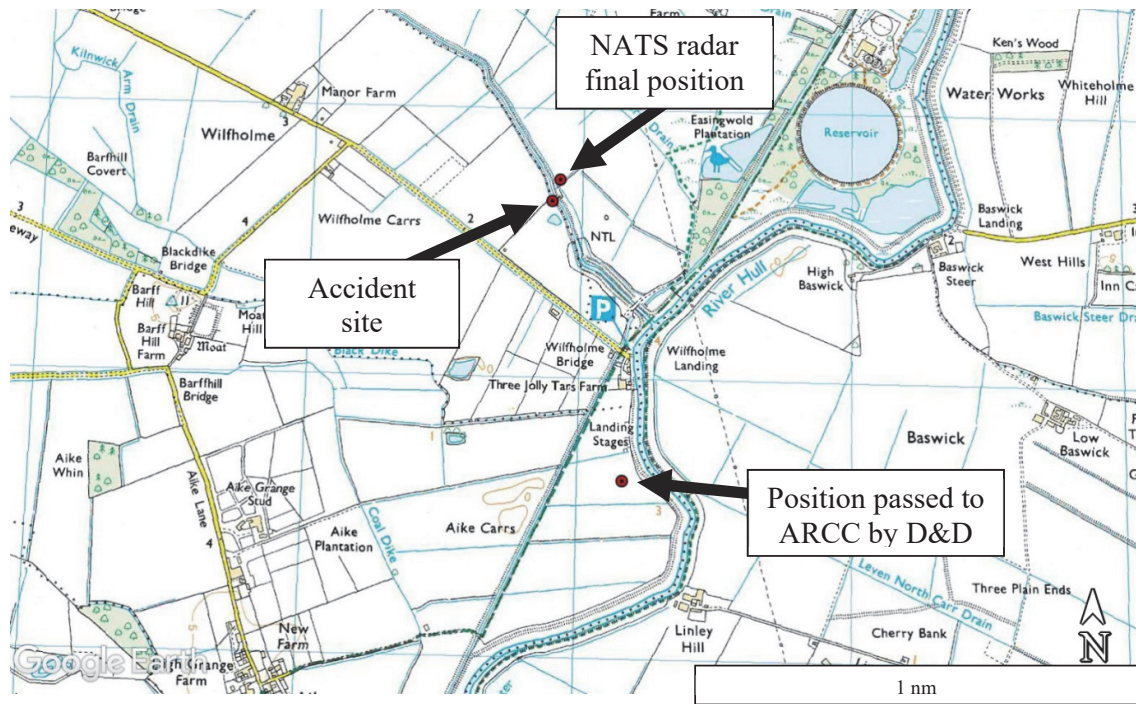
Figure 6

Once informed of this event, D&D sourced coordinates of the last known aircraft position from radar and passed them to the ARCC who coordinated the search. The position passed to ARCC was $53^{\circ} 54.3'N$, $000^{\circ} 23.13'W$. This is shown on Figure 6, along with the final radar position provided to the AAIB by NATS and the accident site.

Final radar positions and G-BGSV accident site location

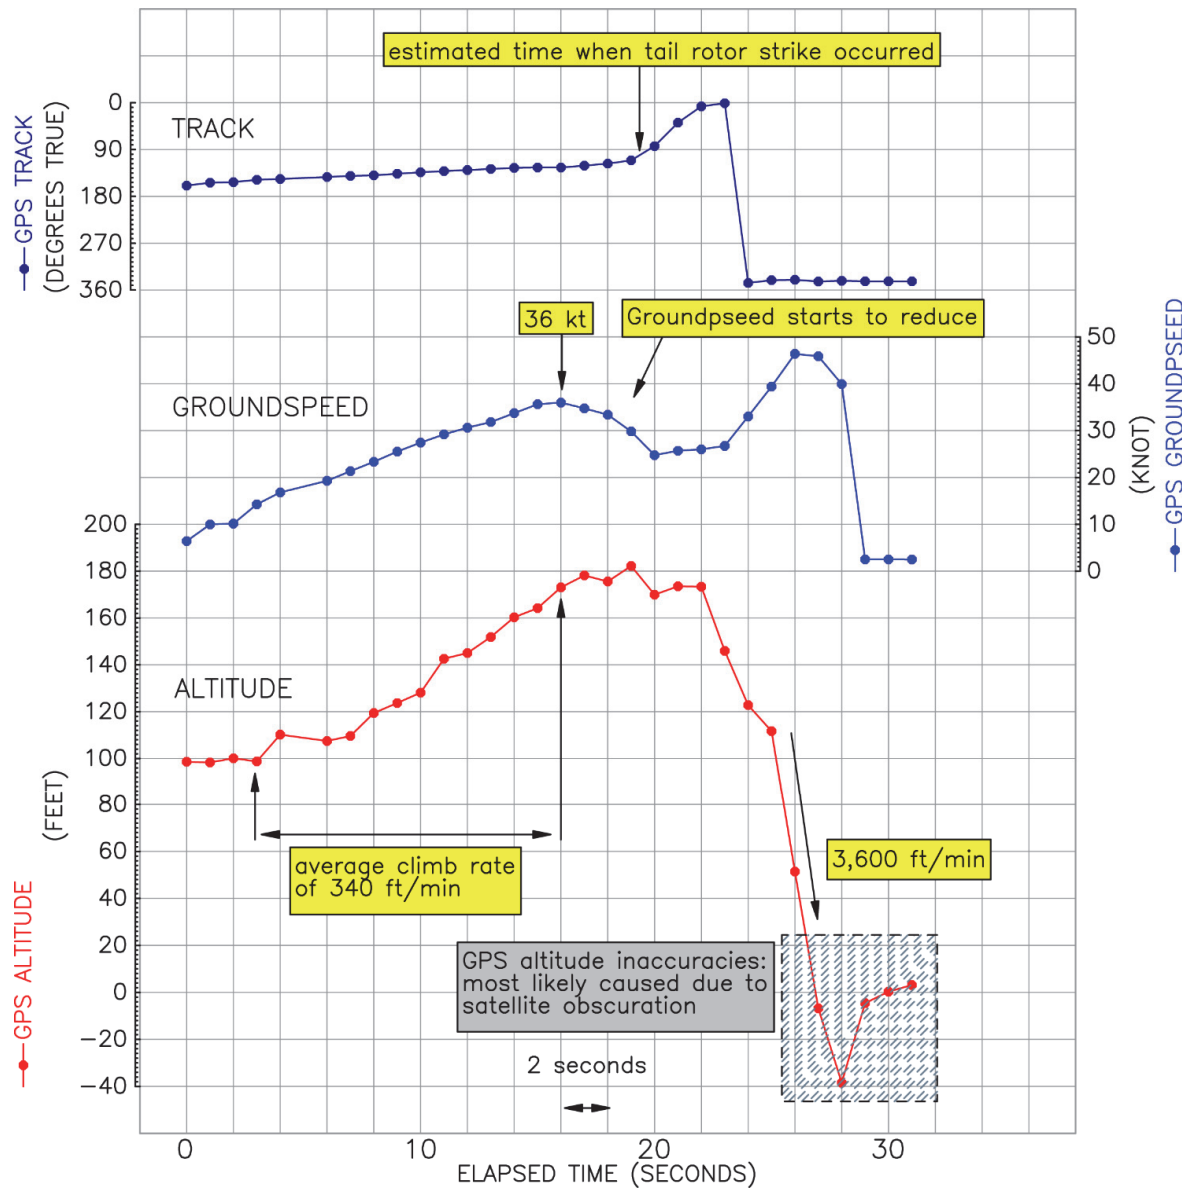
Figure 4
GPS-derived data from the accident flight

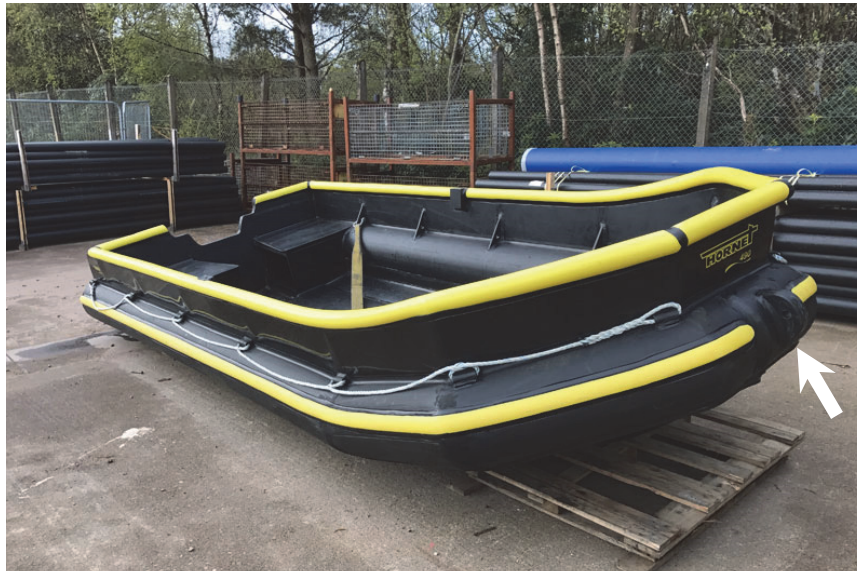
Figure 8

Boat 1 was approximately 4.9 m long, 2.0 m wide and weighed 420 kg. An outboard motor weighing approximately 45 kg was fitted on the transom. It was lifted solely by the attachment on its bow. A similar boat, but without an outboard engine fitted, is shown in Figure 8.

A boat similar to Boat 1 (arrow indicates lifting eye location)

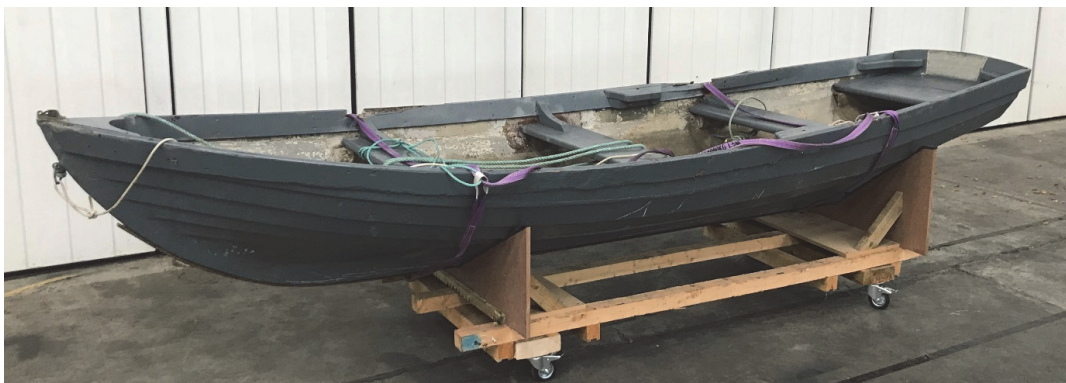
Figure 9

Boat 2 was approximately 4.4 m long, 1.4 m wide and weighed 192 kg. The mooring ring on the bow was not considered by the crew to be strong enough to lift the boat, so the lifting hook was connected to the boat using two strops, at approximately 1/3 of the length in from each end of the boat. These were secured in place by rope to stop them moving on the curved surfaces of the boat's hull (Figure 9). The strops were arranged such that the boat would be carried on its side.

Boat 2 showing arrangement of lifting strops
(cradle added for storage purposes)

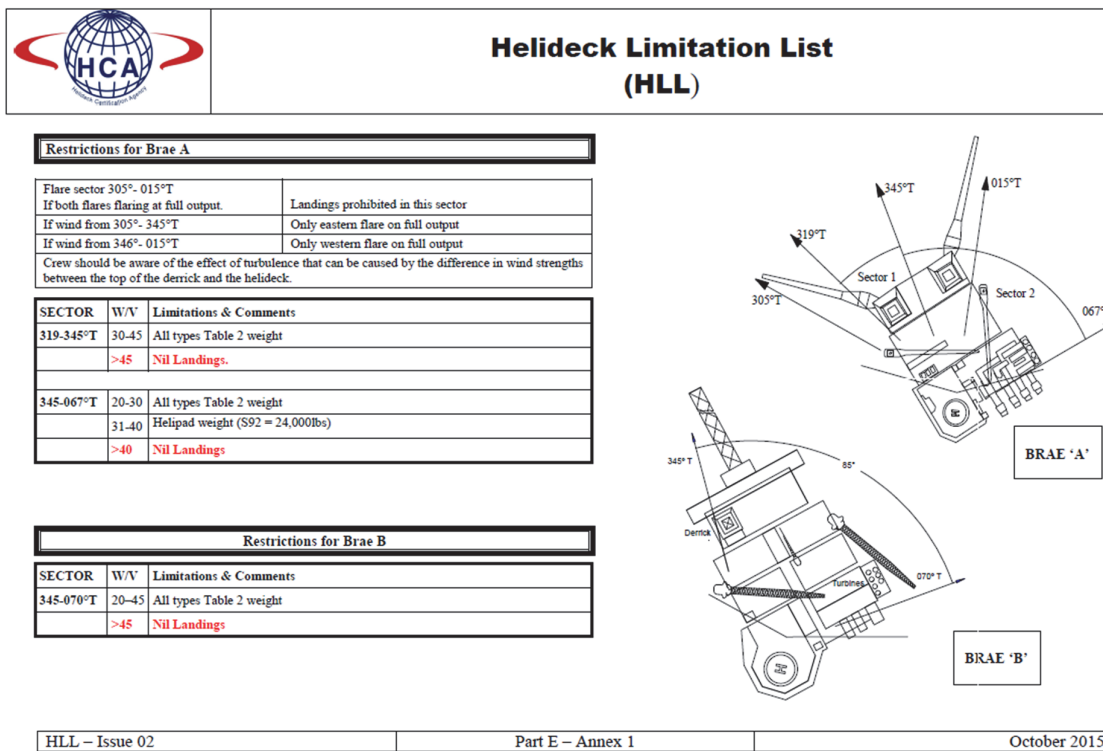
Figure 3
HLL Part E Annex 1 – Restrictions for Brae A (HCA)
