AAIB Bulletin

9/2019

Published 12 September 2019

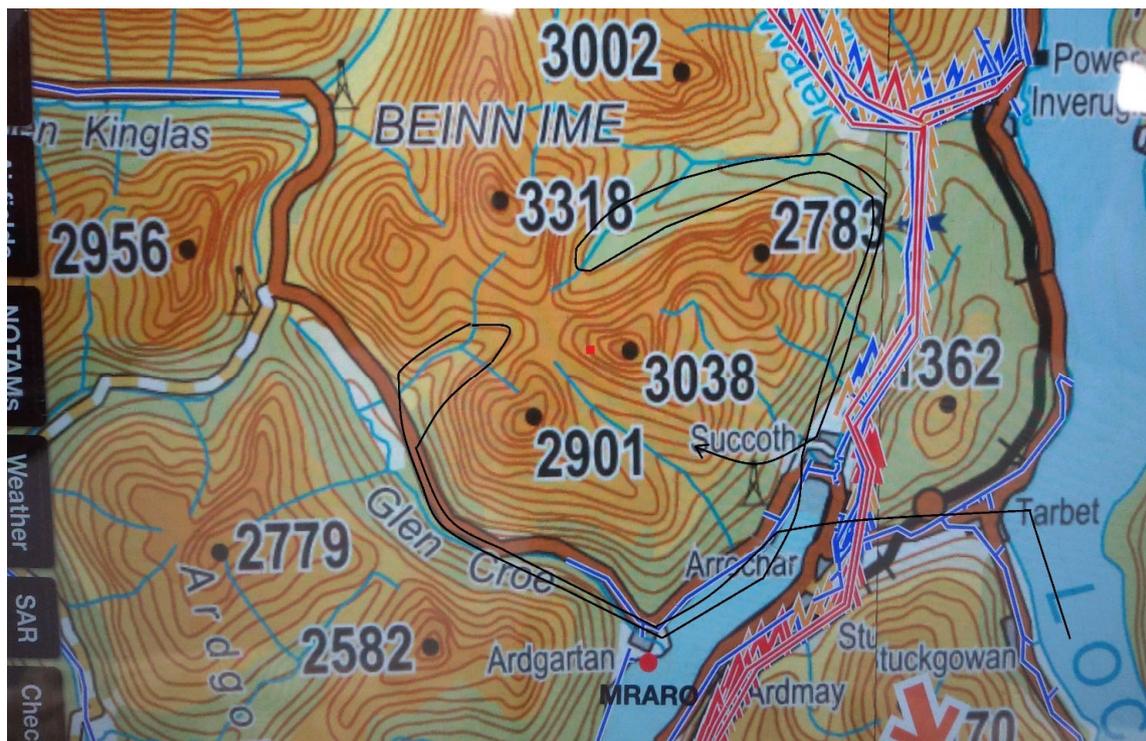
Figure 1

Ground tracks of the rescue attempts

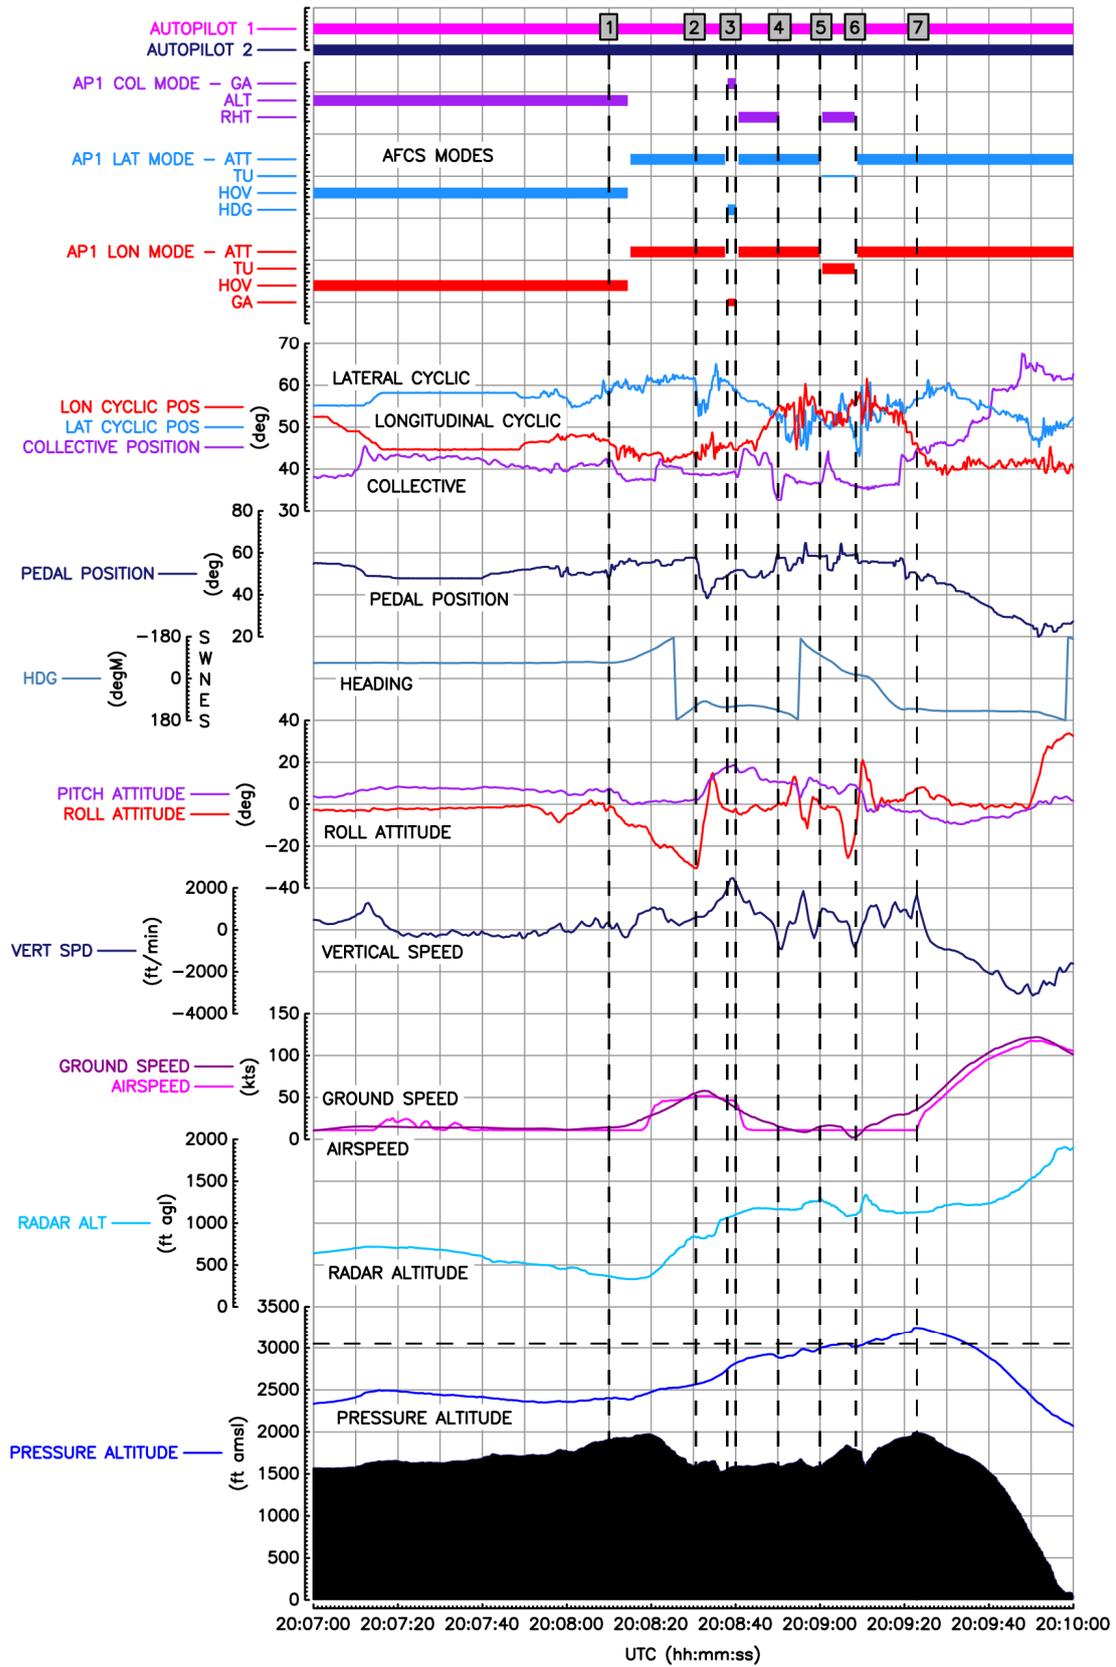
Figure 2 shows a plot of the salient data for the event and starts with the helicopter already within the re-entrant, which it had entered one minute earlier on a heading of 295°M at about 2,180 ft amsl and with 4 kt groundspeed (11 KIAS) before climbing to about 2,400 ft amsl and accelerating to 14 kt groundspeed. Both autopilots were on with HOV and ALT modes selected on the AFCS.

- UTC 20:09:10 – The helicopter climbed above the height of highest ground (Beinn Narnain at 3,050 ft amsl). Radio altitude was 1,100 ft agl, airspeed 11 KIAS and the heading was 345°M. TU and RHT modes were decoupled with the AFCS defaulting to the ATT mode.

- UTC 20:09:23 – The maximum altitude of 3,250 ft amsl was reached and the helicopter then descended and accelerated on a heading of 130°M.

Salient parameters from recorded with the terrain elevation immediately below the helicopter in black

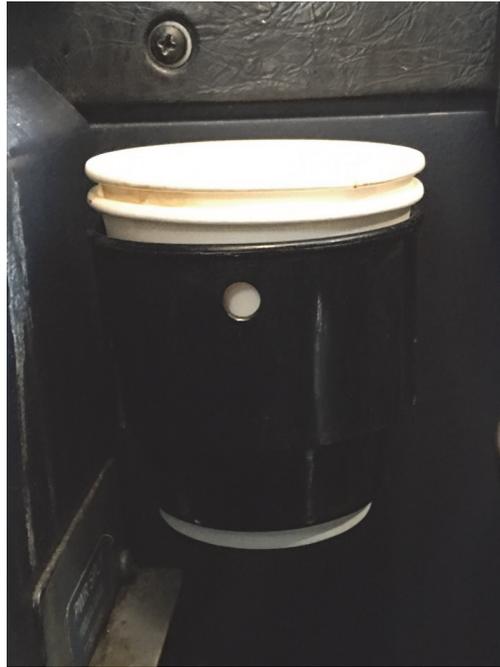
Figure 1

The flight departed from Frankfurt airport in Germany and was scheduled to fly to Cancun in Mexico. Approaching position N5500.0 W02000.0 the flight crew were served coffee in cups without lids (Figure 1). This was normal for this operator and route.

The commander was pilot monitoring. He put the coffee on his tray table while he completed tasks required due to approaching a waypoint. At approximately 1620 hrs, the cup was knocked over. Most of the liquid fell onto the commander's lap and a small amount spilled onto the commander's ACP (ACP1, see Figure 2).

Example of cup used in the aircraft cup holder

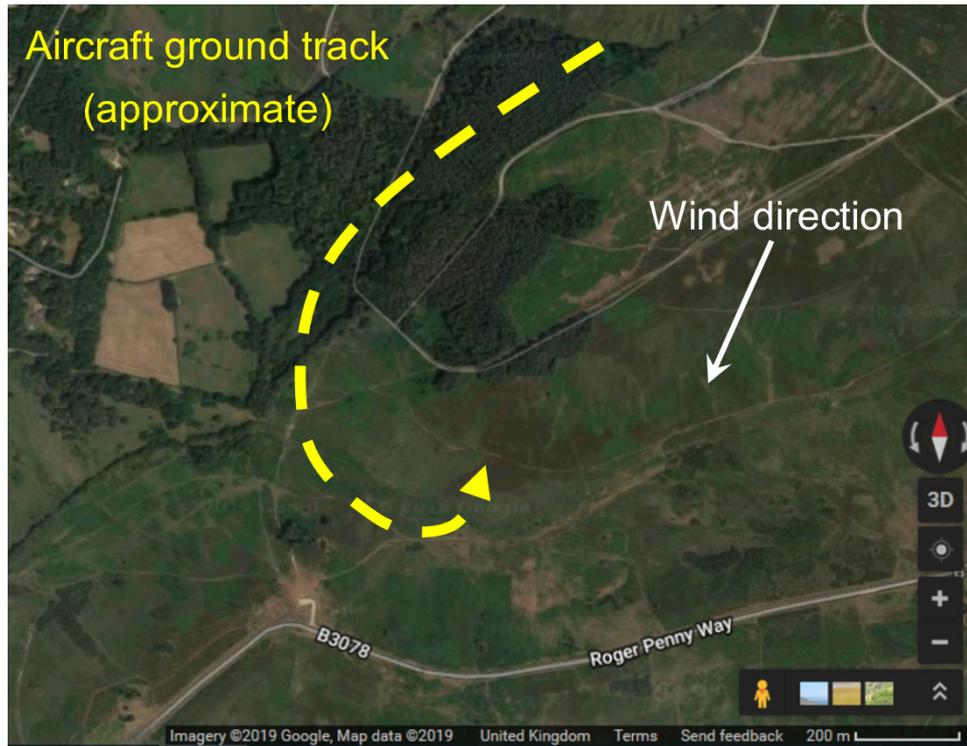
Figure 1

While cruising at 2,000 ft and 80 kt G-BZOR's engine suddenly began misfiring and lost power. An increase in vibration and reduction in throttle response led the pilot to believe that one engine cylinder had failed. Unable to maintain height, he positioned the aircraft for a forced landing. The pilot was not receiving an air traffic control service at the time and decided to concentrate on flying the aircraft rather than transmitting a MAYDAY call.

Initially over a copse of trees, the pilot selected a suitable landing site south of the woods, on an uphill slope in open heathland (Figure 1). Aware that he would have to execute a tight turn into wind on finals, he increased his airspeed from 55 to 75 mph to give a higher stall margin in the turn.

Approximate ground track of G-BZOR during the forced landing
