Published 14 November 2019

Aircraft Type and Registration:	Luton LA4A Minor, G-AWMN	
No & Type of Engines:	1 Volkswagen 1800 piston engine	
Year of Manufacture:	1987 (Serial no: PFA 827)	
Date & Time (UTC):	3 February 2019 at 1145 hrs	
Location:	Near Belchamp Walter, Essex	
Type of Flight:	Private	
Persons on Board:	Crew - 1	Passengers - None
Injuries:	Crew - 1 (Fatal)	Passengers - N/A
Nature of Damage:	Aircraft destroyed	
Commander's Licence:	UK Private Pilot's Licence	
Commander's Age:	55	
Commander's Flying Experience:	317 hours (of which 150 were on type) Last 90 days - n/k Last 28 days - n/k	
Information Source:	AAIB Field Investigation

The pilot was conducting a test flight in G-AWMN to renew the aircraft's Permit to Fly. Whilst climbing away from the runway, the aircraft was observed to bank to the right and then descend steeply to the ground.

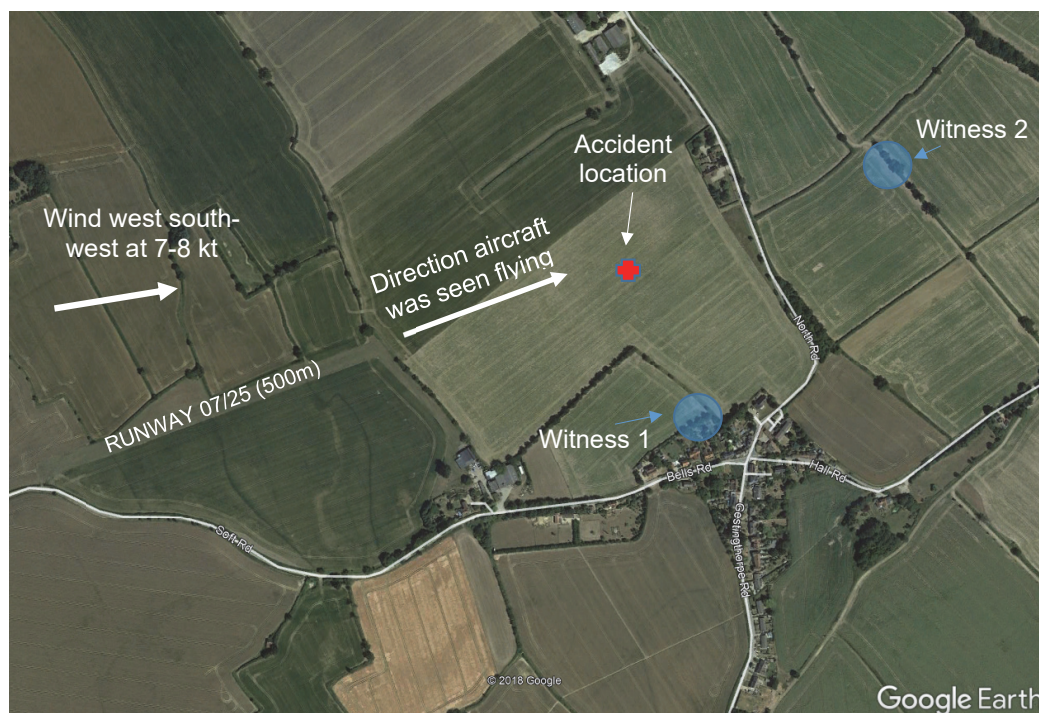
Figure 1

No one witnessed G-AWMN taking off and it is not known exactly when the aircraft was started up. The airfield owner heard G-AWMN start up but was not sure exactly what time this occurred, but he was informed of the accident approximately 10 – 15 minutes later.

Waits Farm showing the accident and witness locations

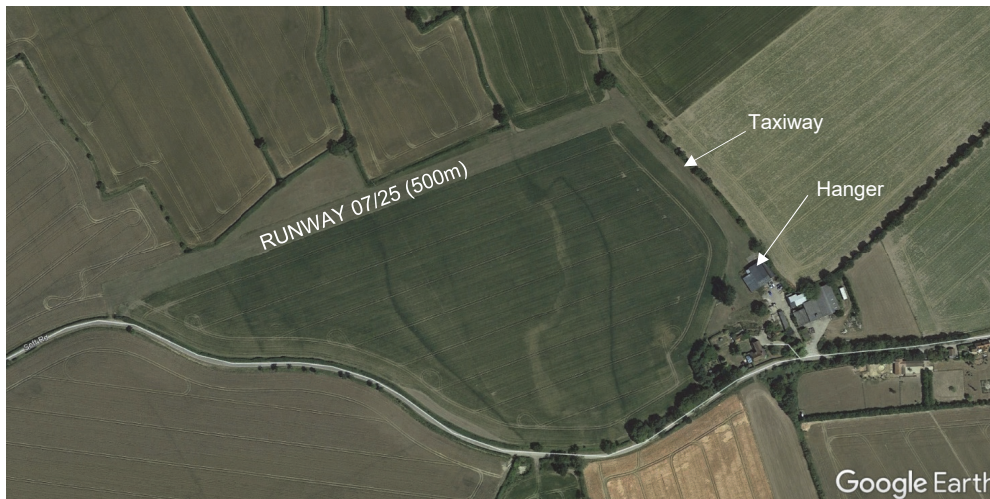
Figure 2
Waits Farm Airfield

returned later in the day used Runway 25. As no one witnessed G-AWMN taking off, it is not known which runway was used. However, the aircraft was seen climbing away from Runway 07.

The airfield owner reported that he inspected the runway after the accident and, despite the soft ground, found no tyre marks in the first third of Runway 07. This suggests that no aircraft had used this part of the runway recently.

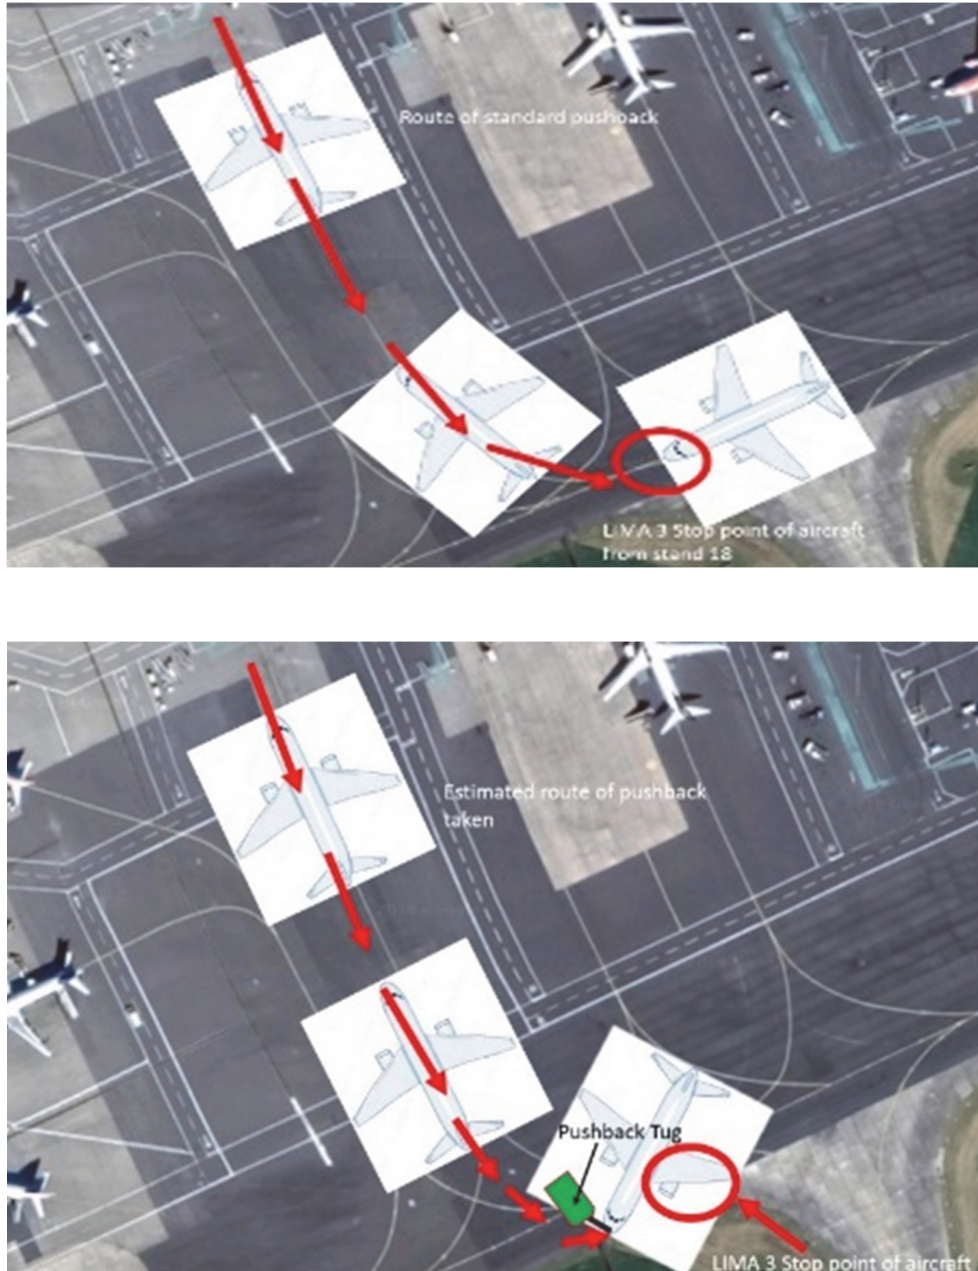
Figure 4

The pushback groundcrew comprised a tug driver and headset man who was in direct contact with the aircraft's flight crew, but there was no radio communication between the tug driver and the headset man. There was also a third person who was observing the pushback for training purposes. The aircraft was close to maximum all up weight and the latter part of the pushback was uphill which, when combined with the engine start and wet surface, increased the workload on the pushback groundcrew. The tug driver had difficulty seeing the taxi line due to the wet reflective surface of the apron and the tug was struggling to move the aircraft due to a high gear having been selected. The turn to L3 was made late and the aircraft's position was closer to the edge of the apron than normal (Figure 4).

Images showing the normal and incident pushbacks

The tug driver attempted to correct the situation by stopping the pushback and selecting a lower gear on the tug. When the pushback was stopped, the tug was at an acute angle to the aircraft and the tow bar angle was possibly close to the 75° maximum angle to the aircraft's centreline. The aircraft, which was at idle power and facing down-slope, moved forward and, at some point, the shear pin in the tow bar failed disconnecting the tow bar and tug from the aircraft (Figure 5).

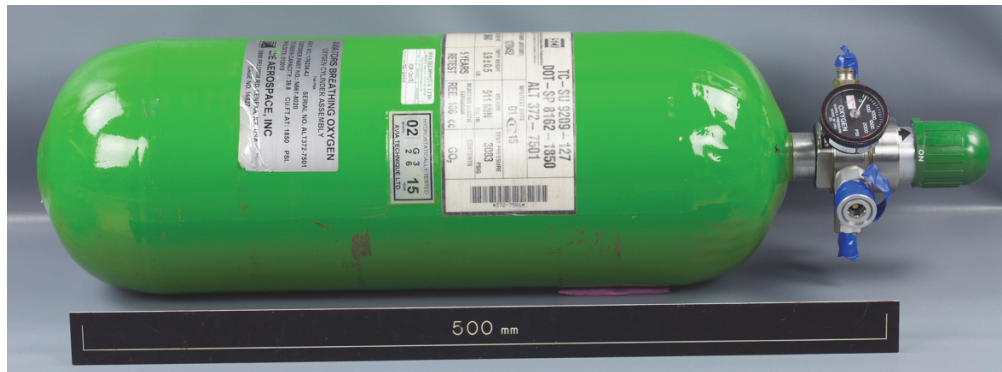
Figure 2
Oxygen cylinder assembly

The oxygen cylinder assembly (Figure 2) has sufficient capacity for a descent to FL140 in 4 minutes followed by continued flight at FL140 for a further 116 minutes. The cylinder assembly consists of a composite bottle and a regulator assembly attached to the outlet (Figure 3).

Following the incident on 13 December 2018, the oxygen cylinder assembly was removed from the aircraft and taken to a laboratory for further analysis. The regulator was removed from the bottle and a visual examination revealed debris blocking the crew oxygen supply line port (Figure 4).

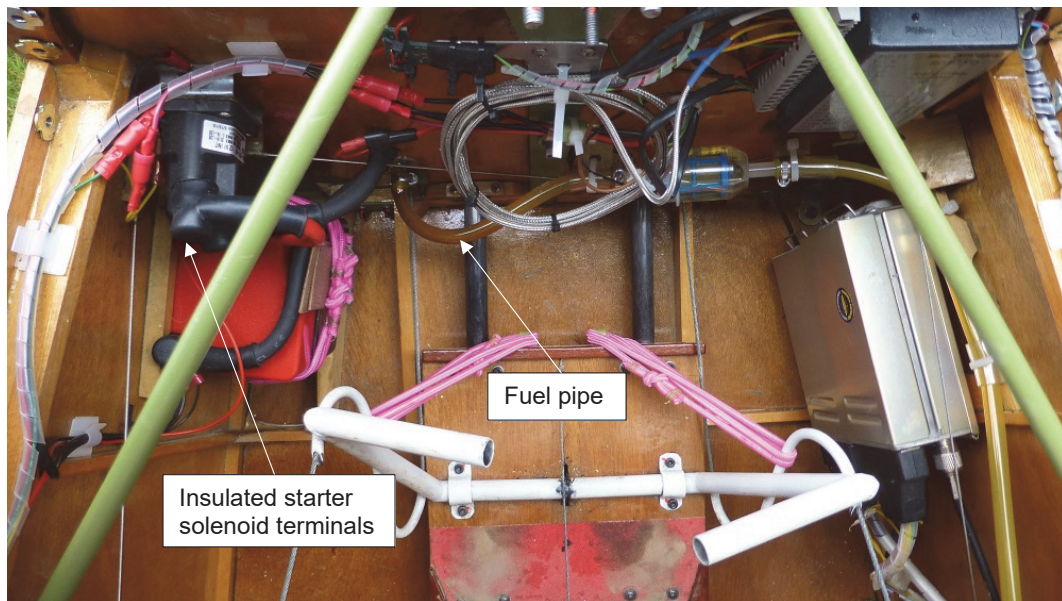
Figure 3

During the taxi manoeuvres the pilot noted a restriction when he applied full left rudder pedal and shortly afterwards smoke was seen in the cockpit. It is probable that, as the rudder pedal carriage was in the fully forward position, the metal pedal contacted the exposed terminals of the starter solenoid. The solenoid is connected directly to the battery and the metal rudder pedal created a short circuit to earth, resulting in rapid discharging of the battery and overheating of the electrical system. Evidence was found of local heat damage to the engine bulkhead around the starter solenoid. This overheating may have caused the fuel pipe to melt, with a spark igniting the fuel and the aircraft was then consumed by the fire.

The plans for the aircraft state that the terminals of the solenoid should be “*perfectly isolated*”. The Light Aircraft Association (LAA) has examined all other Luciole aircraft registered in the UK and confirmed that all the terminals are insulated (Figure 4). It is suspected that only G-CIBJ did not have this insulation and awareness of this issue has been raised by the LAA in their June 2019 “*Safety Spot*” publication and Technical Leaflet TL3.26. The LAA intends to mandate a change to the specification of the fuel pipe in the cockpit to one that is more heat resistant and will require all UK owners to modify their aircraft to this new fuel pipe specification.

Cockpit interior (not G-CIBJ)
