AAIB
Air Accidents Investigation Branch

AAIB Bulletin

12/2019

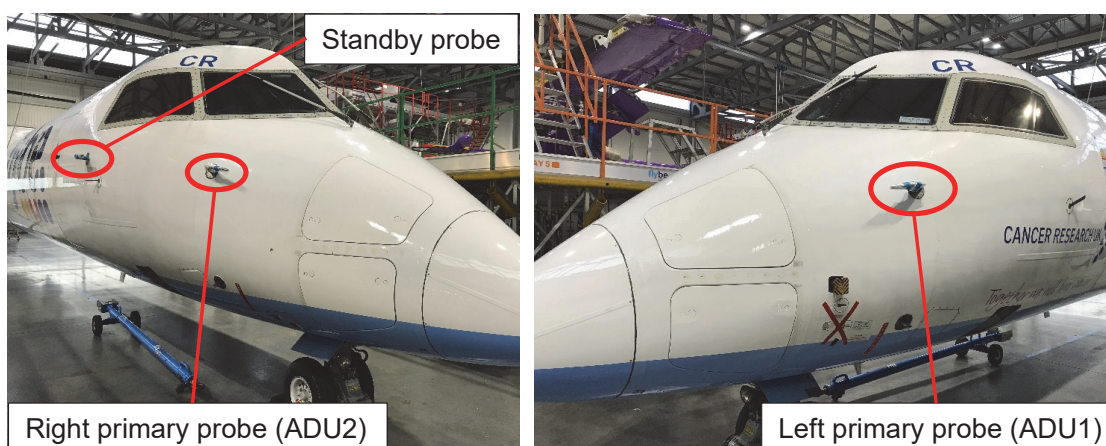
Figure 1

The two functionally independent ADUs use inputs from a variety of sources to calculate parameters such as altitude, indicated and true airspeed, and temperature. Two such inputs are static and total pressure which are sensed by the pitot static probes installed on the front of the aircraft. There are two primary pitot static probes located on the left and right side of the nose fuselage, linked to ADU1 and ADU2 respectively, and a third pitot static probe on the right side of the nose fuselage linked to the standby instruments (Figure 1).

Pitot static probe locations

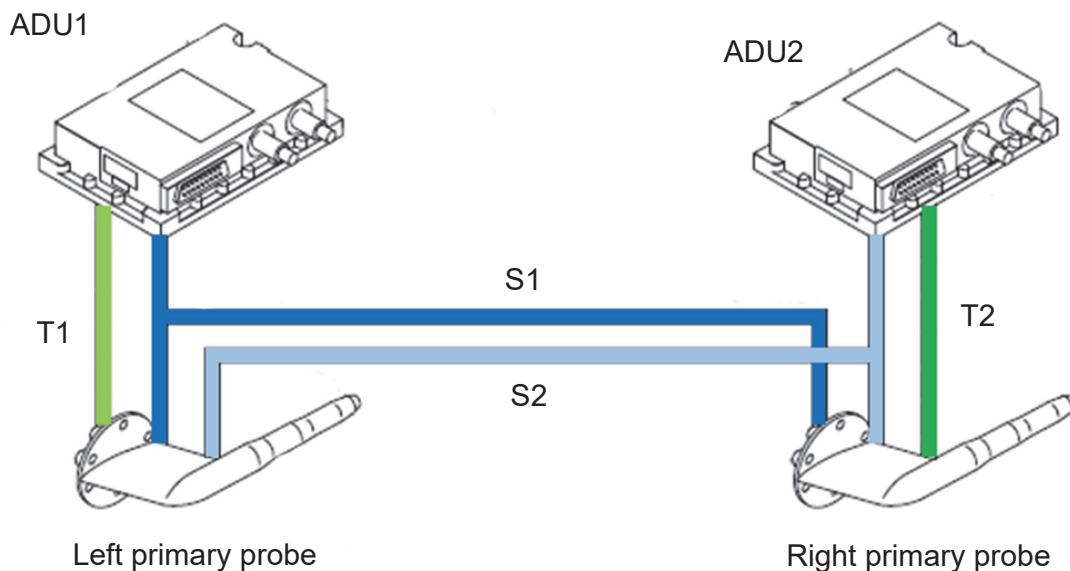
Figure 3

The two primary pitot pressures (T1 and T2) are fed directly to the respective ADU, whereas the static pressures from the two static holes from each primary probe are averaged (S1 and S2) and fed to each ADU to minimise any sideslip effect (Figure 3).

Pitot static system

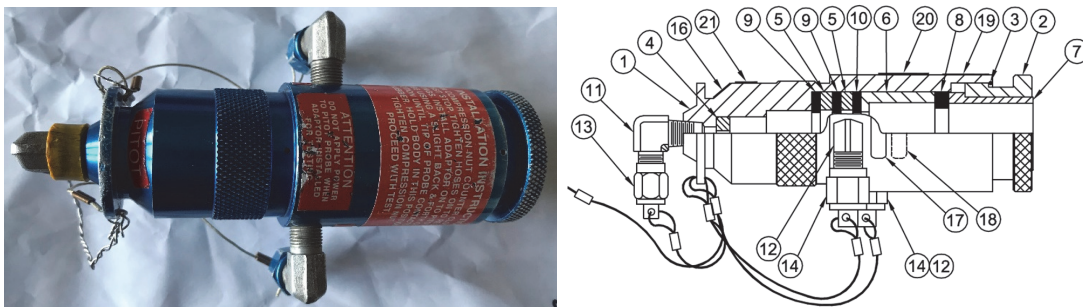
Figure 6

The primary pitot static probe adaptor is a machined aluminium tube which is slid onto the pitot static probe and has three hose connectors; one for pitot pressure [13], and one each for static pressure S1 and S2 [14] (Figure 6). Internally, there are seals [4, 8, 9 & 10] to enable the separate parts of the system to be tested and a knurled locking sleeve [2] to compress the seals onto the probe. A glycol and water-based lubricant (LF5050) is also supplied to aid installation.

Primary pitot static probe adaptor

of each adaptor and the FT-IR results showed that it was a type of petroleum product, with the SEM-EX results showing elevated levels of silicone that were not consistent throughout the sample. There was evidence of damage to the knurled finish on the locking sleeves of all the adaptors.

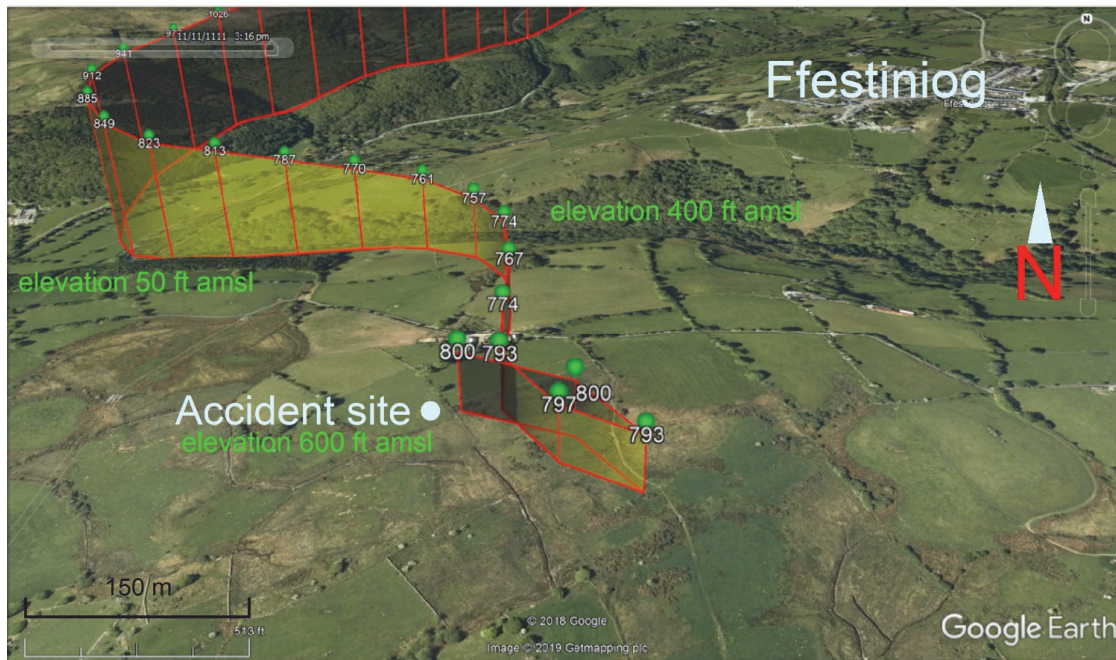
Figure 3

GPS track of final 15 minutes of flight
(values presented are aircraft altitude amsl and terrain elevation)

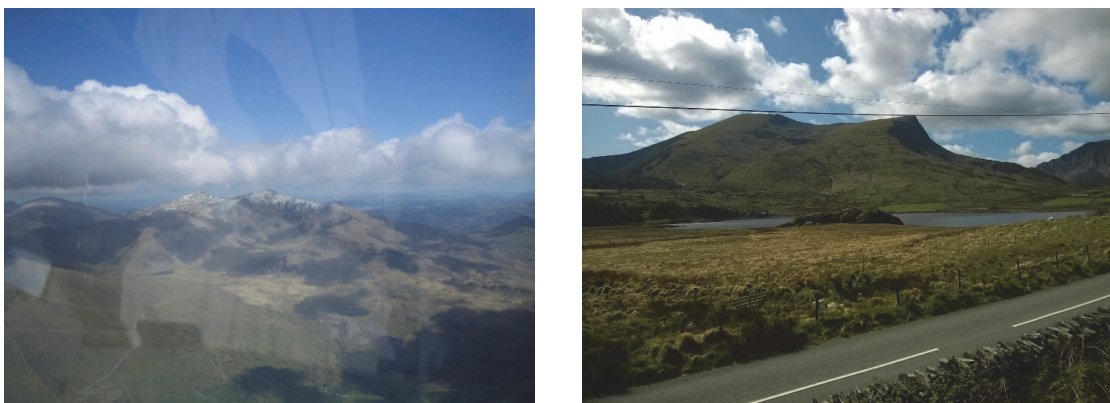
Three other glider pilots who were flying in the same region at a similar time that the accident occurred were interviewed. They described the weather as northerly wind at approximately 20 kt with cloud base around 4,000 ft amsl. The cloud base was higher further south. They described challenging gliding conditions with significant turbulence particularly in the lee of the hills. The photographs in Figure 5 give an indication of the cloud cover in the area at the time of the accident. The left picture was taken by a glider pilot flying to the west of Mount Snowdon approximately one hour before the accident. The right picture was taken from the ground near Rhyd Ddu (9 nm north-west of the accident site) looking west.

Photographs showing the weather near the accident location

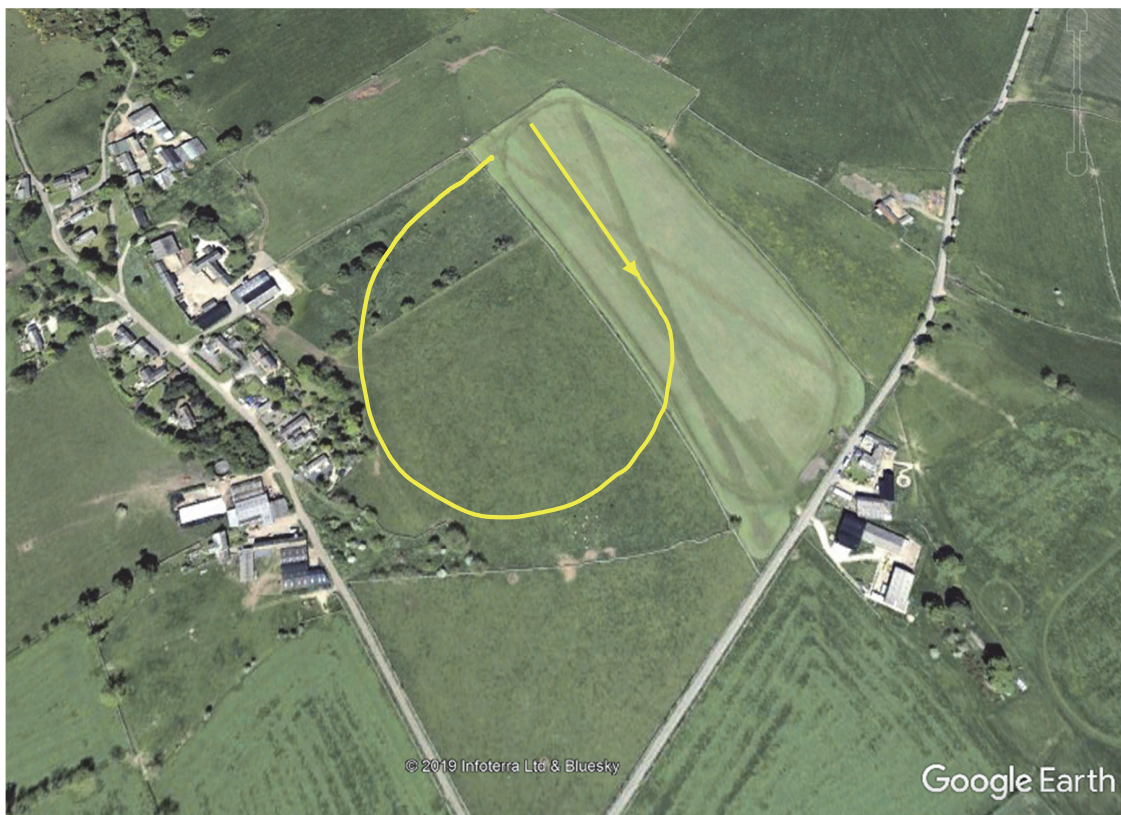
Figure 1

The pilot taxied onto the runway and began to accelerate for his high-speed run. He was surprised when he felt the aircraft become airborne at around 45 kt which he thought was significantly below the normal speed for lift off. As it lifted off, the pilot heard a sound which he described as a “ping” and the aircraft immediately began to roll right. The pilot was concerned that the right wingtip would hit the ground so, whilst he applied opposite stick to the roll, he decided to leave the power set, hoping that the aircraft would climb. He felt that even the application of full opposite stick did not alter the angle of bank to the right. Witnesses describe the aircraft lifting off and immediately banking to the right. The aircraft was then seen to climb, still turning to the right. It flew a continuous right turn through approximately 270° to the west of the airfield before it struck the top of a group of trees. The estimated flight path from witness statements is shown in Figure 1.

Estimated flight path of G-MVOJ

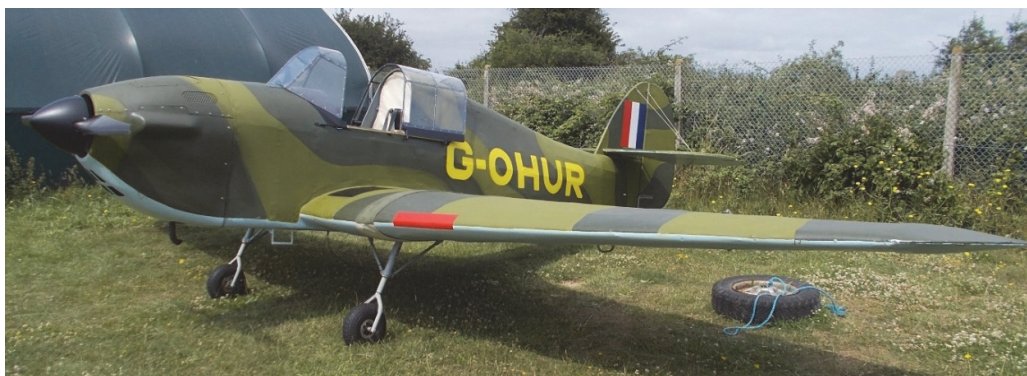
Figure 2

G-OHUR was classified as a SSDR microlight aircraft and as such it could be designed and constructed privately without the airworthiness oversight of either a member association or the CAA. The pilot had designed and built the aircraft, which was based on a scaled down version of the Hawker Hurricane (Figure 2). The aircraft first flew in May 2018 and had flown 14 hours.

Hurricane 315, G-OHUR (picture courtesy of the owner)
