AAIB Bulletin

1/2020

Aircraft Type and Registration:	Eurocopter EC135T1, VP-CPS	
No & Type of Engines:	2 Turbomeca Arrius 2B1A turboshaft engines	
Year of Manufacture:	1999	
Date & Time (UTC):	26 February 2019 at 1631 hrs	
Location:	Owen Roberts International Airport, Cayman Islands	
Type of Flight:	Training and search	
Persons on Board:	Crew - 3	Passengers - None
Injuries:	Crew - 3 (Minor)	Passengers - N/A
Nature of Damage:	Damage to tail boom, landing gear and transmission deck	
Commander's Licence:	Commercial Pilot's Licence	
Commander's Age:	58 years	
Commander's Flying Experience:	7,842 hours (of which 3,879 were on type) Last 90 days - 56 hours Last 28 days - 22 hours	
Information Source:	AAIB Field Investigation

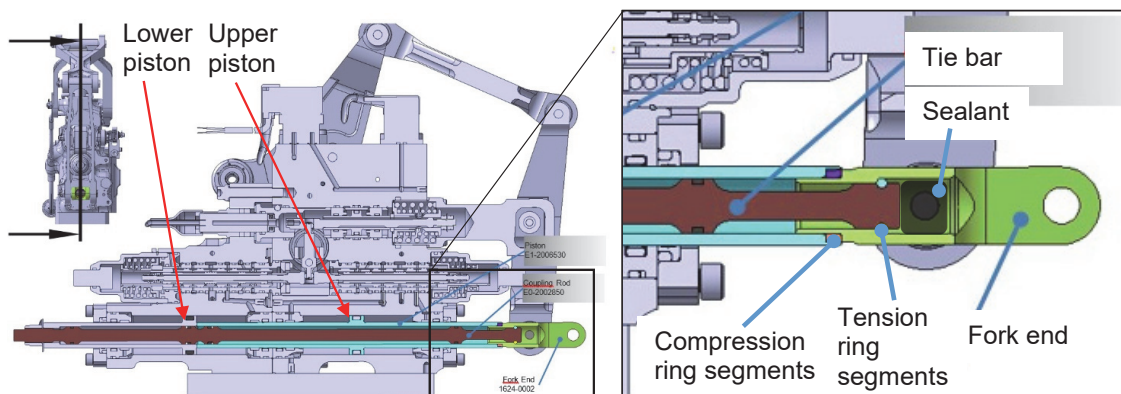
Figure 3

The MRA is installed vertically and, depending on control input, the actuators either push upwards or pull downwards on the swashplate linkage. Inside each individual actuator are two axial pistons, one per hydraulic system, which are linked with a tie bar (Figure 3). This bar is manufactured from passivated, high-strength, corrosion-resistant steel, and attached to a fork end which connects to the swashplate linkage. Tension loads from the pistons are transferred to the fork end by the tension ring segments and compressive loads are transferred through the compression ring segments. Sealant is applied to the centre bore of the fork end to prevent moisture ingress into the upper piston through the tension ring segments.

Cross section views of a single axis actuator from the MRA (rotated)

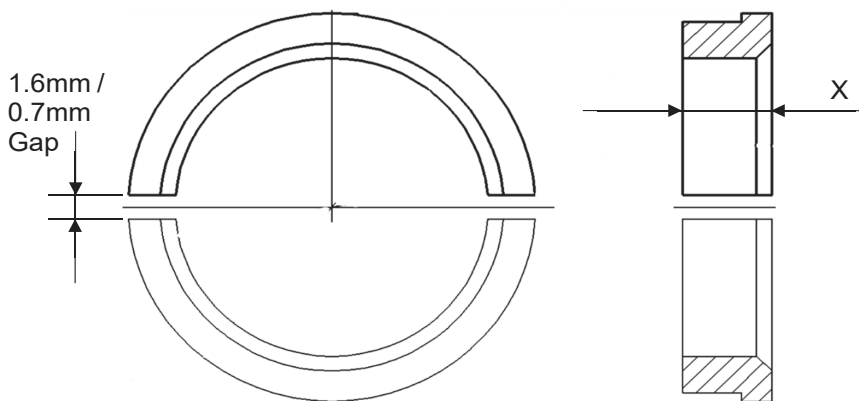
Figure 4
Compression ring segments

To enable the replacement of an actuator on the helicopter without the need to adjust the swashplate linkage, the length of the actuator is controlled to +/- 0.1mm. To achieve this tolerance, the completed actuator length is measured, and new compression ring segments (Figure 4) are fitted to achieve the length tolerance. The replacements are chosen from a group with a range of different lengths [X].

Two half-segments are used to remove the need to fully disassemble the actuator at the final stage of manufacture and no sealant is applied, to ensure ease of removal. The dimensional tolerances of each segment result in a gap between the segments of 1.6 mm to 0.7 mm on each side (Figure 4) when installed into the upper piston (Figure 5).

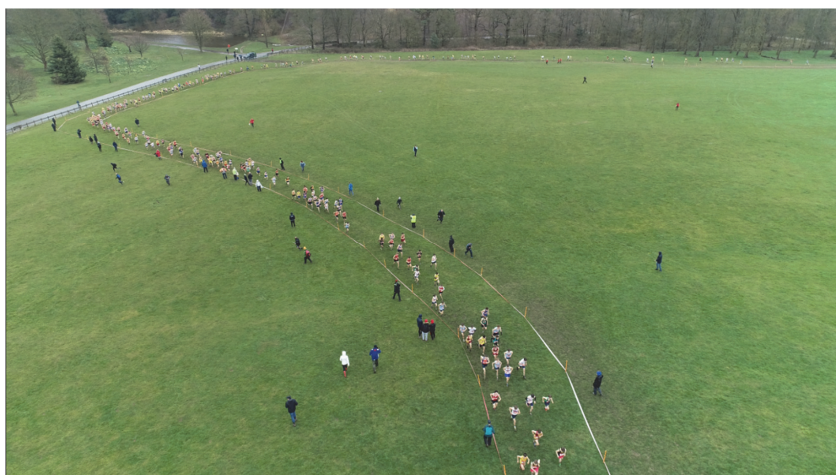
Figure 2

Whilst en route to the TOLS, the aircraft passed overhead people at a height of about 10 m (~30 ft) agl (Figure 2 and Figure 3). At some point during this period the pilot saw the aircraft do "a little wobble" and became concerned that there was a problem and stopped filming. As the aircraft approached the TOLS at a height of about 3 m (10 ft) agl it suddenly "flipped itself upside down and drove itself into the ground". No person was injured, but the aircraft was severely damaged. The recorded flight time was about eight minutes.

Footage taken whilst en route back to the TOLS

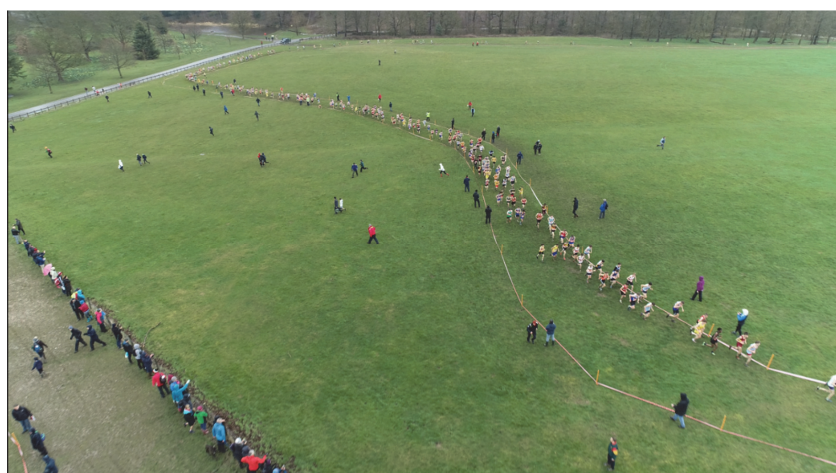
Figure 3

Footage captured one minute before the accident

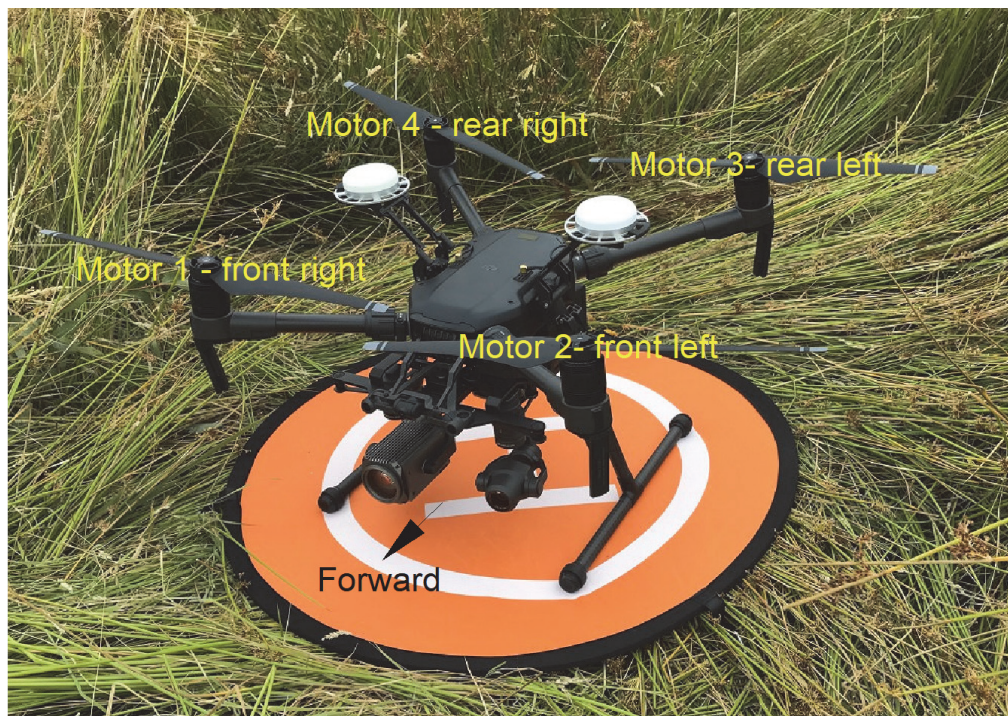
Figure 4

The Matrice 210 is a quadcopter aircraft with a maximum takeoff mass of 6.14 kg (Figure 4). With its flight controller, the aircraft forms a UAS. During the accident flight the mass was 4.97 kg, which included an underslung camera mounted on a gimbal and two TB55 batteries. The Matrice 210 forms part of the manufacturer's model range referred to as the Matrice 200 series.

RTK version of the Matrice 210
The accident aircraft was fitted with one camera and did not have external GPS antennas attached (two white circular components)

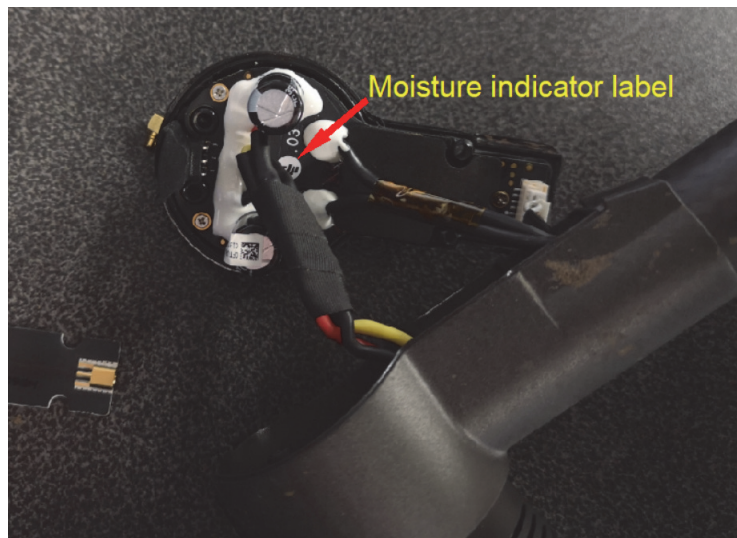
Figure 6

ESC moisture indicator position

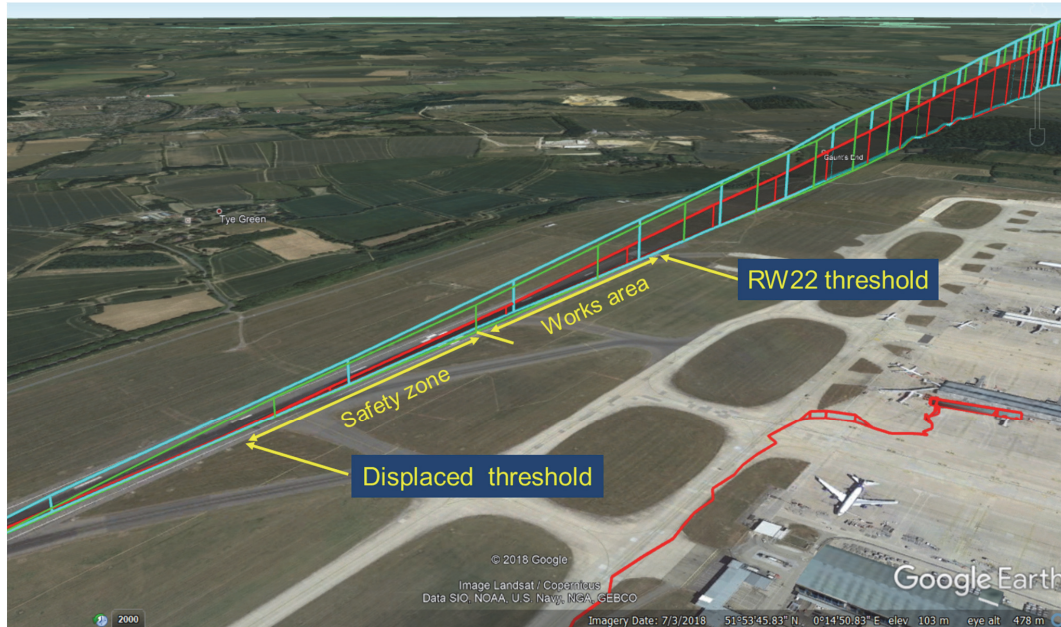
Figure 3

Radar data for the incident aircraft and the two aircraft that landed after it revealed that YL-LCQ was consistently lower during the approach than the following aircraft which had both flown the RNAV22C procedure (Figure 3).

Comparative radar traces (YL-LCQ trace in red)

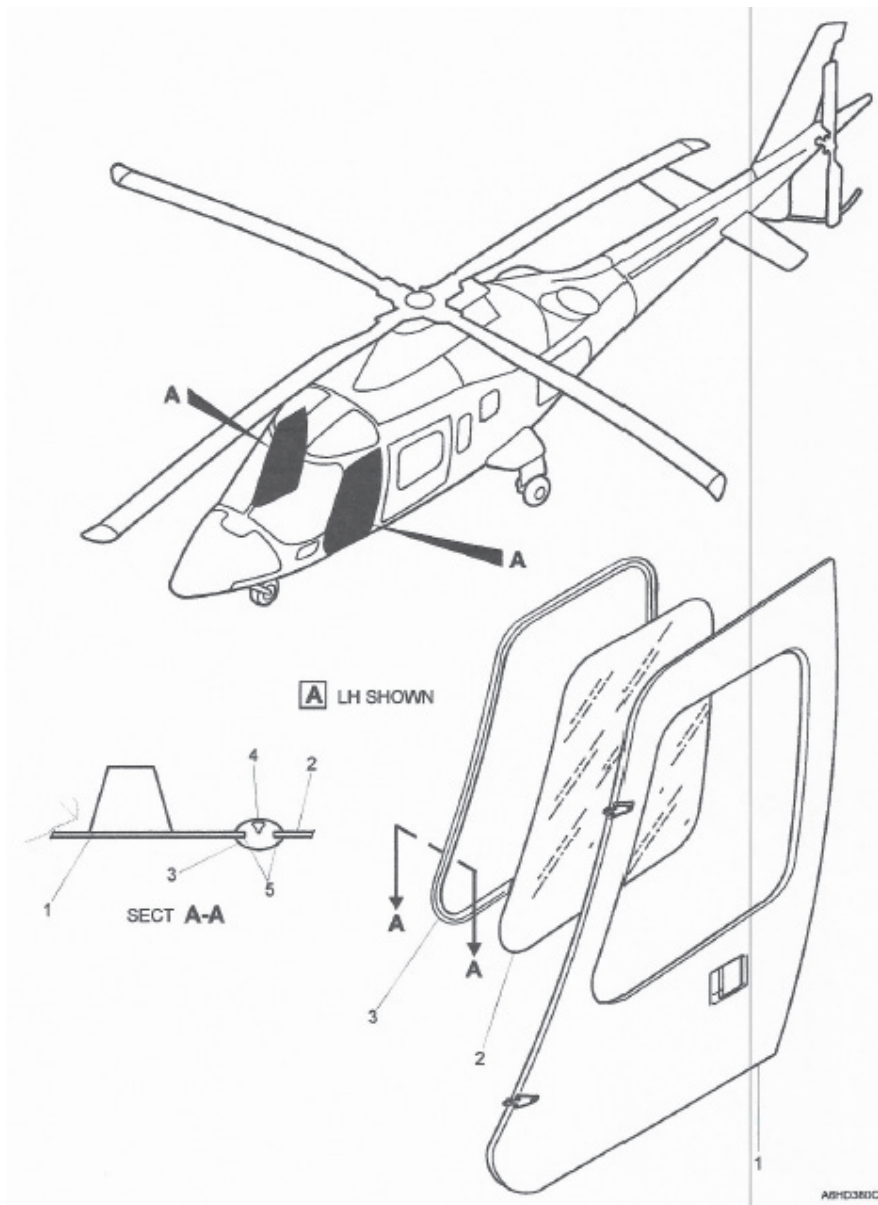
Figure 1

Illustration showing installation of A109E cockpit doors

NOTE: make sure to install the seal channel and the seal filler as detail in [Fig 1].

- (4) Insert the seal filler (4) into the seal channel (3). When starting, hold the end of the seal filler (4) in position with a thumb and, if a new seal filler is being used, provide a slight overlap before cutting the seal filler strip to allow for a tight joint when both ends are forced into place.*
- (5) Butt ends and compress seal filler (4) into the seal channel (3).*

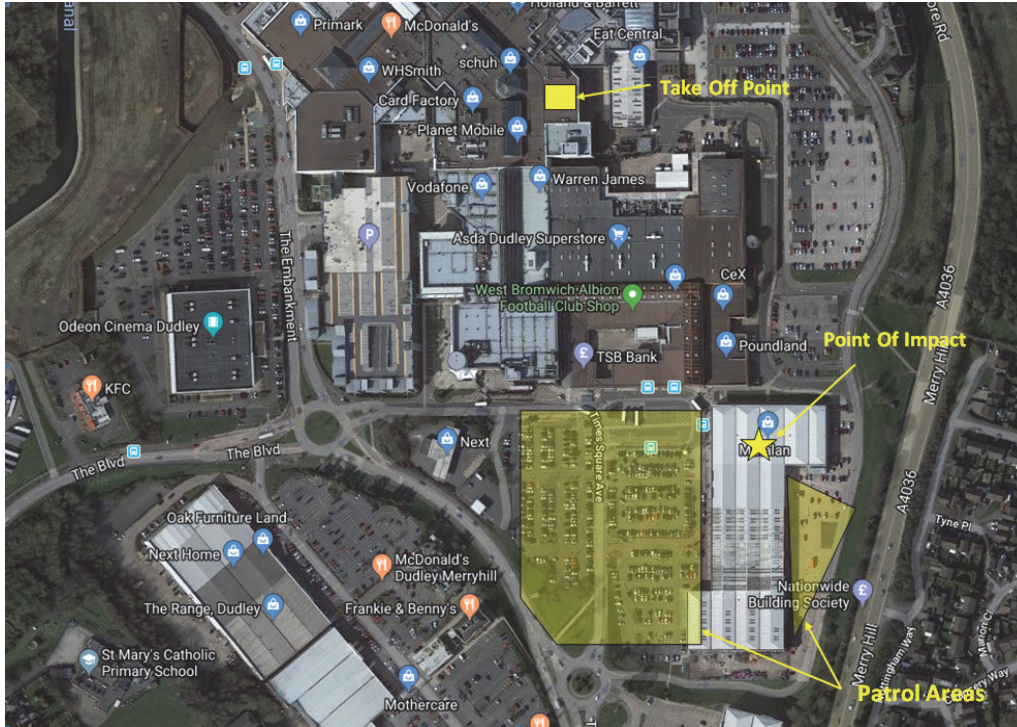
Figure 1
Accident site location

pilot brought the aircraft to a hover about 50 m above the roof of a shopping centre building. About one minute later, the aircraft suddenly dropped vertically and crashed into the roof of the building (Figure 1). The pilot had not made any control inputs and it was stated that there had been no warnings on the controller. The aircraft suffered severe damage (Figure 2).
