# ***AAIB Bulletin***

# ***2/2020***

Published 13 February 2020

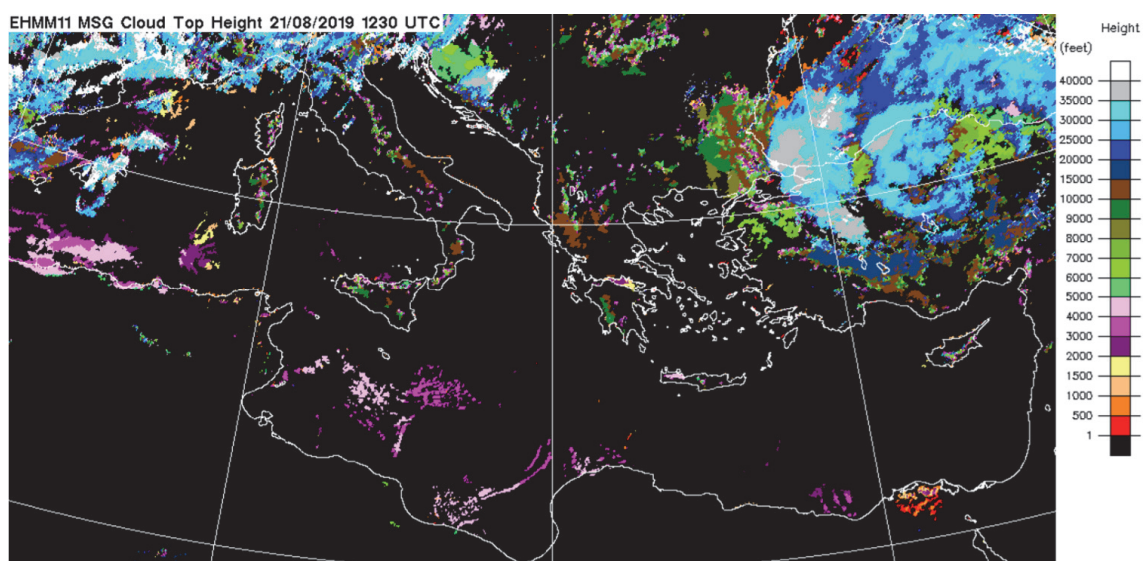
**Figure 4**

Figure 4 shows a derived satellite image showing cloud top heights at the time of the incident, produced by the Met Office after the accident. The image indicates there was a large area of cloud with tops between 30,000 ft and 35,000 ft across the area in question.

Derived Satellite Image showing Cloud Top Heights  
valid at 1230 hrs on 21 August 2019

The aircraft encountered turbulence over northern Turkey during which a passenger was seriously injured. The turbulence was caused by a rapid wind shift.

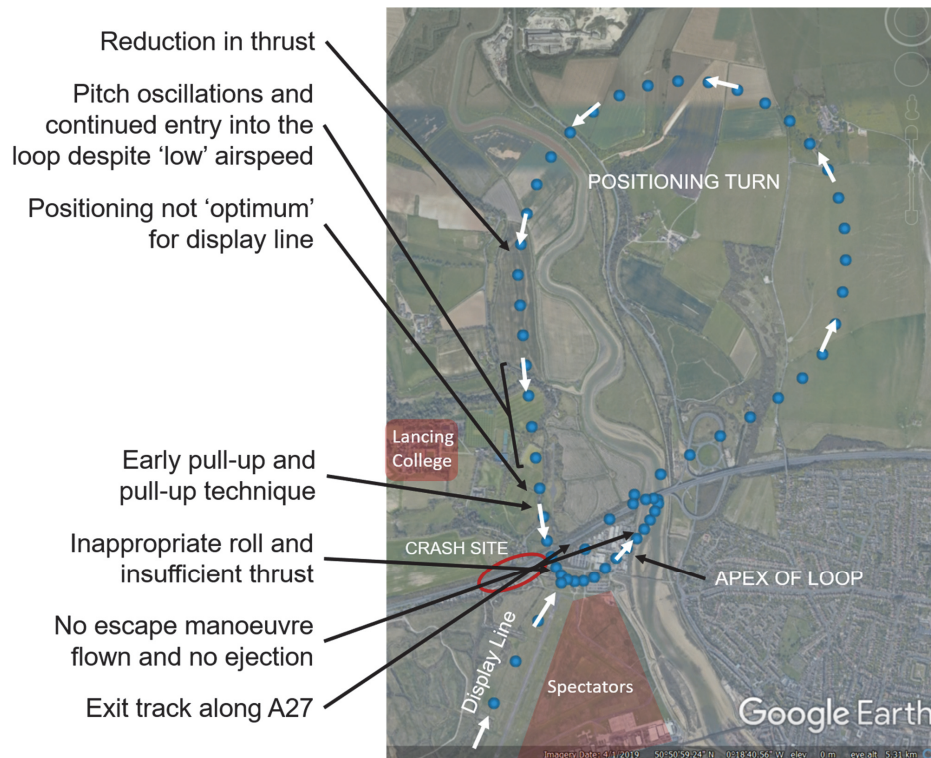
**Figure 1**

Summary of pilot actions according to material provided to the AAIB

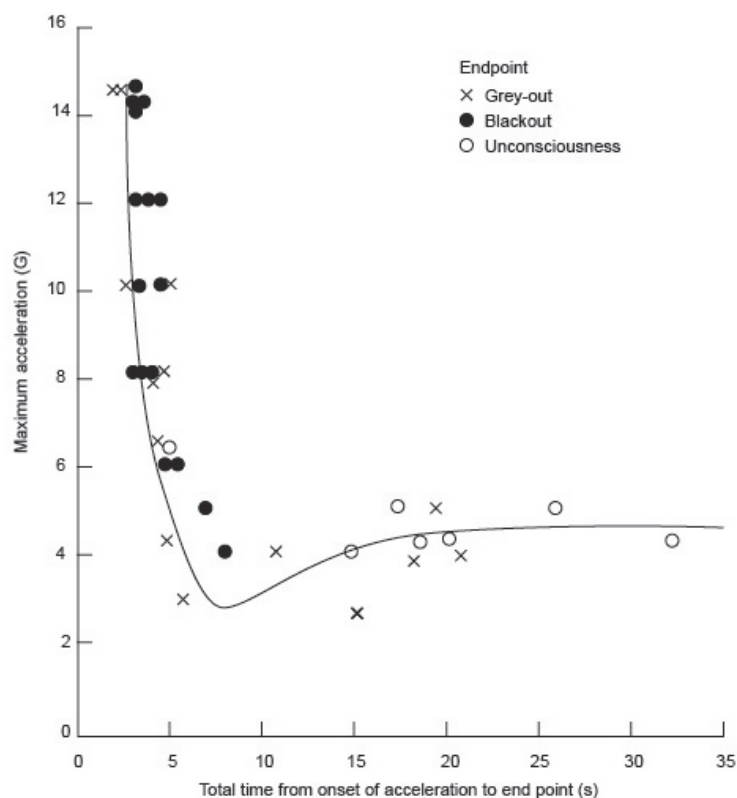
**Figure 2**

The figures stated for average levels of Gz tolerance varied slightly in the literature depending on what research source was used. Figure 2 summarises results from a compilation of Gz tolerance studies involving participants who were not wearing any anti-G clothing or performing any techniques to increase their G tolerance. Each point on the graph shows the result of a research study in terms of when the end point of greyout, blackout or unconsciousness was experienced under different levels of Gz and different durations of exposure. The line on the graph summarises the general finding seen across studies that high levels of Gz of short duration may not result in symptoms, but symptoms progress quickly if the onset of Gz is rapid. Lower levels can be tolerated for longer, especially if the onset is slow. It shows that it is rare to find effects within four seconds of exposure or below +3 g.

Relaxed participants' tolerance to +Gz acceleration based on a compilation of research studies (reproduced from Gradwell, D.P. and Rainford, D.J., 2016)

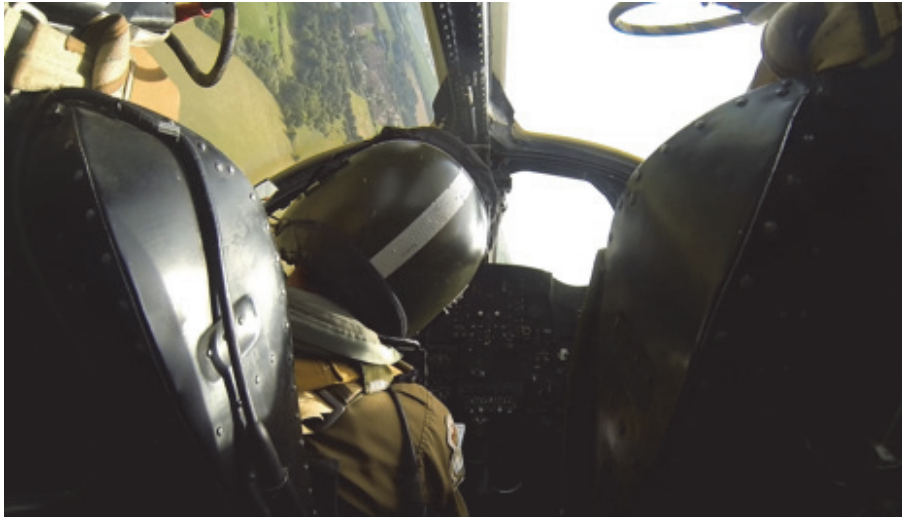
**Figure 3**

Figure 3 and Figure 4 illustrate one of the behaviours he described as an example of optokinetic cervical reflex.<sup>16,17,18,19</sup> This is a well-documented phenomenon in low-level flight in visual meteorological conditions, in which a pilot orients their head with respect to the visible horizon rather than the aircraft's attitude. This aeromedical expert noted that:

Shoreham 2014: Head movement example of optokinetic cervical reflex

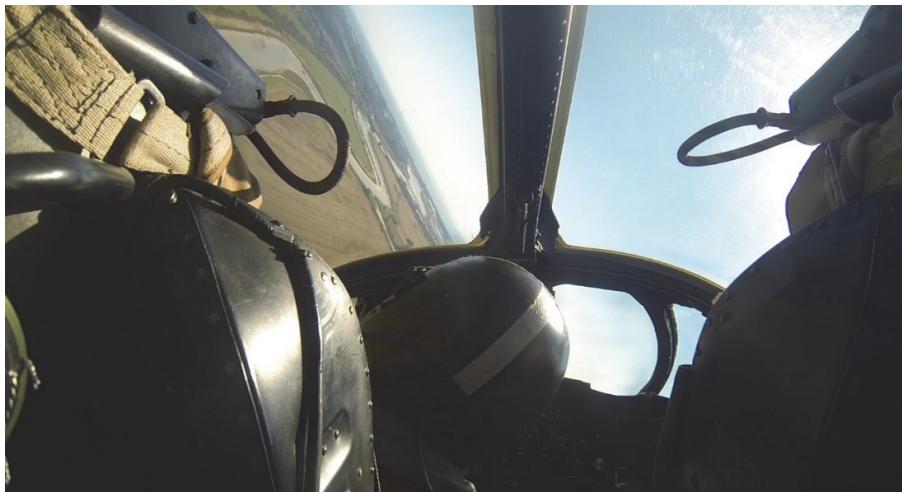
**Figure 4**

Accident flight: Head movement example of optokinetic cervical reflex

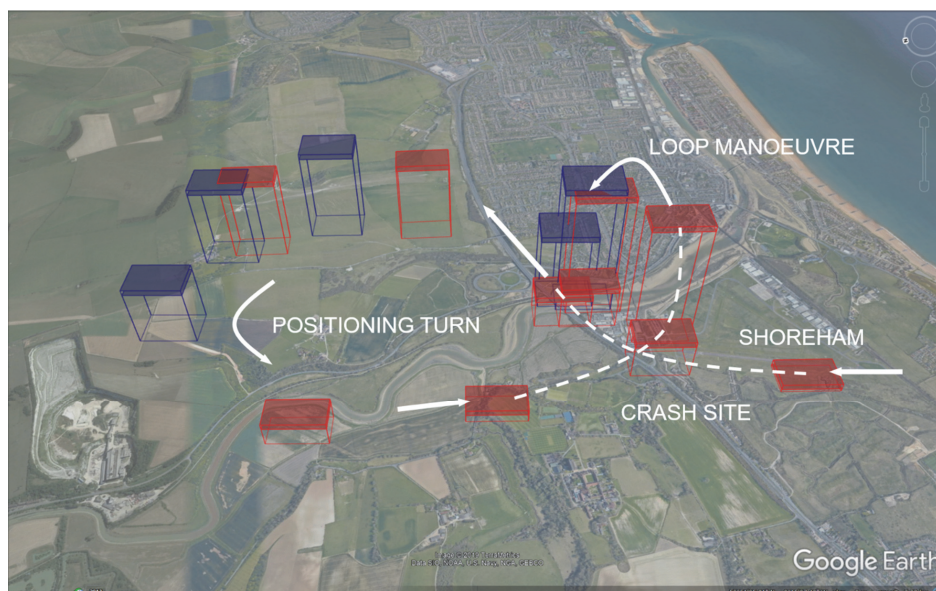
**Figure A-1**

Boxes showing with 95% confidence the position of the aircraft indicated by Pease Pottage (red) and Gatwick (blue) radar heads (note that the corners of the boxes have been extended down to show their position over the ground)

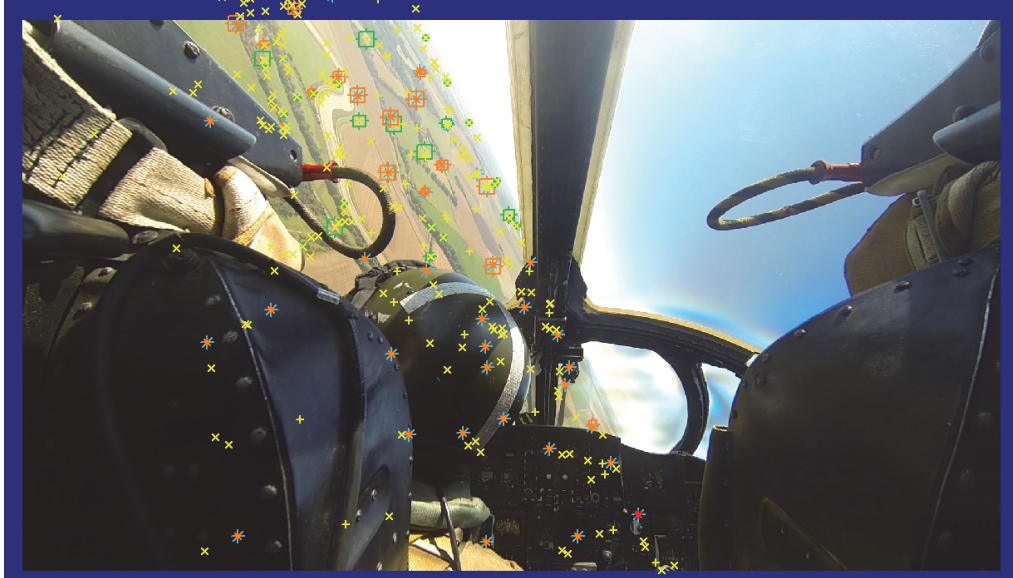
**Figure A-2**

Figure A-2 shows a frame from the GoPro video and the associated track points used by the photogrammetry software. The position calculations close to the start of the pull-up of the loop manoeuvre are less accurate due to the diminishing view of ground reference points with the wings level. The cockpit windows create distortions in the imagery of the scene beyond it in a way that the software is not designed to derive and compensate for. However, the quality of the results indicates that the additional errors this introduces are small enough to be addressed adequately by a standard lens distortion derivation process.

Snapshot from the GoPro action camera with markers for track points and the locations of ground features including those not in frame or obscured in the frame

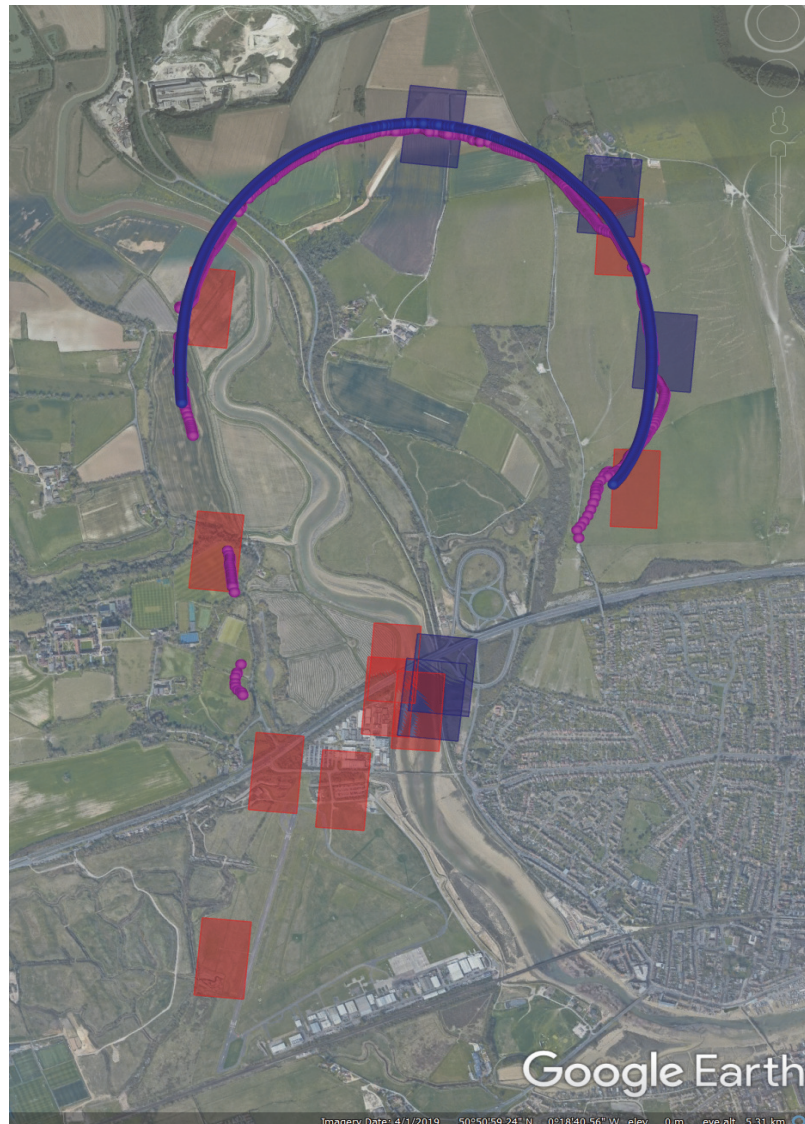
**Figure A-3**

Overview and comparison of derived tracks from DogCam (dark pink dots) and GoPro (dark blue dots) cockpit action cameras with Pease Pottage (red) and Gatwick (blue) radar boxes

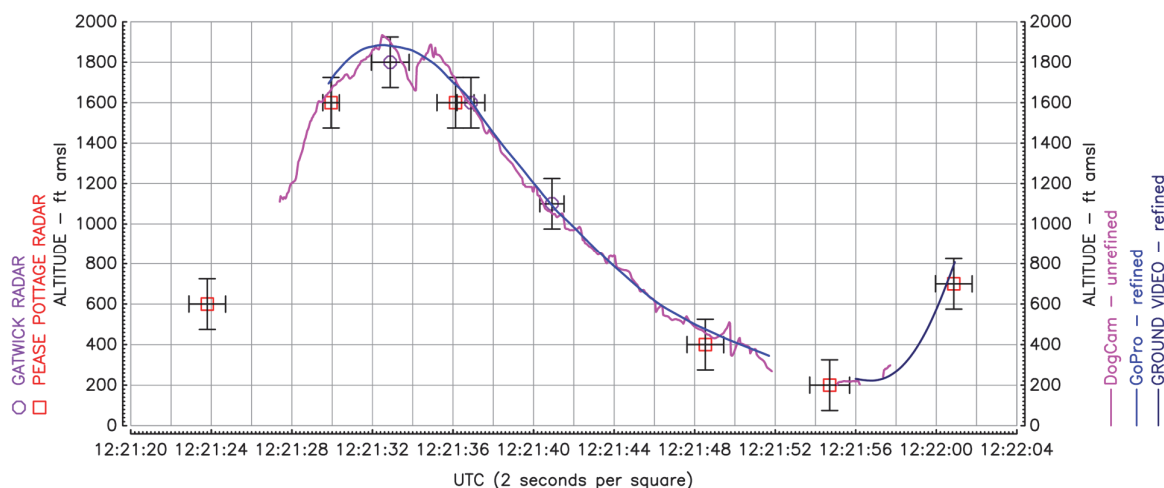
**Figure A-4**

Comparison of altitude derived from DogCam (dark pink), GoPro (dark blue) cockpit action cameras and ground video (black) with Pease Pottage (red square) and Gatwick (purple circle) Mode C altitudes

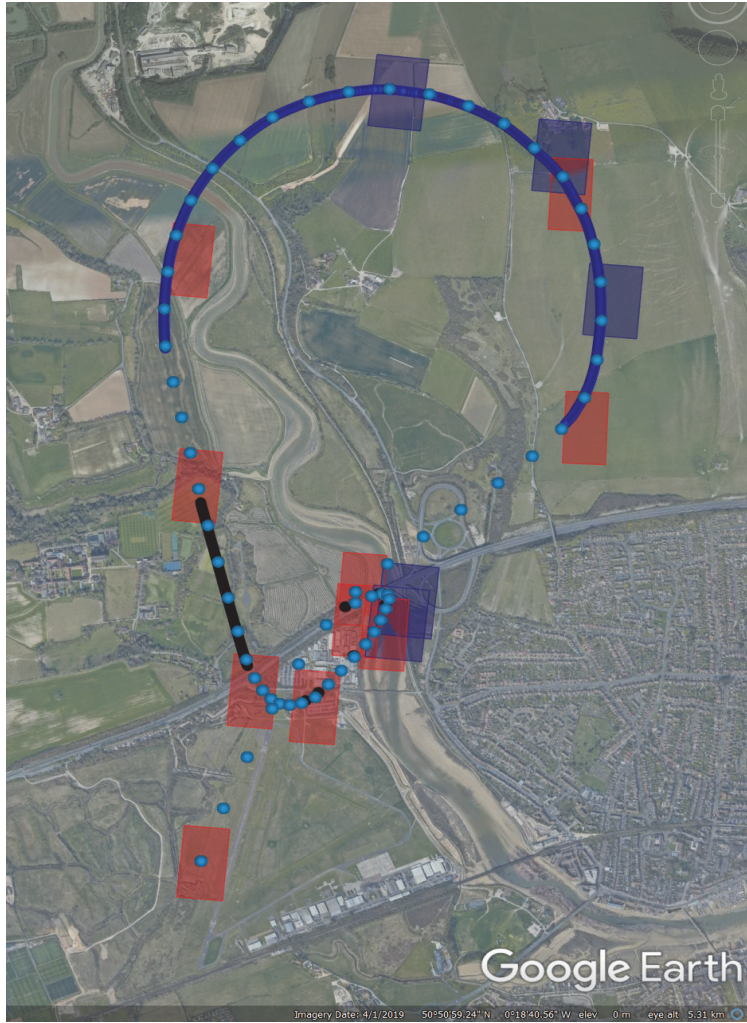
**Figure A-5**

1Hz interpolated flightpath ground track (light blue dots) through the radar boxes and the derived GoPro (dark blue dots) and ground video (black) positions

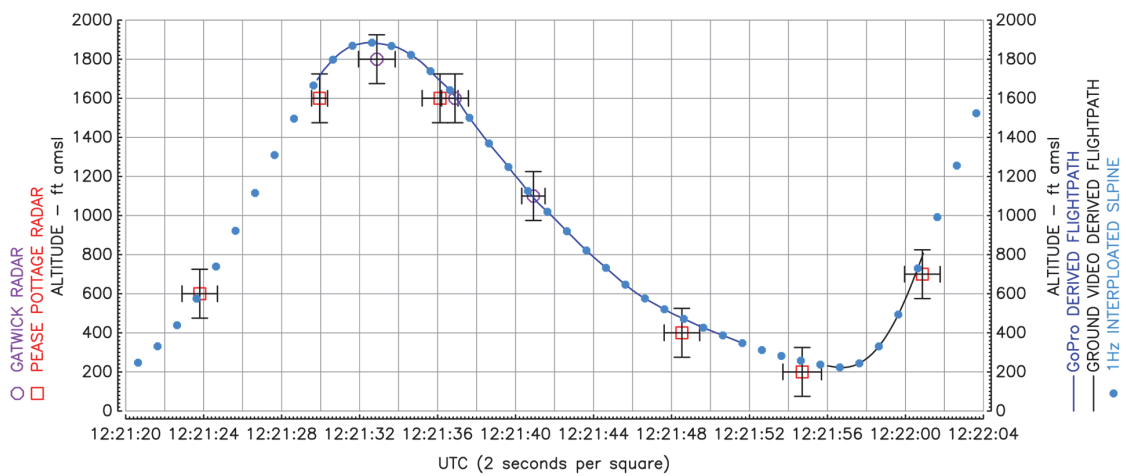
**Figure A-6**

1Hz interpolated altitude profile (light blue) through the radar boxes and the derivedGoPro (dark blue) and ground video (black) positions

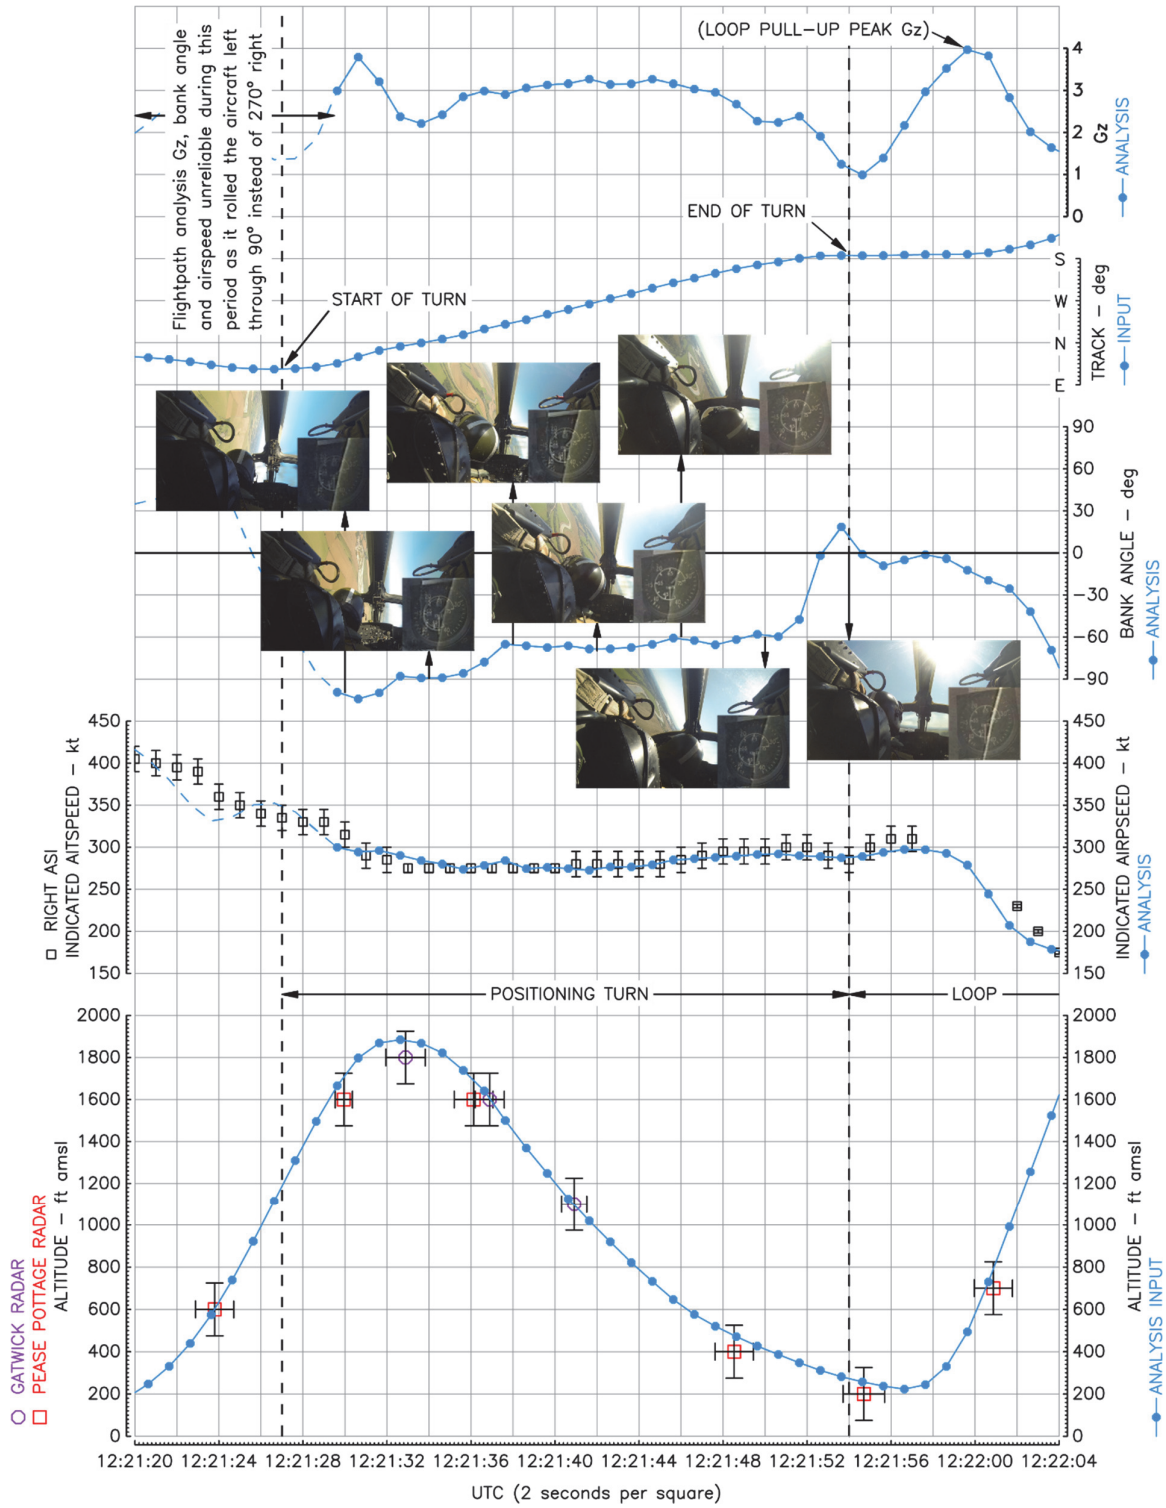
**Figure A-7**  
Results of flightpath analysis to determine Gz in the positioning turn

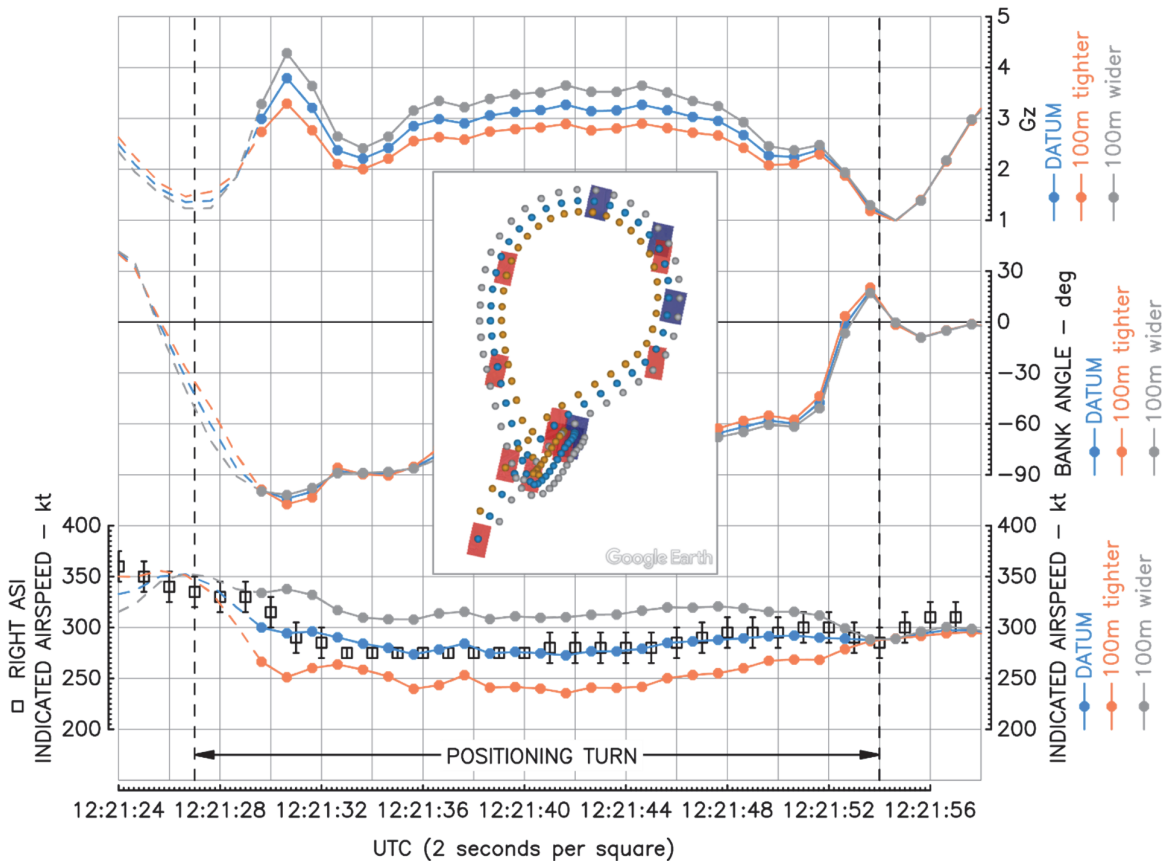
**Figure A-8**

Results of sensitivity study comparing datum flightpath analysis (light blue dots) with a turn which is tighter (orange dots) or wider (grey dots) by 100 m (the overlay shows a plan view of these tracks relative to the radar boxes)

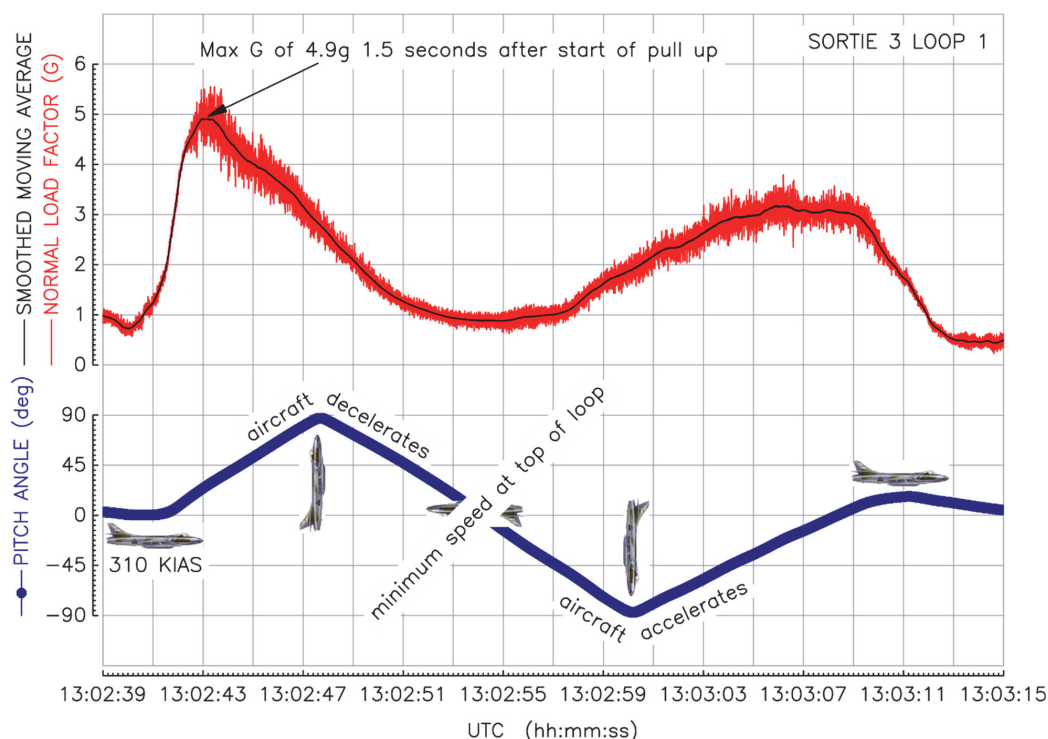
Figure A-9 shows the Gz profile of a maximum performance loop that was flown during Sortie 3 of the data gathering flights. The Gz trace has lots of noise which is probably a result of the accelerometer used to measure the Gz vibrating; therefore, a smoothed moving average has been calculated to find the median Gz of the noise. The figure shows that the maximum Gz of 4.9 g occurred shortly after the initial pull-up, and since Gz is proportional to lift, which is proportional to equivalent airspeed<sup>41</sup> (EAS) squared, this corresponds to when the airspeed was at its highest. The G-onset rate peaked at 3.3 g/s.

The entry speed for the loop in Figure A-9 was 310 KIAS which was the highest entry speed for the loops flown in the flight trials. It was also the nominal entry speed for the accident manoeuvre.<sup>42</sup>

**Figure A-9**  
Gz profile for a maximum performance (minimum radius) loop

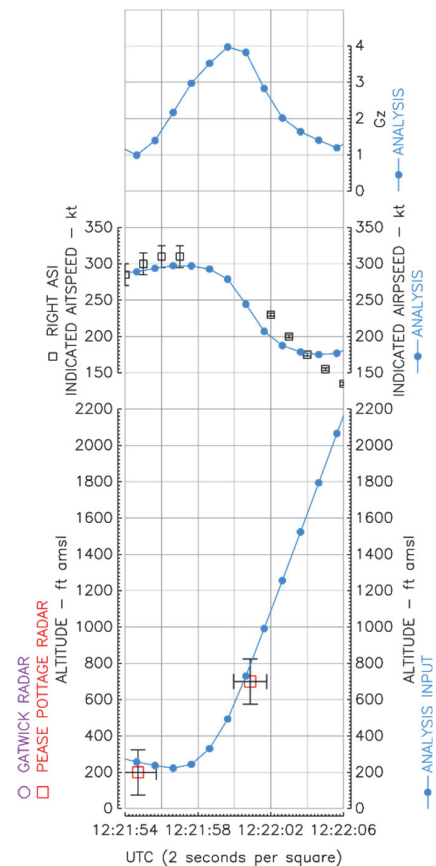
**Figure A-10**

Had this been a maximum performance loop, with an entry speed of 295 KIAS, the peak Gz would have been about 4.4 g; however, the lower G-onset of the accident manoeuvre indicates that the pull-up was not at maximum performance.

Photogrammetry provided a flightpath up to approximately 700 ft amsl, just beyond the point of peak G, after which the flight path model will be less accurate. This is evident in the divergence of the airspeeds later in the climb.

Results of flightpath analysis to determine Gz during the loop pull-up
