AAIB

AAIB Bulletin

3/2020

Aircraft Type and Registration:	Sikorsky S-61N Sea King, G-ATBJ
No & Type of Engines:	2 General Electric Co CT58-140-2 turboshaft engines
Year of Manufacture:	1965 (Serial no: 61269)
Date & Time (UTC):	1 February 2018 at 1100 hrs
Location:	Marchwood, Hampshire
Type of Flight:	Commercial Air Transport (Non-Revenue)
Persons on Board:	Crew - 2 Passengers - None
Injuries:	Crew - None Passengers - N/A
Nature of Damage:	Damaged beyond economical repair
Commander's Licence:	Air Transport Pilot's Licence
Commander's Age:	60 years
Commander's Flying Experience:	11,233 hours (of which 1,501 ¹ were on type) Last 90 days - 26 hours Last 28 days - 0 hours
Information Source:	AAIB Field Investigation

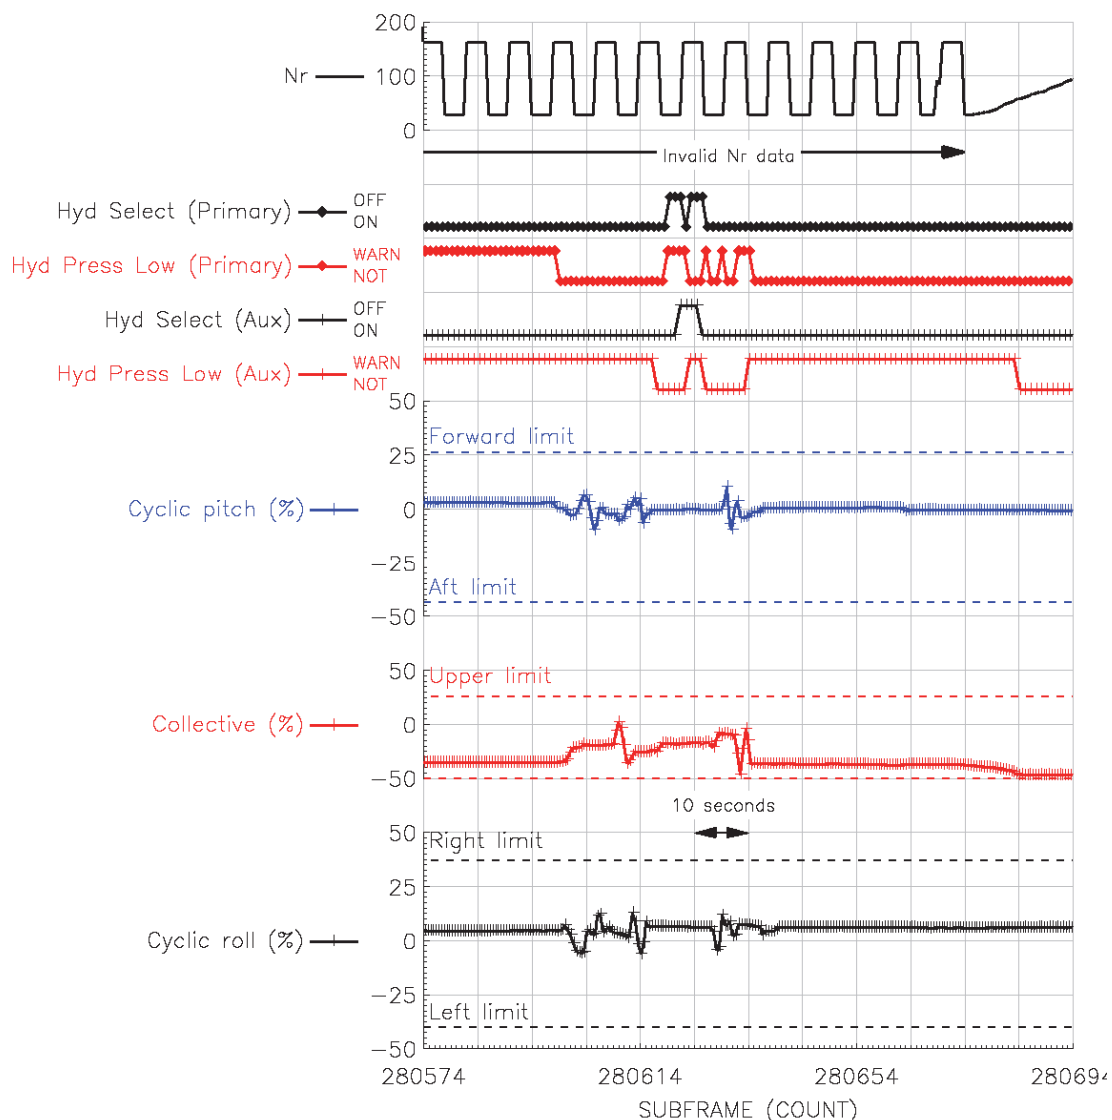
Figure 3 shows the limited extent of the cyclic inputs made by the crew during the pre-flight *Flight control servo system check*.

Flight control servo system check from the accident flight

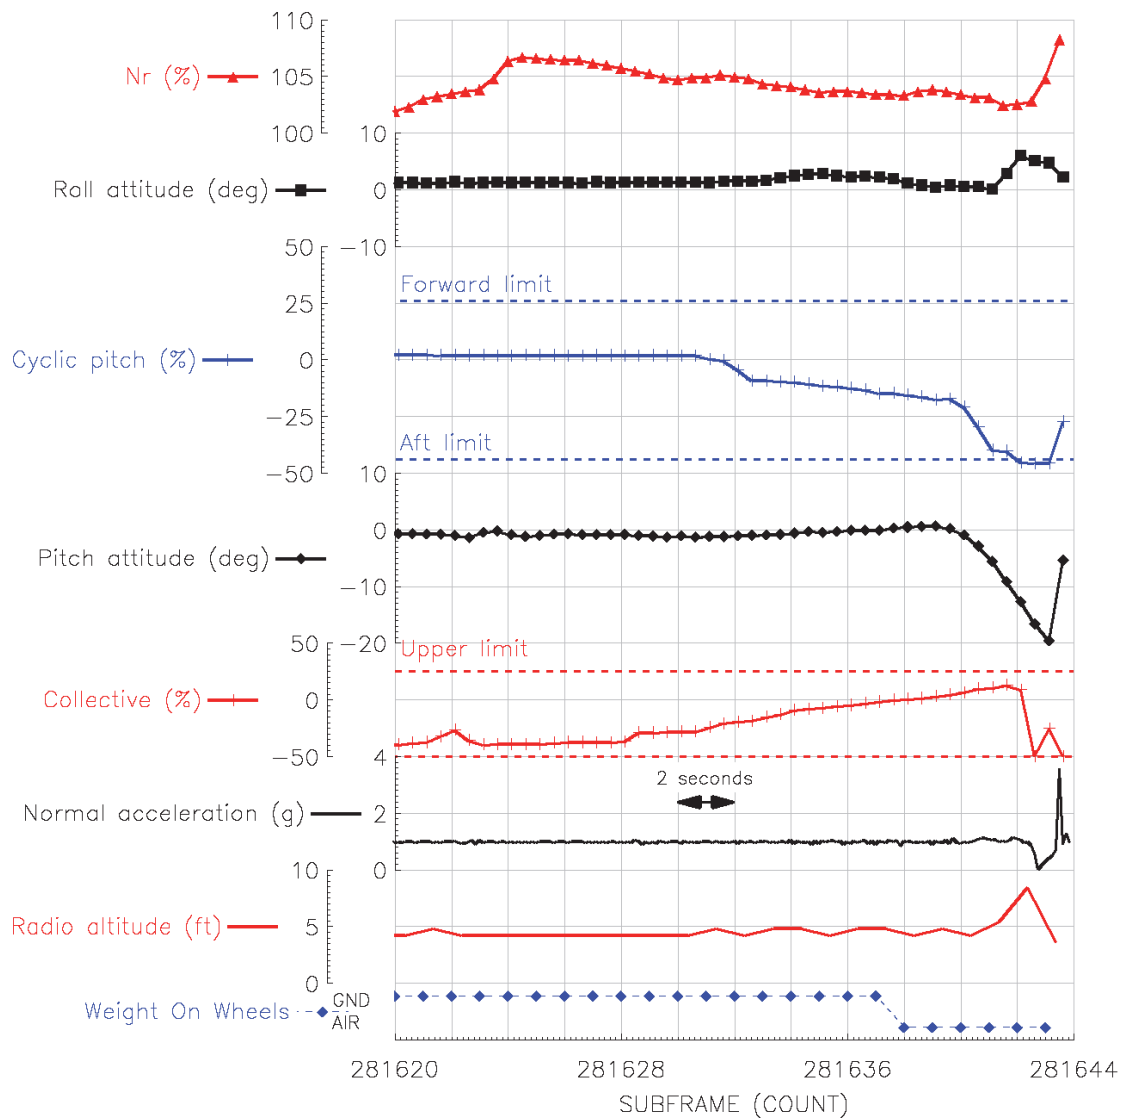
Figure 4 is a plot of pertinent parameters recorded during the takeoff. Just after takeoff, the helicopter started to pitch nose-down, reaching a pitch rate of approximately $-7^\circ/\text{s}$. The commander applied aft cyclic but, even at the full aft limit, there was no significant effect on the pitch rate. He rapidly lowered the collective and the helicopter struck the ground at a pitch attitude of approximately 20° nose-down.

Pertinent recorded parameters for the accident flight

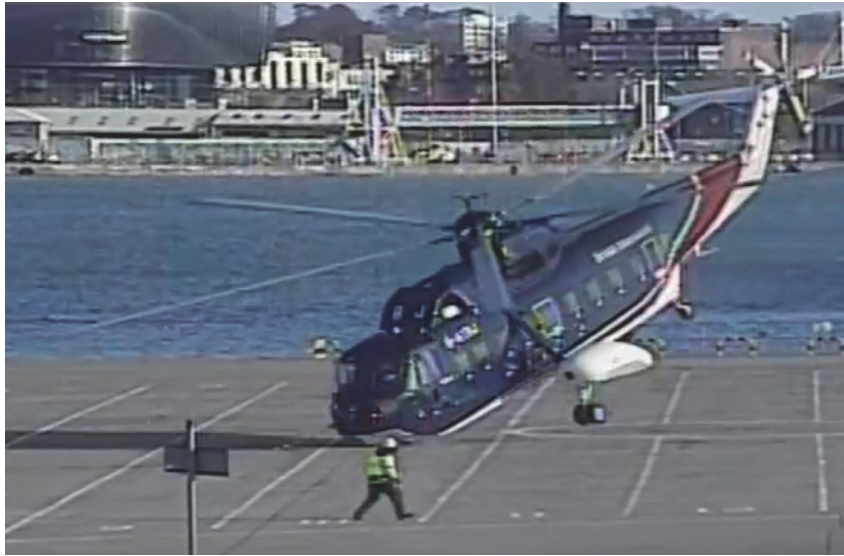
Figure 5 is a snapshot from the CCTV recording. This shows the main rotor disk did not appear to have any significant rearward component given the full aft cyclic input which was being made at that time.

CCTV snapshot at the point of impact

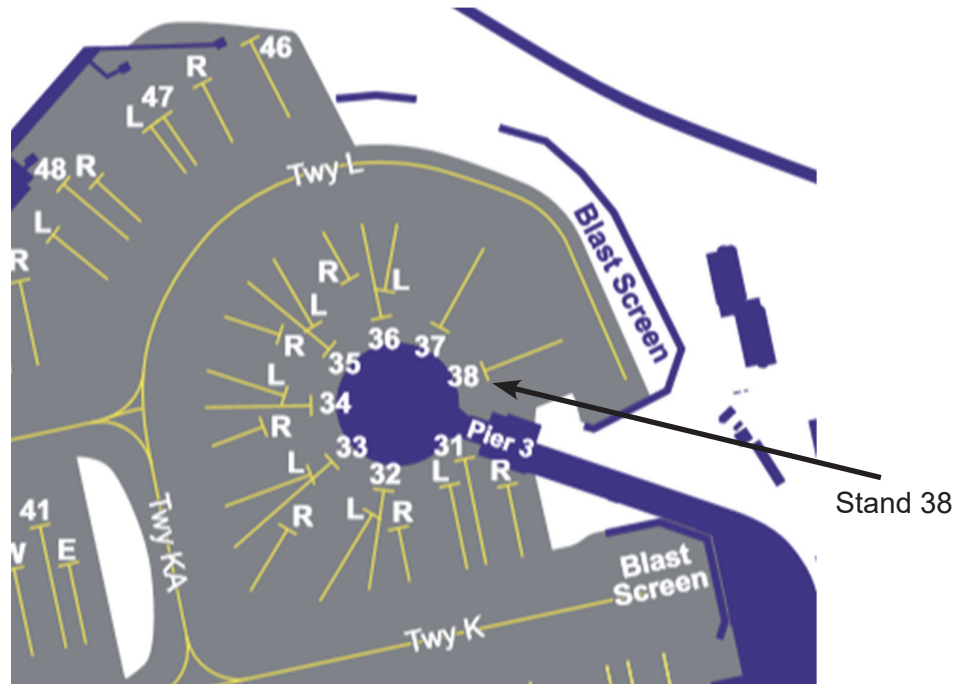
Figure 1

The aircraft was parked on Stand 38 at Gatwick ready to push back. Stand 38 is in a corner of the ramp with blast screens on two sides (Figure 1).

Position of Stand 38 at Gatwick

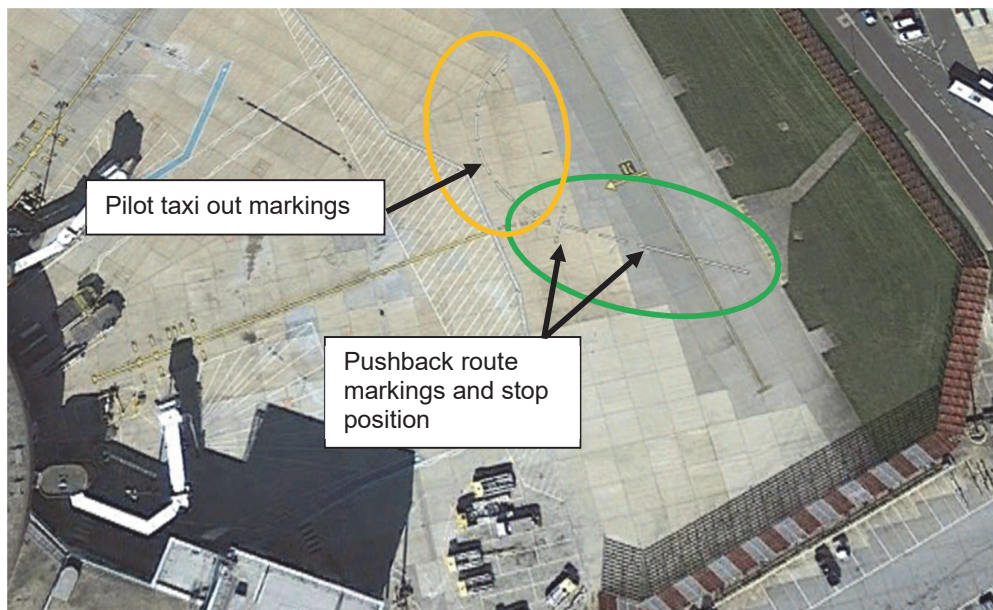
Figure 2

Due to the confined nature of the stand, special procedures are used so that sufficient clearance from the blast screens is maintained both during the pushback and subsequent taxi out. The apron has a line on the ramp to indicate to the pushback tug driver where the aircraft should be pushed to and where the nose wheel should be before the aircraft is disconnected from the tug. The pushback requires the aircraft to be positioned by the driver at an angle to the taxiway, and markings are also provided for the guidance of the flight crew when taxiing for departure. There is insufficient room for an aircraft to be pushed back onto the centreline of the taxiway at right angles to the stand. The markings for the pushback are shown in Figure 2.

Apron markings Stand 38
