AAIB Bulletin

4/2020

Published 9 April 2020

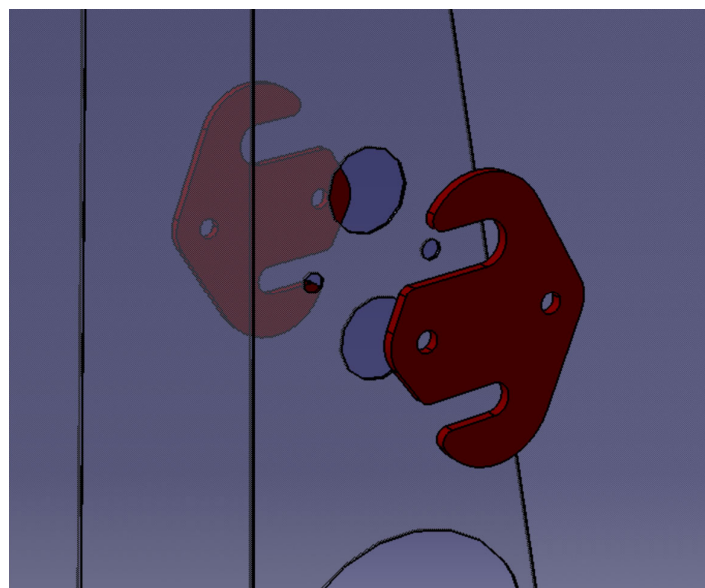
Figure 5

An aluminium baffle is mounted to the front of the engine to aid cooling around the engine. The starter and alternator cables, which run from the battery compartment, on the left of the aircraft behind the firewall, to the engine mounted starter and alternator, pass through the baffle and are held in place by two cotton impregnated phenolic clips either side of the baffle. (Figures 4 and 5)

Exploded view of correct installation of cable clips

The subject cable uses a polymer tape insulation wound around the wire bundle. The insulation was consumed during the fire but was probably cut or worn away by contact with the edge of the hole.

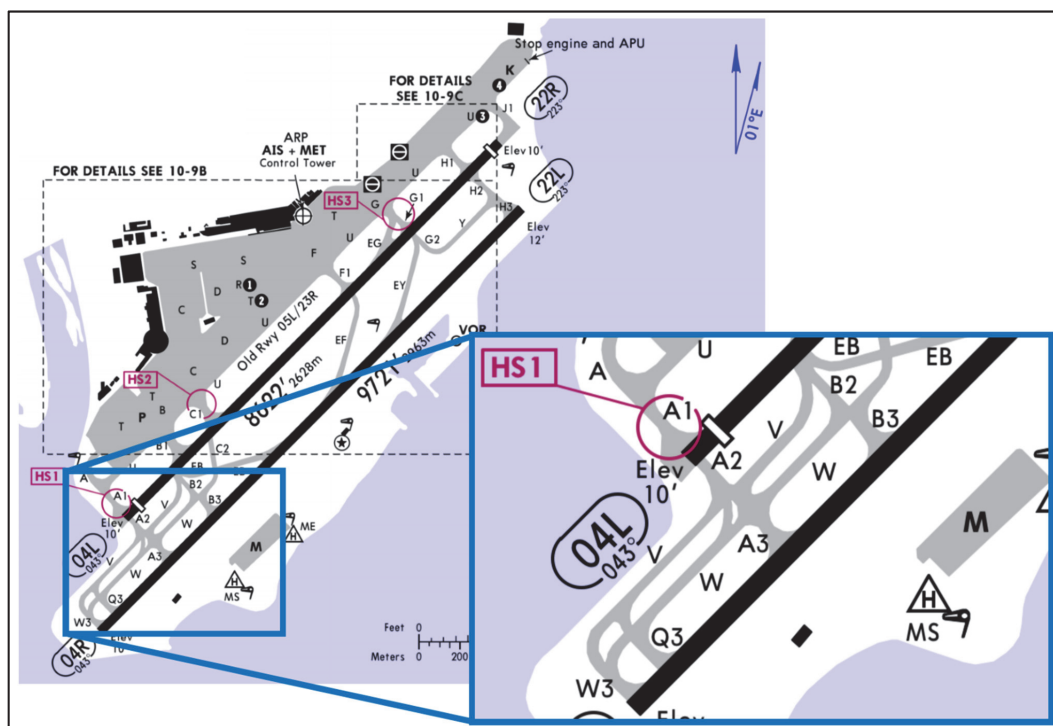
Figure 1

During their pre-flight preparation, the flight crew chose to calculate takeoff performance for Bravo 3 (B3), the most-limiting viable runway intersection on Runway 04R (RW04R) at Nice Côte d'Azur Airport (NCE) (Figure 1). The subsequent cross-check of their independent performance calculations revealed a 1 kt discrepancy between takeoff speeds. The pilots considered the discrepancy to be acceptable and used the most conservative figures for departure.

A takeoff performance calculation error was detected after flight by the operator's flight data monitoring (FDM) programme. Cross-checking FDM information with electronic flight bag (EFB) calculations indicated that both pilots had inadvertently selected the Quebec 3 (Q3) intersection, rather than B3, in their performance software. The mis-selection was not detected during an initial data validation *'departure distance check'* and cross-checking EFB calculation outputs did not trap the error.

Overview of NCE with zoomed view of RW04R departure intersections

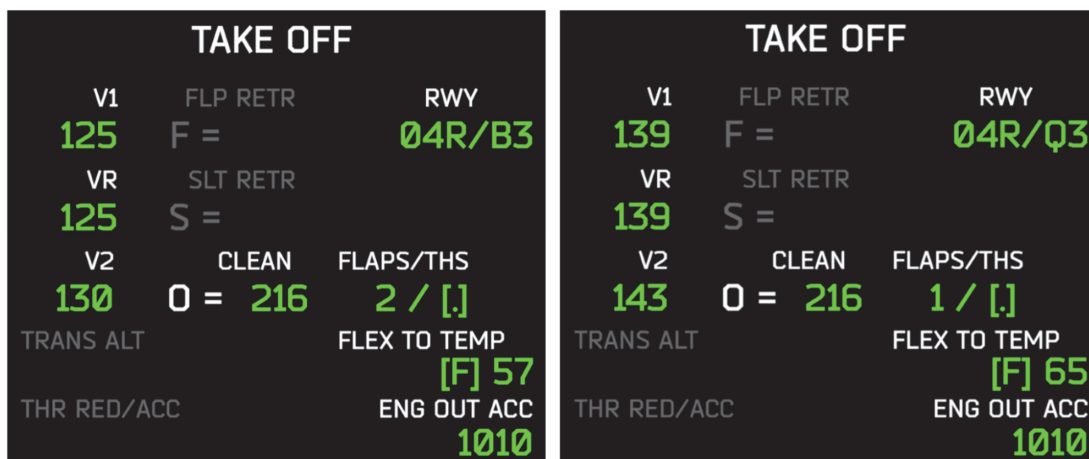
Figure 2

An indicative calculation conducted by the AAIB revealed that outputs from takeoff calculations based on B3 and Q3 differed significantly. For a departure from B3 rather than Q3, takeoff speeds were ≥ 13 kt slower, the thrust reduction (flex) temperature was 8° lower and a different flap setting was required (Figure 2). From A3 the speeds were 8 kt slower than from Q3, the flex temperature was 61° and Flap 2 was the optimum setting. Meaningful comparisons of takeoff run required could not be drawn because all three calculations used different settings to achieve balanced-field performance.²

Indicative performance comparison for NCE RW04R intersection B3 (left) and Q3 (right)

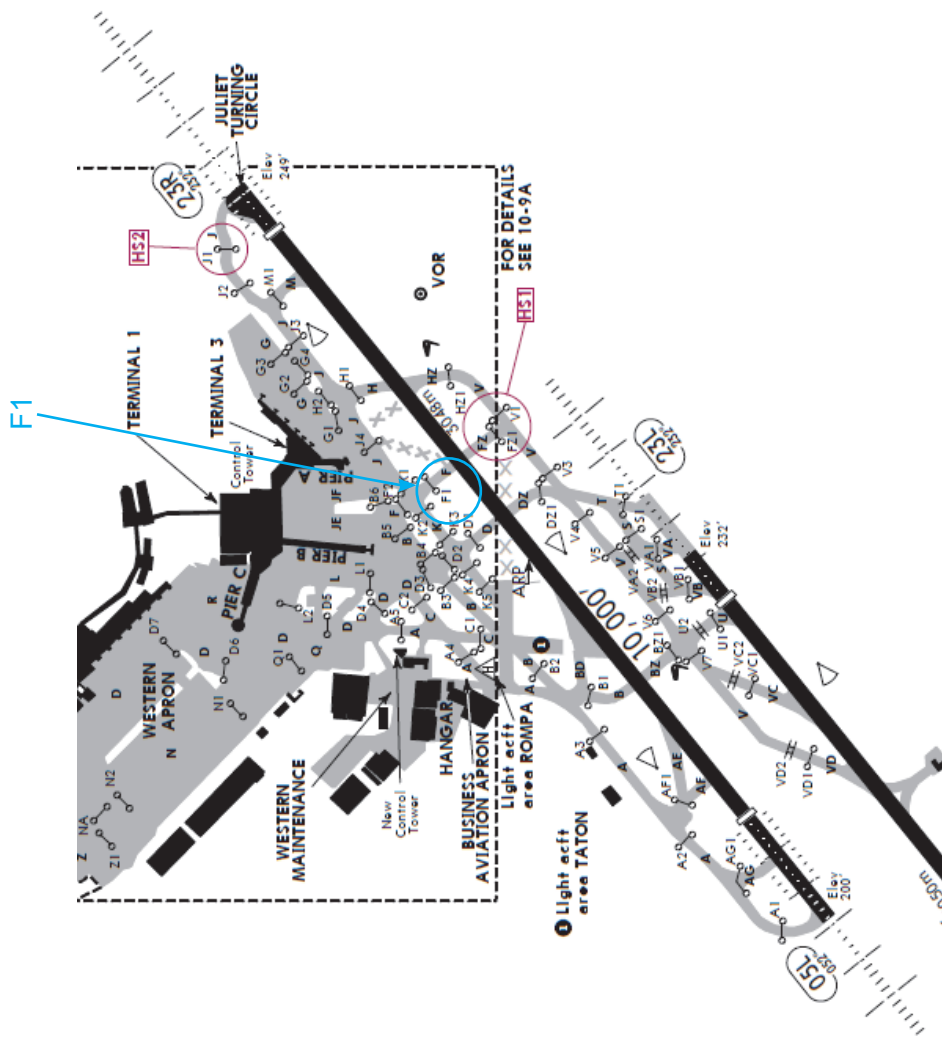
Figure 2
Excerpt from chart 10-9

D-COLT's pilot recalled hearing "D-COLT, stop taking off, stop taking off" from ATC so promptly rejected the takeoff⁴. He recalled the aircraft's airspeed to have reached around 80-90 KIAS. While decelerating, he realised the aircraft was misaligned on the runway. He reported that the aircraft came to a halt next to F1 (Figure 2), then after a conversation with ATC he taxied again for departure without delay.

The pilot used chart 10-9 during taxiing (Figure 2). Following is an excerpt of that plate, including Runway 05L/23R; Juliet turning circle; Hot Spot 2¹⁰ and its definition; and HZ.

The ATCO stated that upon realising D-COLT was tracking the runway edge stripe, he considered its airspeed as being in the mid-range of its takeoff roll. Given the runway shoulder's lower load bearing strength, he was concerned about potential debris from it, so he instructed the aircraft to stop. He recalled it was in the vicinity of M1 (Figures 2 and 3) when he did so.
