AAIB Bulletin

5/2020

Published 14 May 2020

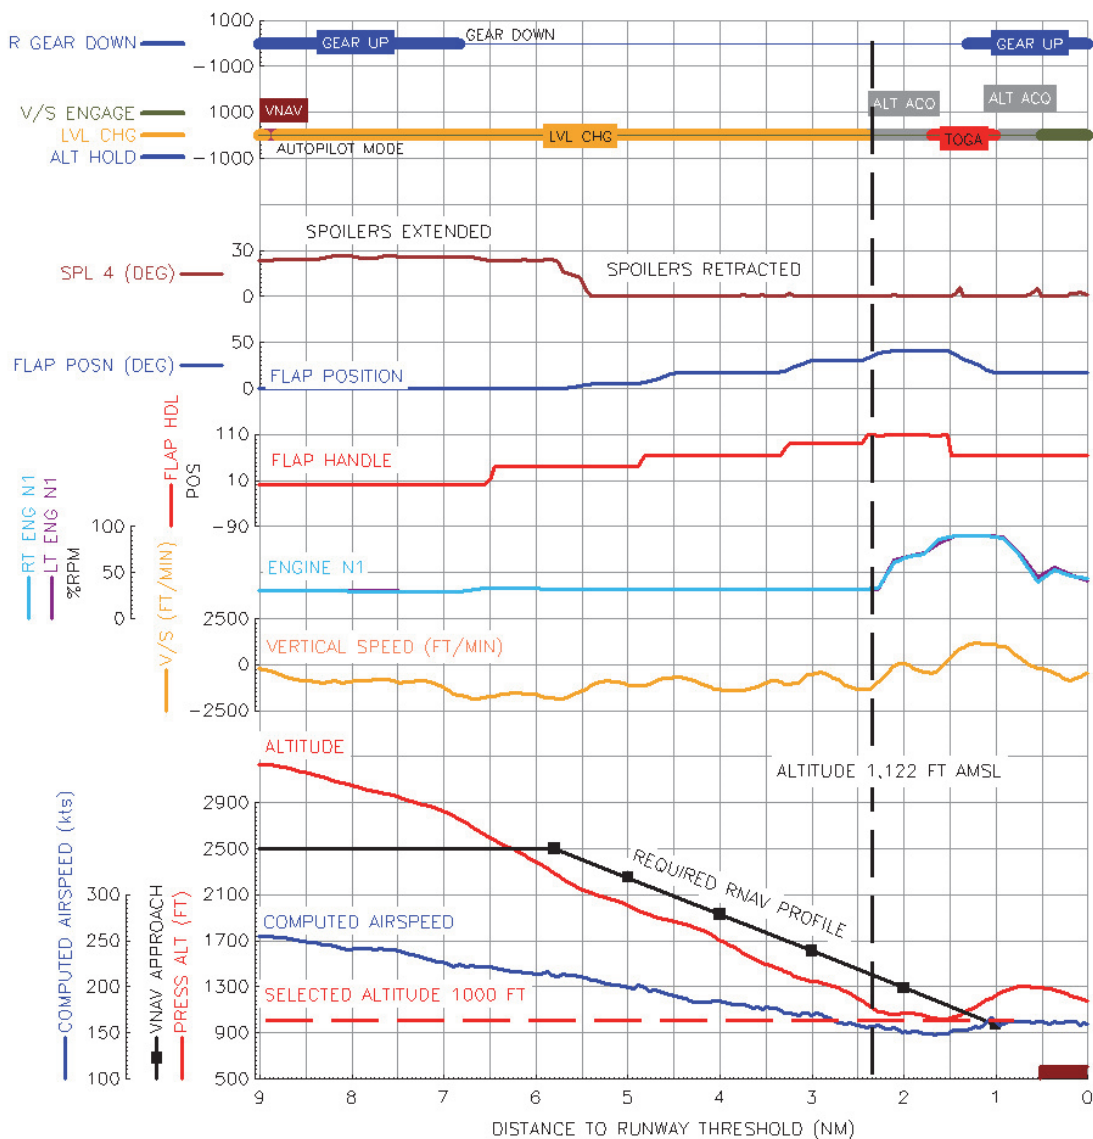
Figure 3

The aircraft continued its descent below the 2,500 ft pattern altitude before the final approach fix¹⁰ descent point. This meant it crossed this point 227 ft below the required altitude, 70 kt above the target final approach speed (Figure 3). The aircraft continued to descend below the design 3° approach gradient. Between 5 nm and 2 nm, the aircraft was an average of 249 ft below the required altitude, ranging from between 203 ft and 293 ft below. The speed of the aircraft was reducing slowly. The crew were aware and had commented that the aircraft was high and fast. Table 1 shows the recorded altitude and speed of the aircraft compared to the design profile and the target final approach speed.

As the aircraft approached 1,000 ft, the AFDS vertical mode became ALT AQ as the system attempted to level off at the selected 1,000 ft. This led to a reduction in the rate of descent, and the aircraft path began to close slightly with the design 3° approach gradient. However, from 5.8 nm to 2 nm on the final approach, the minimum obstacle clearance altitude permitted by the procedure is 1,130 ft (shaded grey in Figure 1). Therefore, from a point 2.34 nm from the threshold until the aircraft passed inside 2 nm from the threshold, I-NEOT was below the minimum obstacle clearance altitude¹¹ in that segment of the approach.

I-NEOT FDR data for initial approach into Bristol Airport

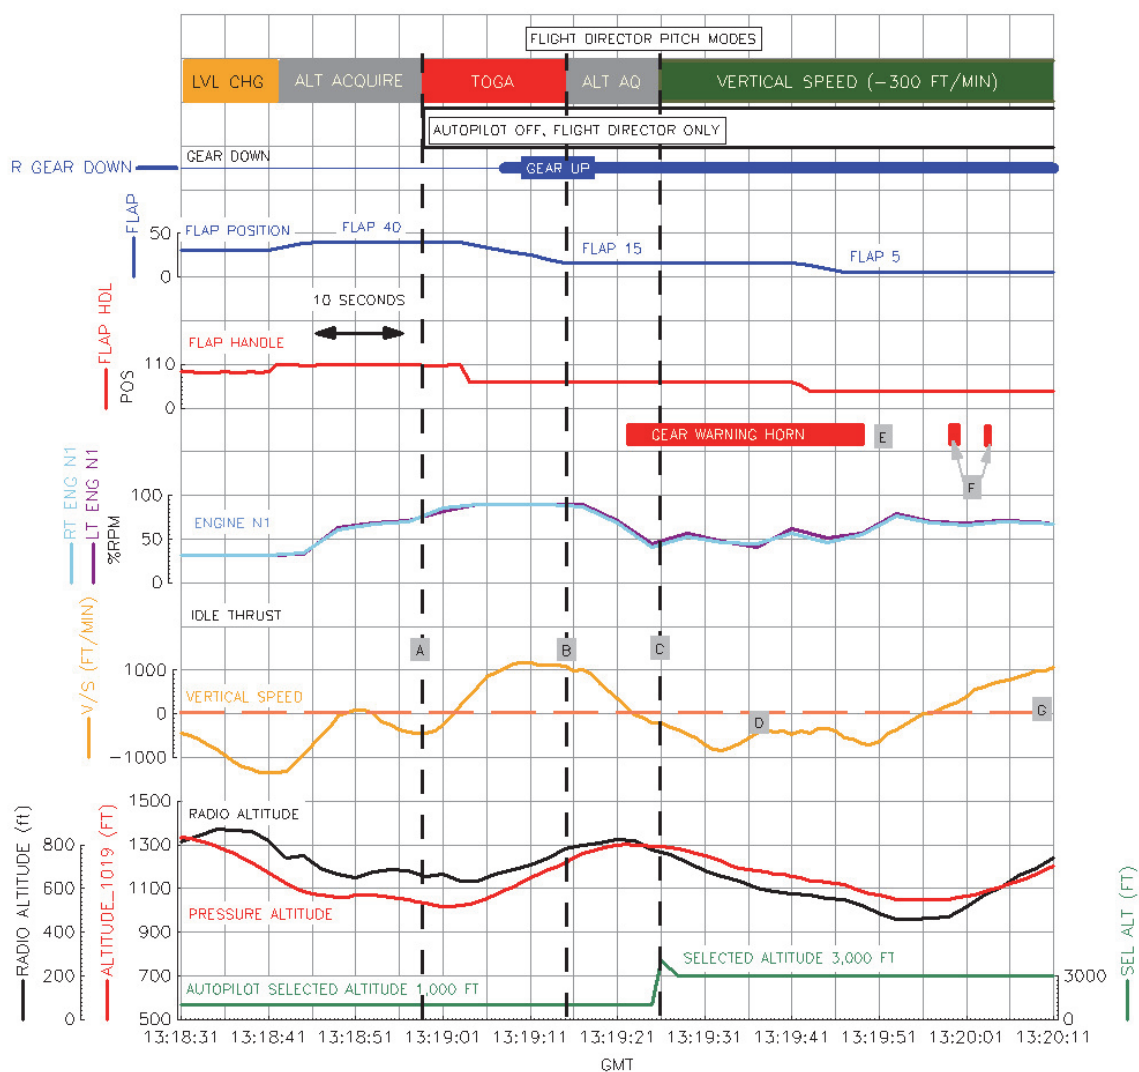
Figure 4

The PF pressed the TOGA button and the aircraft AFDS system transitioned into go-around modes (Figure 4, label [A]). The vertical and lateral modes became TOGA and the A/T increased the thrust to the calculated go-around setting. The autopilot disconnected as designed. The PF asked for the standard flap setting for the go-around (Flap 15) which was selected by the PM.

I-NEOT go-around salient parameters

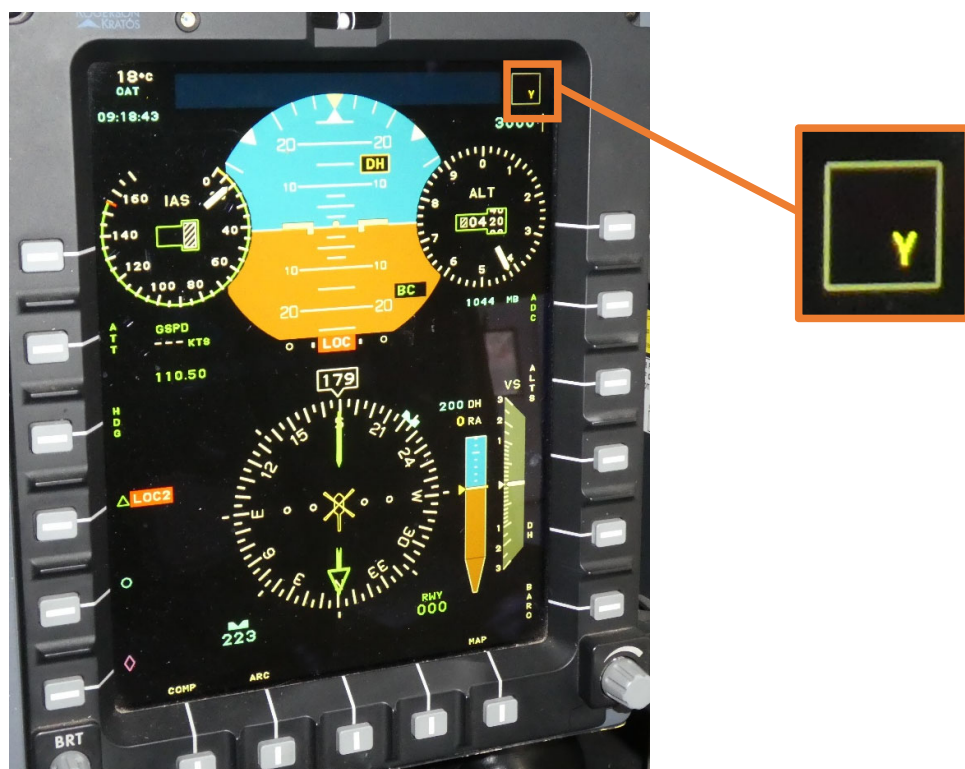
Figure 7

If the pilot makes an input using the pedals, the spring in the trim actuator will deflect. The detent microswitch will change state and an out-of-detent condition will be detected. If the pedals are out-of-detent, a small yellow 'Y' is displayed in the trim status box in the upper right corner of the pilot's DU (Figure 7). Changes in the detent status indication are not accompanied by an audible tone or any other attention getting features, and the pilot's attention was not drawn to the indicator in either incident on G-WLTS.

Yaw out-of-detent indication

The out-of-detent condition would have been indicated by a yellow 'Y' in the trim status box on the DU (Figure 7). However, the focus of the pilot's attention was elsewhere, and the trim status box has no attention getting qualities, so the indication was not noticed (and was unlikely to have been).

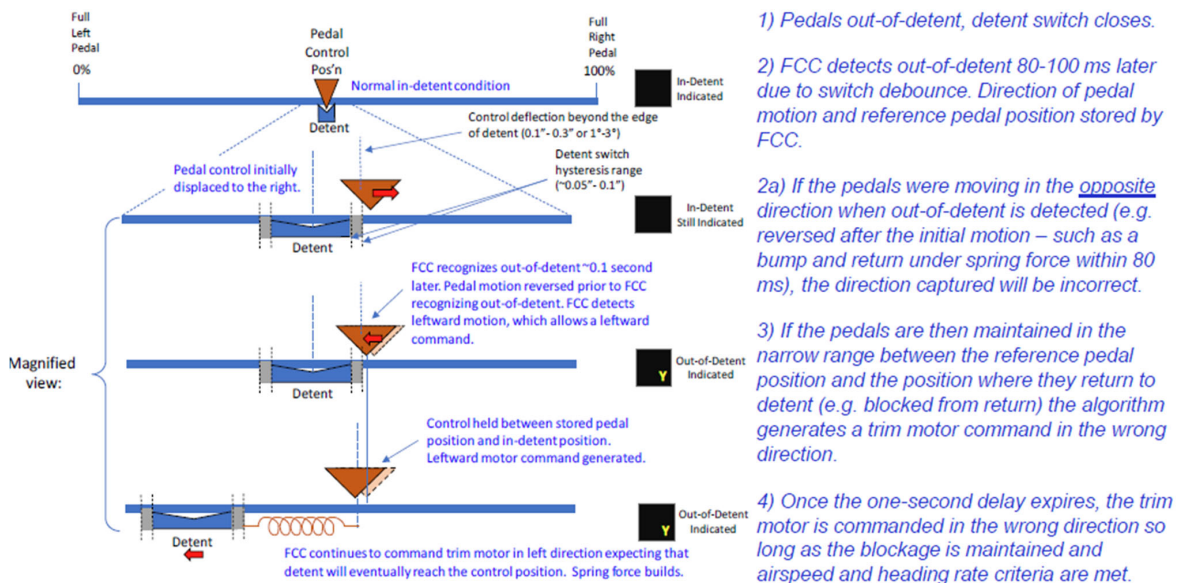
Figure 10

Additional analysis of the system logic identified another scenario that could occur if the pedals changed direction within 80 ms of initially being displaced. This would result in the AFCS detecting an out-of-detent condition but capturing the wrong direction of pedal movement. If the pedals were subsequently held in a very narrow range, automatic trim would attempt to drive the pedals in the wrong direction and the force at the pilot's feet would increase. The manufacturer was able to induce this scenario on a test platform but was unable to recreate it on a helicopter (Figure 10).

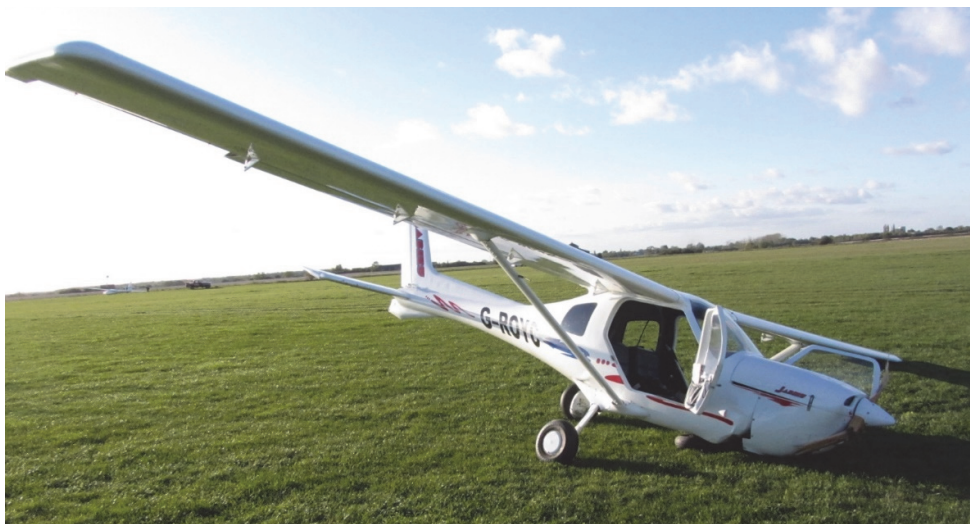
Figure 2 shows the left wing of the glider with marks from the tyres of G-ROYC. Measurement of the marks show that the right tyre of G-ROYC passed just behind the canopy of the glider. Figure 3 shows the final position of G-ROYC. Figure 4 shows G-ROYC after the accident with the flaps fully retracted.

G-ROYC after the accident showing the flaps UP

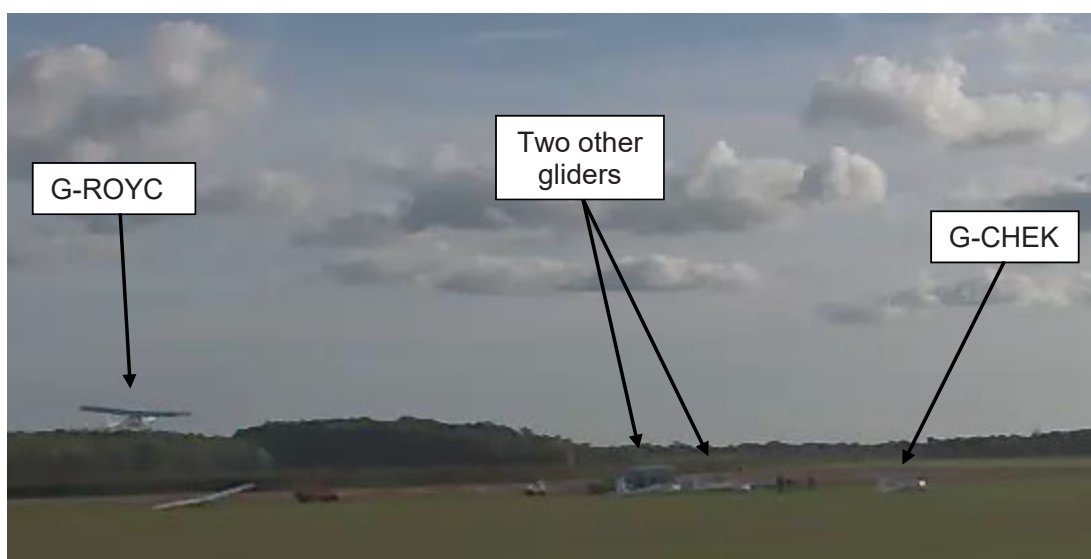
The accident was recorded on CCTV. However, the distance, frame rate and angle of the camera meant it was not possible to determine the aircraft speed, pitch angle or heading with any accuracy. The recording showed the landing motor glider touching down at 1420:19 hrs on the right side of the runway. After slowly rolling across a track that crosses the runway the motor glider started accelerating for another takeoff at 1421:09 hrs. G-ROYC entered the image at 1421:16 hrs and appeared to be in level flight at low level. At 1421:19 hrs G-ROYC started to sink and at 1421:22 hrs collided with the glider. Figure 5 is an image taken from the CCTV recording which shows G-ROYC in flight and the three gliders on the left of the runway. Several members of the gliding club can also be seen standing by the gliders.

CCTV image just prior to the accident

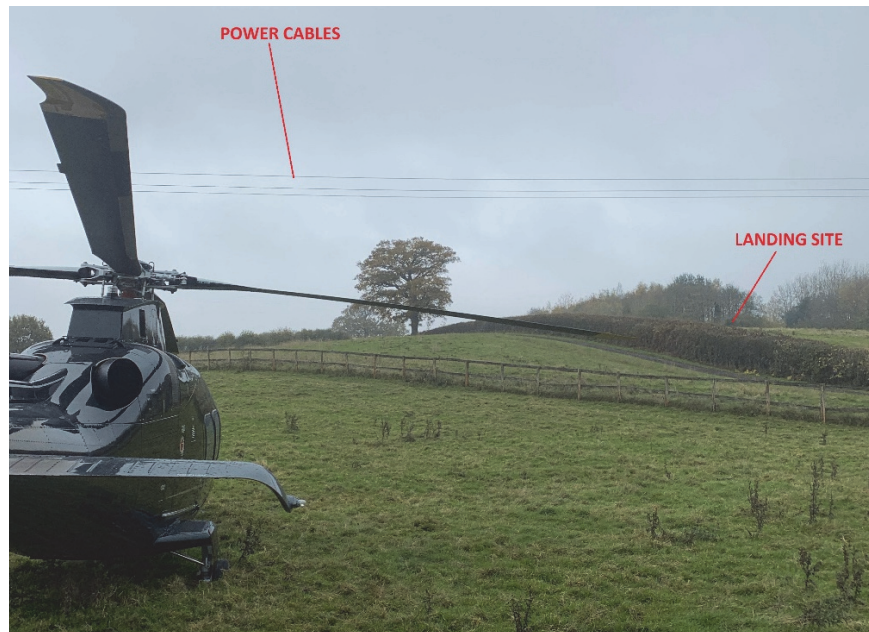
The planned landing site and the aircraft actual landing site are shown at Figure 2.

Figure 2
Landing site photograph

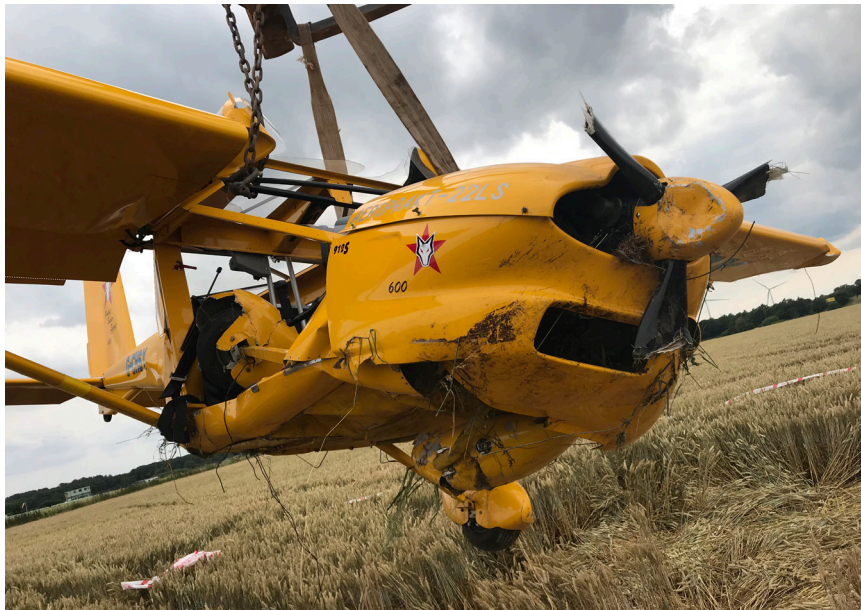
Figure 1

Photographs showed that the aircraft came to rest upright in a crop field immediately beyond the end of the runway. They indicated that the aircraft struck the ground with very little forward speed and with the right wing low. Damage sustained by the propeller indicated that it was turning when the aircraft hit the ground.

General view of damage sustained in the accident

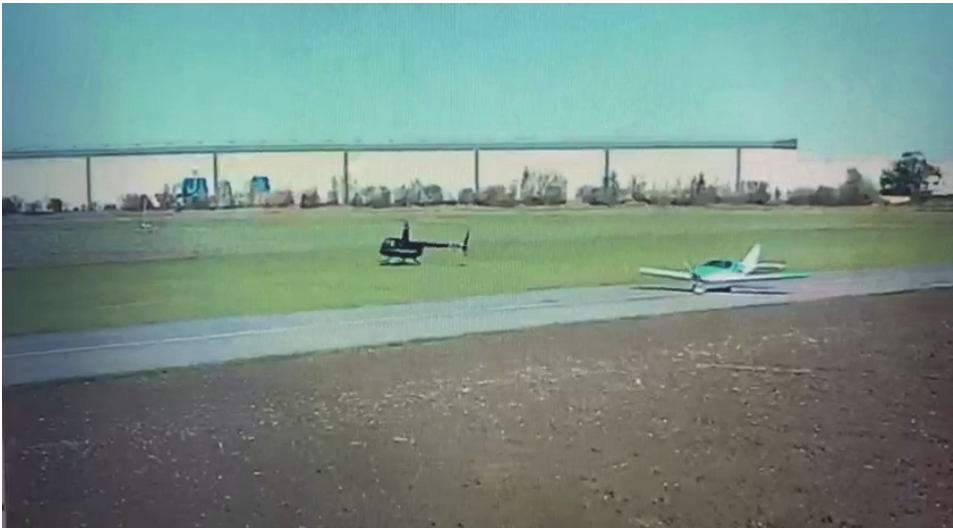
Figure 1

G-LLIZ begins to pitch nose up

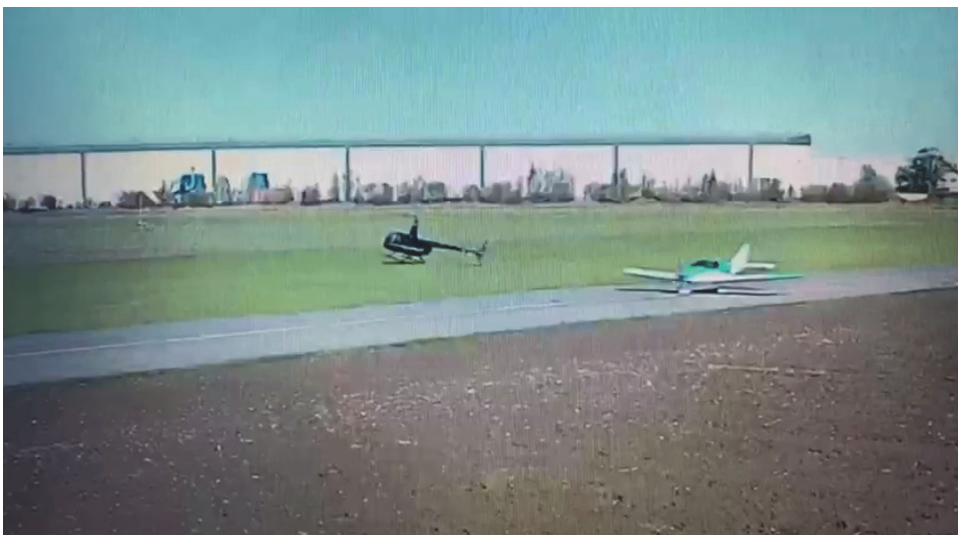
Figure 2

The tail stinger contacts the ground

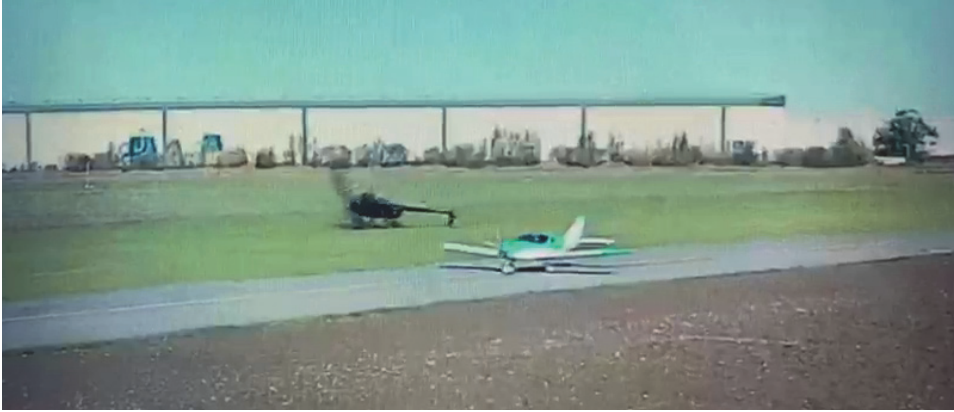
Figure 6
Second blade impact

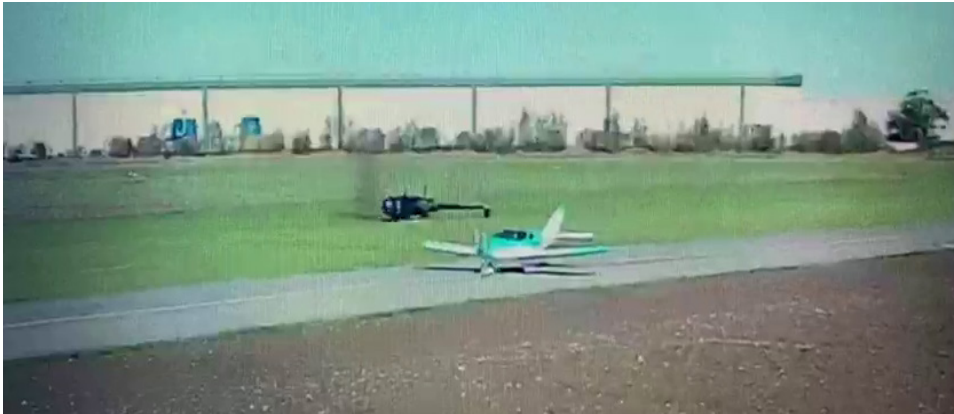
Figure 7
G-LLIZ comes to rest on its right side

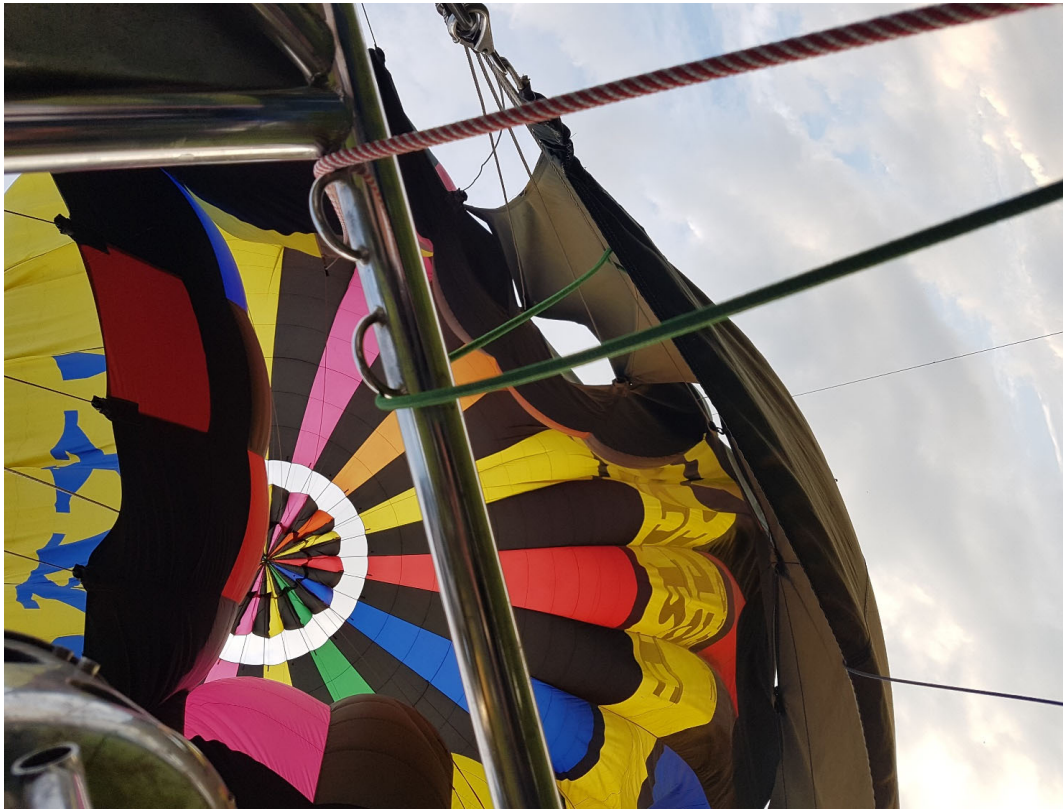
Figure 2

At the end of the 2018 flying season, the pilot reported that the Q-vent system was not able to fully operate because there was not enough slack in the candy stripe line (Figure 2). The red and candy stripe deflation lines are made of poly sheathed Kevlar which shrinks with time due to the heat of the burner and the operating temperature within the envelope.

G-LLGE maximum operation of the rapid deflation system showing the candy stripe line at full stretch taken by the pilot in October 2018. The green line is the turning vent line and is not relevant to the accident.
