**AAIB**  
Air Accidents Investigation Branch

# ***AAIB Bulletin***

# ***6/2020***

Published 11 June 2020

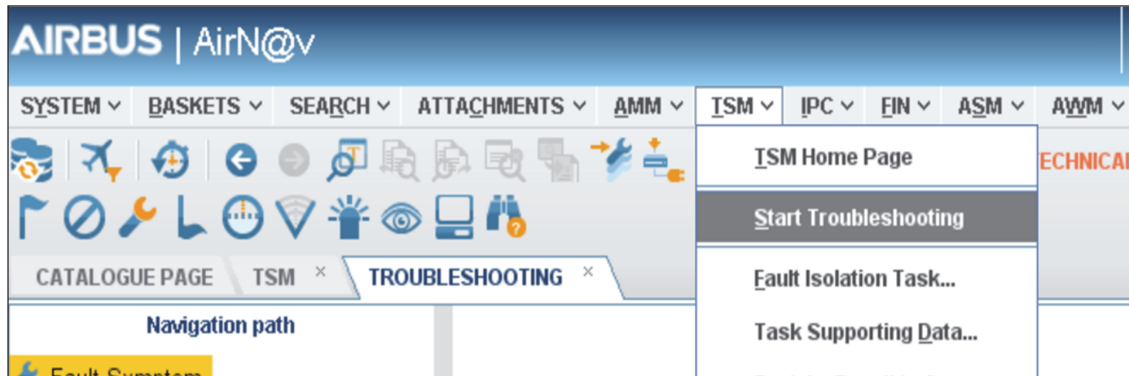
**Figure 2**

Airbus recommended that the TSM must always be filtered for a specific aircraft registration, fleet serial number or effectivity and that the TSM should be accessed using the 'Start Troubleshooting' function in *AirN@v* (Figure 2) and the 'Troubleshooting' tab in *airnav<sup>x</sup>* (Figure 3).

Airbus recommended way to access the TSM in AirN@v v3, 'Start Troubleshooting' function

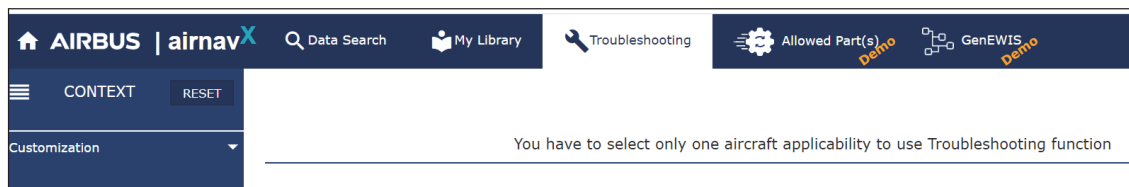
**Figure 3**

Airbus recommended way to access the TSM in airnav<sup>x</sup>, 'Troubleshooting' tab

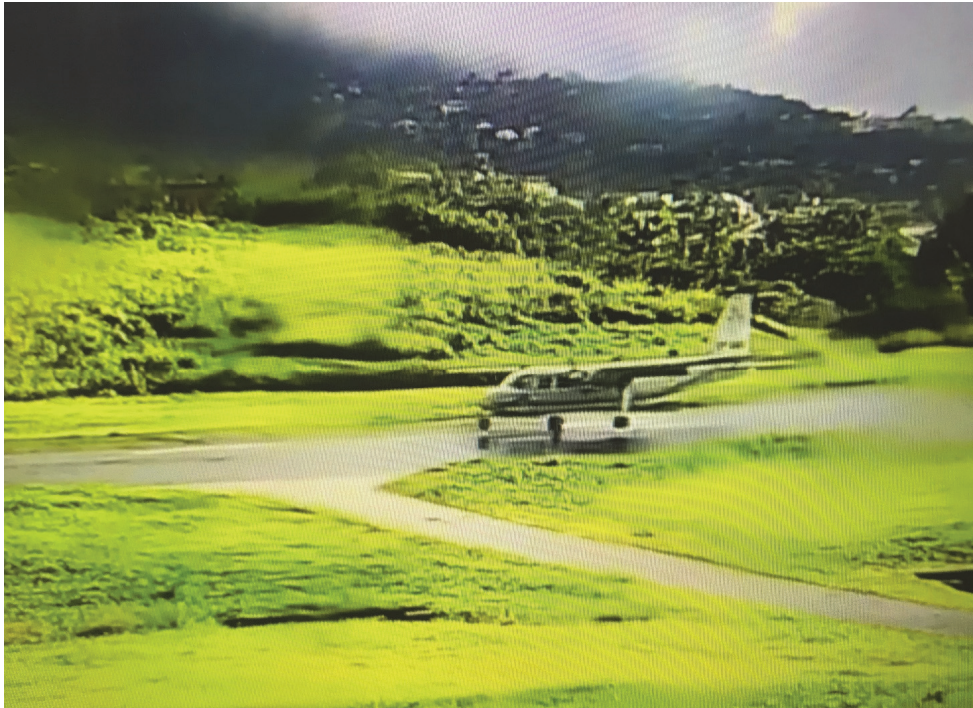
**Figure 2**

A CCTV camera was mounted on the ATC tower and recorded the latter stages of the final approach and touchdown. From these images, the touchdown groundspeed was estimated to be 79 kt. Figure 2 shows a single frame of the recording at the point of touchdown with the wet runway and water spray being produced by the main landing gear wheels.

VP-MNI at the point of touchdown on Runway 10

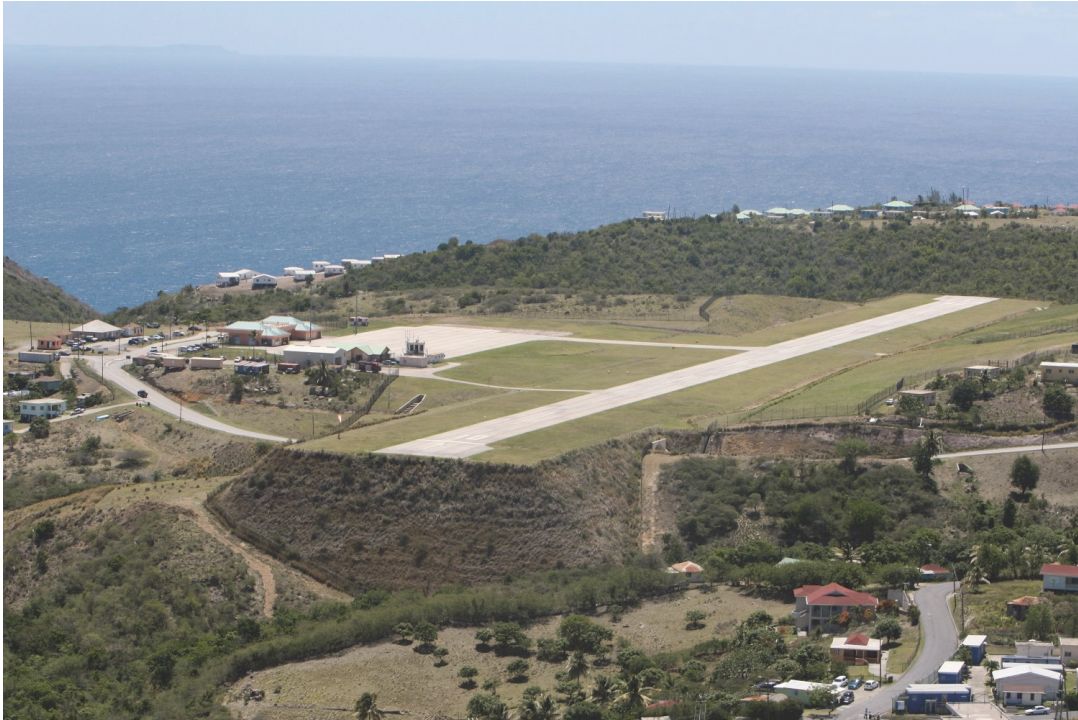
**Figure 6**

Figure 6 shows the airport from south-west of the Runway 10 threshold end, revealing the proximity of the graded bank to the runway end and the hill at the far end.

Montserrat John A Osborne Airport looking towards the north-east

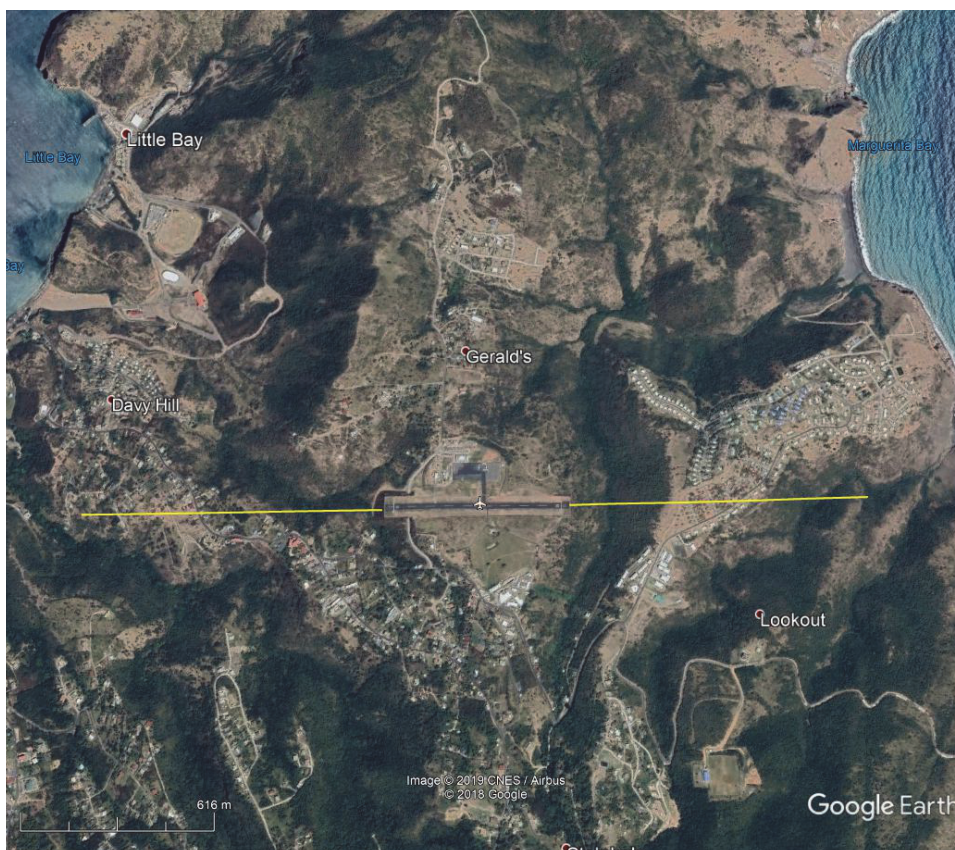
**Figure 9**

Whilst the airport area is level and accessible to vehicles and fire and rescue personnel, the surrounding area within the 1,000 m requirement has differing levels of access. Regarding a runway overrun, as with this accident, both the undershoot areas for Runway 10 and 28 thresholds have steep inclines of about 45° in places.

The Runway 10 undershoot can be reached from the airfield boundary from above and by vehicles accessing the base of the slope from below. There are various level or gently sloping areas navigable by RFFS vehicles, and access roads in the immediate area of the base of the slope. The Runway 28 undershoot has a ravine, some 260 m across, and is more difficult for vehicle access, which is limited to the level area of the airport and possibly as far as the security fence. Any other access to the ravine would be by rescue and firefighting personnel only, with hand carried equipment. Figure 9, shows the airport runway (North is at the top of the figure) with the yellow centrelines extending 1,000 m from each runway threshold.

John A Osborne Airport, showing centrelines extended 1,000 m from each runway threshold

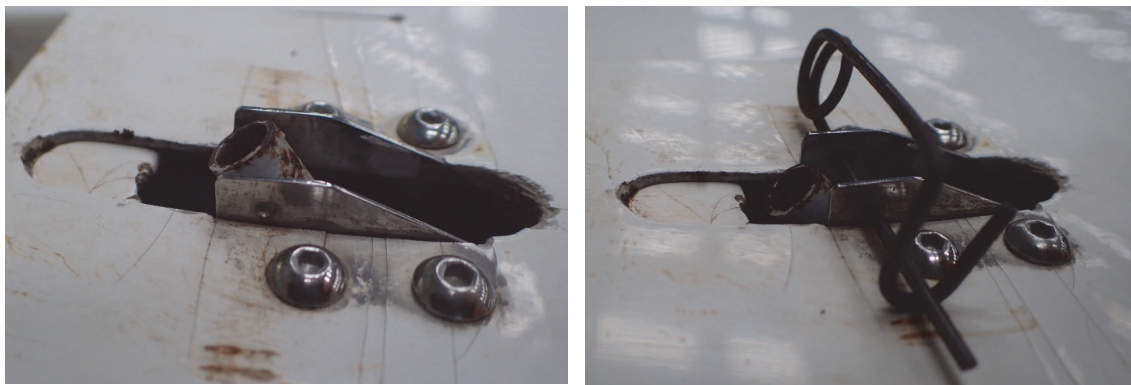
**Figure 6**

When the tailplane is attached, the locking lever protrudes through a slot in the top surface of the tailplane. The locking lever is hollow, and a rigging tool can be inserted for ease of movement. To lock the tailplane in place, the locking lever is moved to the aft end of the slot. A safety pin is then inserted forward of the locking lever to prevent it moving forward towards the unlocked position (Figure 6). To de-rig the tailplane the safety pin is removed, and the locking lever is moved forward to release the locking hooks from the axle.

Locking lever when tailplane attached (left image)  
and when locked with safety pin inserted (right image)

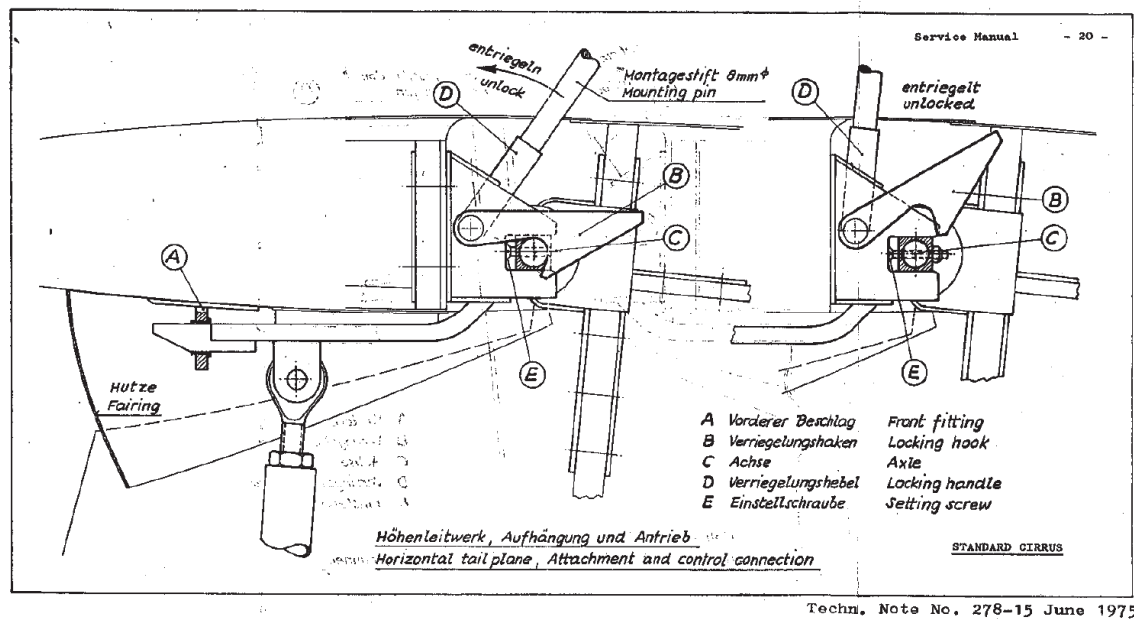
**Figure 7**

In 1975, the modified tailplane attachment mechanism was introduced by Technical Notice (TN) 278-15 *'Attachment and control connection of the horizontal tailplane'* (Figure 7). The reason for the modification was described as *'Simplification of the mounting, easy checking of the mounting, adjustable tangential backlash of the elevator control.'* Later models of the Standard Cirrus, including G-DDGX, were manufactured with TN 278-15 already embodied.

Tailplane attachment and control connection from TN 278-15 and Standard Cirrus flight manual

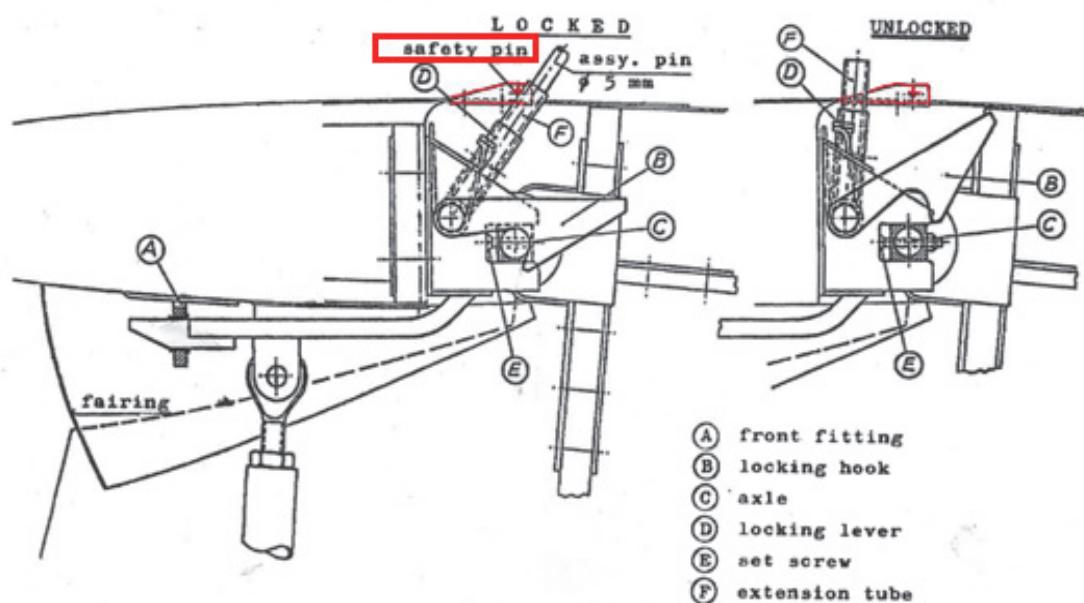
**Figure 8**

TN 278-36 'Safety device for the locking lever of the tailplane attachment,' was introduced on 24 November 1994 and was subsequently mandated by Airworthiness Directive 95-015<sup>6</sup> dated 15 December 1994. It was required to be embodied before 31 March 1995. The reason for the modification was described as: 'Due to the lack of maintenance or because of wear, the locking hook on the tailplane attachment bracket became disengaged in a number of cases, so that the horizontal tailplane was no longer securely attached to the fin.' The actions required by TN 278-36 included: 'Re-adjustment of the set screws on the tailplane attachment bracket to eliminate any tangential play ... Installation of a safety device [pin] for the locking lever... Check of the rigged and secured horizontal tailplane for full and free movement up to the stops.' It did not stipulate any amendments to the existing rigging instructions in the flight manual. An illustration from TN 278-36 is shown in Figure 8.

Tailplane attachment and control connection from TN 278-36 showing addition of a metal bracket and safety pin

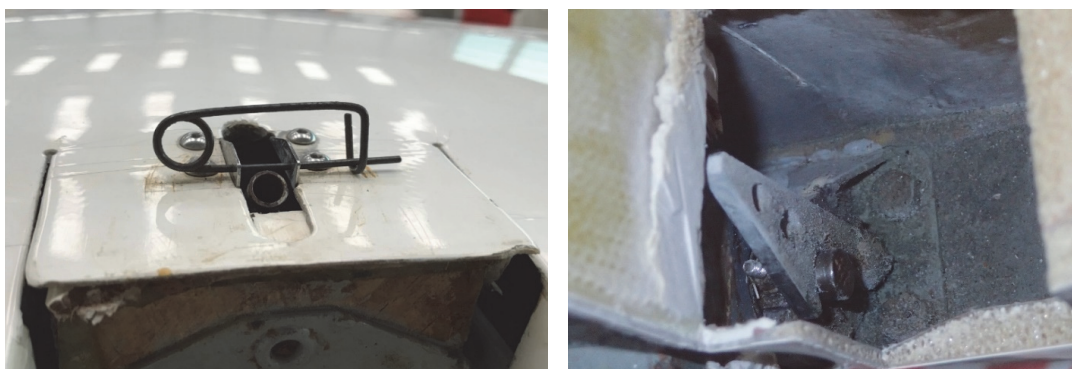
**Figure 10**

When the tailplane was attached to the fin, an audible 'clunk' was heard as the mechanism engaged, as described in the flight manual. The locking lever came to rest directly in-line with the attachment hole for the safety pin and the safety pin could not be inserted without first moving the locking lever. To correctly secure the tailplane the locking lever is moved aft to the (fully locked) position (Figure 10).

Position of locking lever and locking hooks in fully aft (locked) position.  
Note: only right hook shown

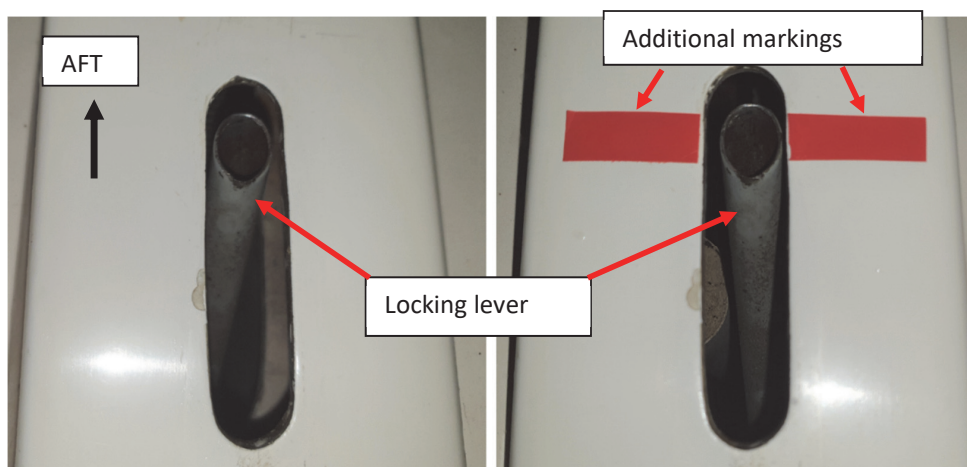
**Figure 16**

Standard Cirrus tailplane (original T-fitting elevator connection) with and without (left) locally-applied indicator for correct locking lever alignment

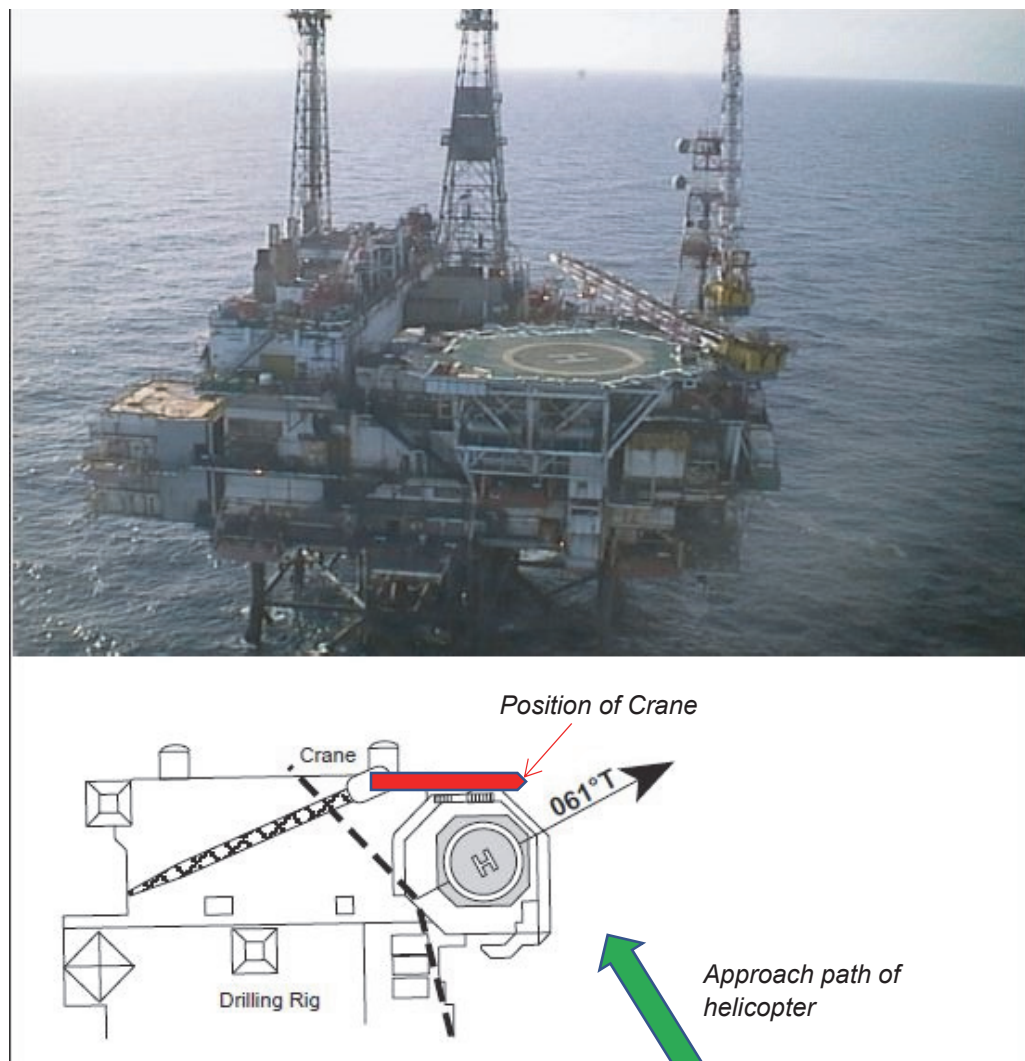
Once the helicopter was established on the final stage of the approach, the commander in the left seat took over the role as PF and carried out the landing on the helideck of the 40C platform. On completion of the landing checks, the pilots noticed that no deck-crew approached the helicopter and it was at this stage the pilots noticed the 'Forties Charlie' name on the helideck.

**Figure 1**  
Forties Charlie (40C) platform

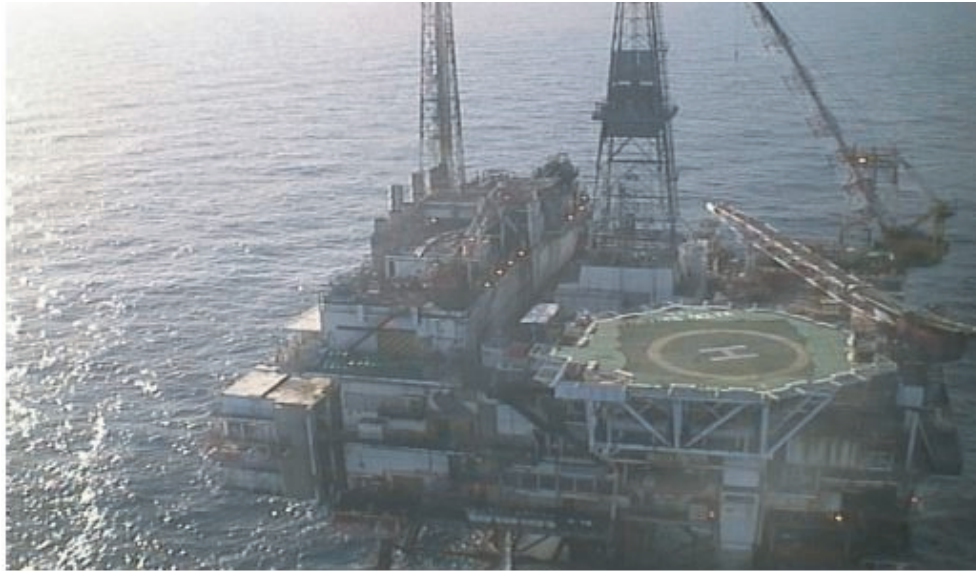
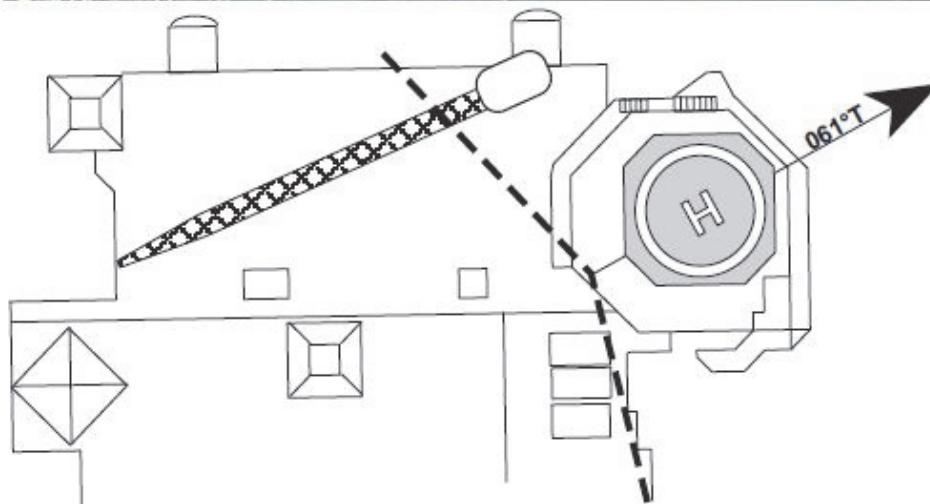
**Figure 3**

Forties Delta (40D) platform

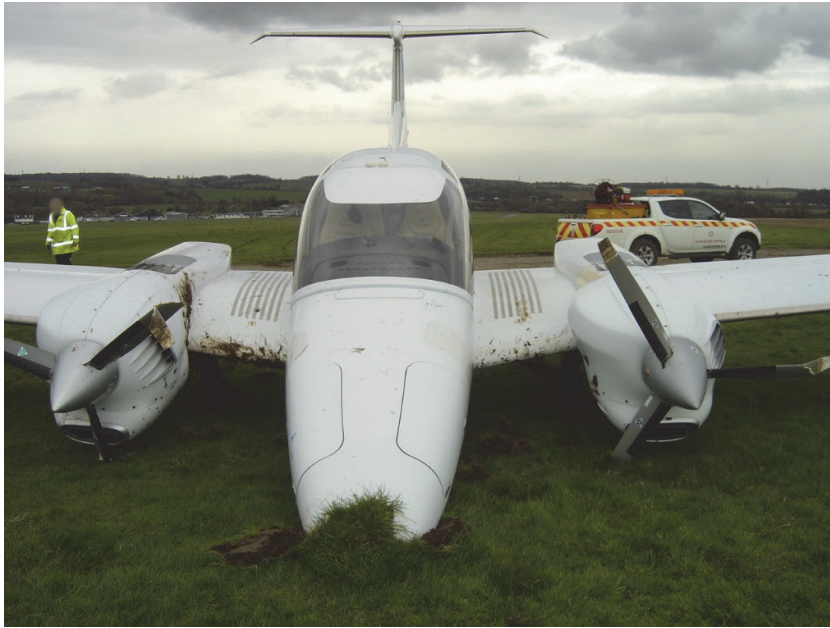
**Figure 1**

adequate runway remaining to safely complete the takeoff and continued to apply full power to try and accelerate the aircraft, but the airspeed did not increase. Not having achieved the desired increase in airspeed, he closed the throttles and applied gentle braking to bring the aircraft to a controlled stop. During the latter part of the deceleration, the aircraft nosewheel sank into the soft grass and separated from the aircraft. The nose lowered, both propellers struck the ground and the aircraft subsequently came to rest close to the end of the runway (Figure 1 and 2). Both occupants were uninjured and exited the aircraft without assistance.

G-SLCT after coming to rest

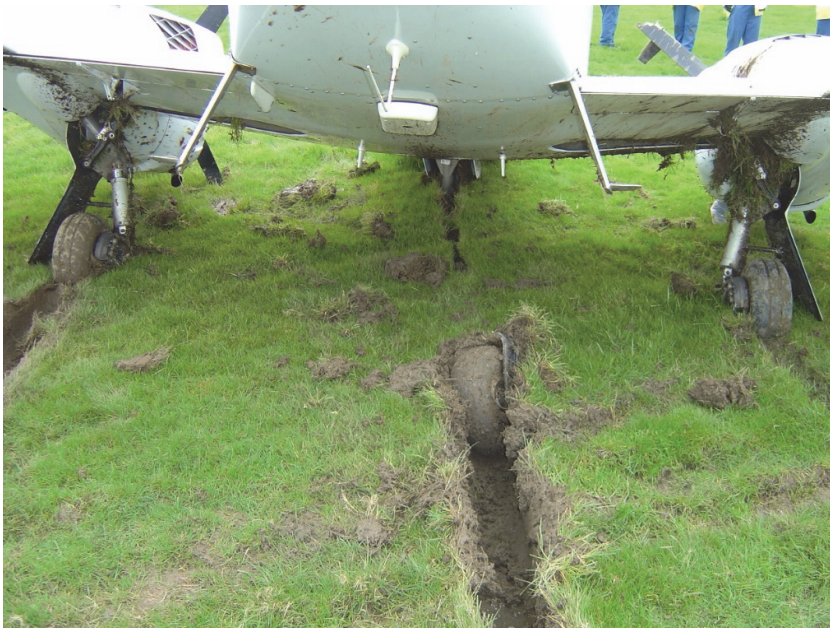
On the first touch-and-go of a circuit training detail, the aircraft ballooned during landing and the instructor took control. He retracted flaps and applied full power for takeoff. During the ensuing takeoff roll the aircraft travelled past the point where the runway surface changed from asphalt to grass. Due to recent inclement weather the ground condition was soft. Despite continuing to apply full power, the aircraft did not accelerate and the instructor elected to bring the aircraft to a stop. While decelerating, the aircraft's nosewheel sunk into the soft earth and separated from the aircraft.

While performing a touch-and-go the aircraft ballooned on landing, increasing the landing distance required and causing the instructor to take control. During the ensuing takeoff roll the aircraft travelled past the point where the runway surface changed from asphalt to grass. The soft ground conditions on the grass surface prevented the aircraft from accelerating sufficiently to achieve takeoff speed. As the aircraft was being brought to a stop the nosewheel detached.
