AAIB
Air Accidents Investigation Branch

AAIB Bulletin

7/2020

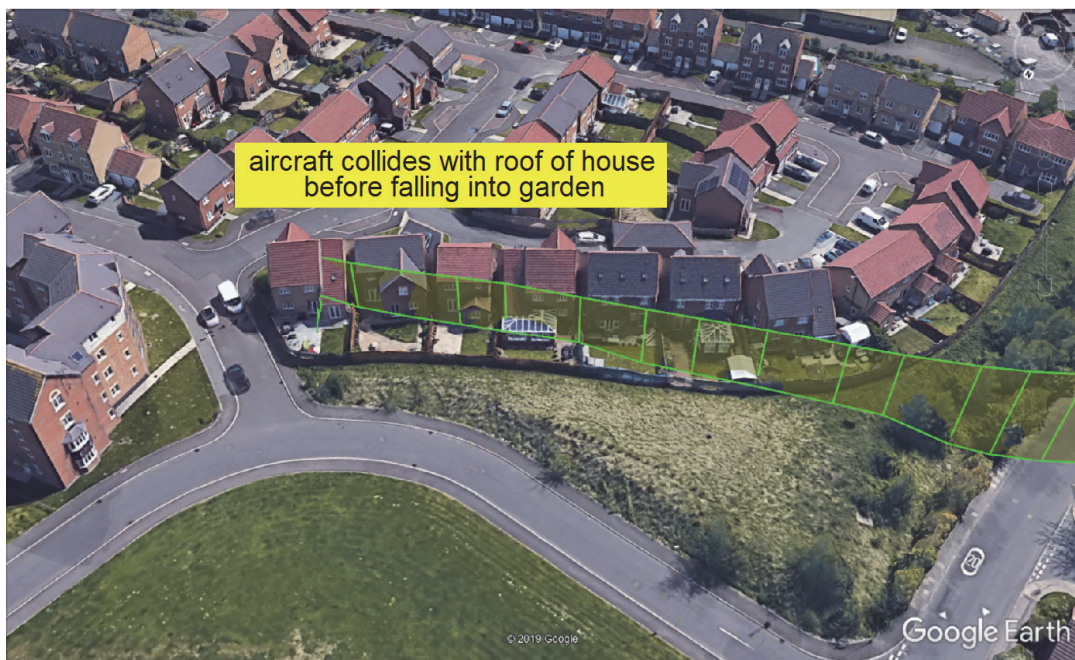
Figure 2
Accident location

The aircraft proceeded to fly overhead a large industrial area before approaching a housing estate located 300 m from where it had taken off. The aircraft had continued to maintain its altitude; however, its relative height above the ground reduced as it approached the housing estate due to the rising terrain. The recorded logs from the aircraft showed that, at 1521:07 hrs, the aircraft collided with the roof of a house before falling into the rear garden of the property (Figures 2 and 3). There were no persons in the garden at the time. The aircraft's propellers, arms, landing gear, gimbal and camera lens were damaged. The flight time from when the GPS-compass error had occurred and the aircraft colliding with the house was 75 seconds. The controller had remained in radio contact throughout the flight.

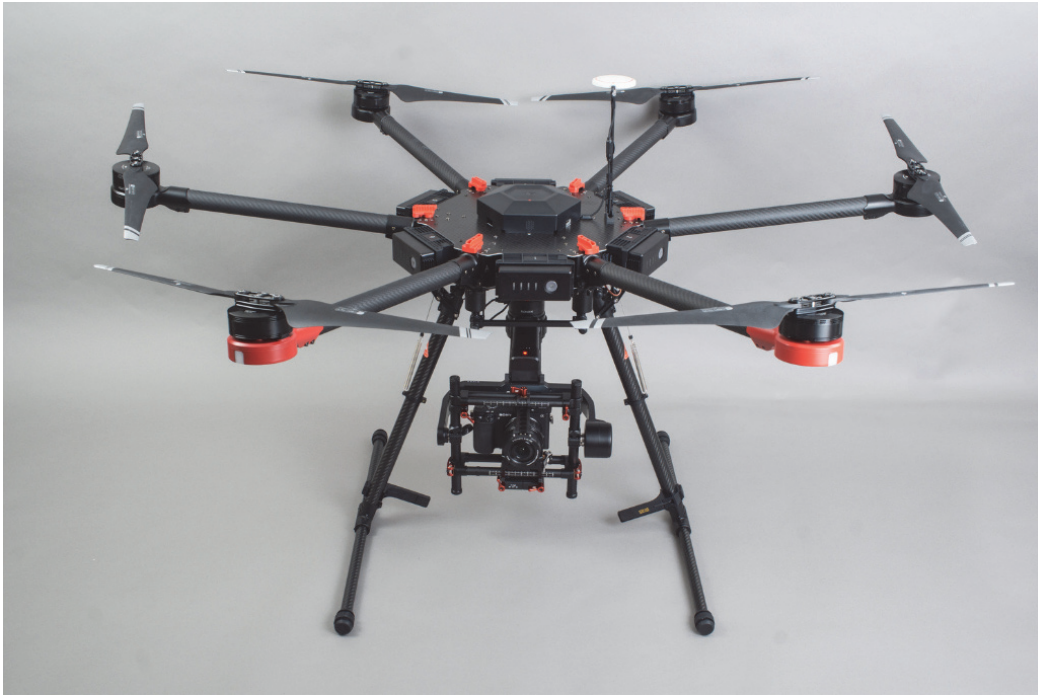
Figure 4

The M600 Pro is a six-rotor aircraft and has a maximum takeoff mass of 15.1 kg (Figure 4) and its flight controller is shown in Figure 5. During the accident flight, the aircraft's mass was 12.8 kg, which included an underslung camera. The accident aircraft had been purchased new in August 2019 and had accumulated just over six hours flight time.

M600 series aircraft

The accident aircraft was fitted with three GPS antenna (white circular components)
(photograph used with permission)

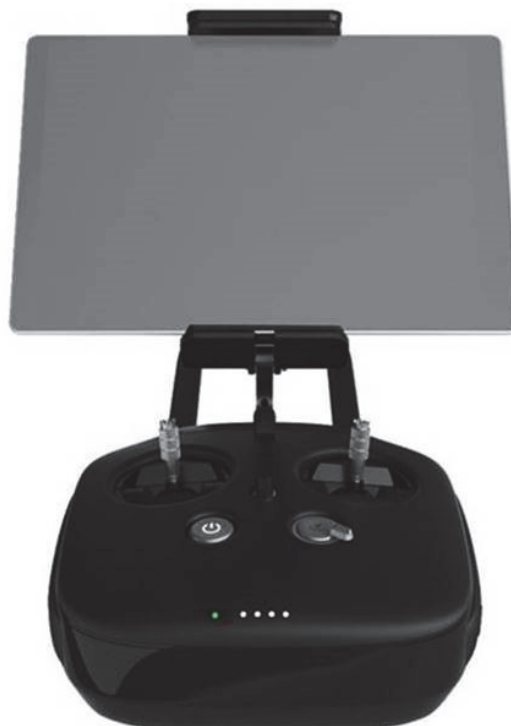
Figure 5

M600 Pro aircraft controller
