AAIB Bulletin

8/2020

Published 13 August 2020

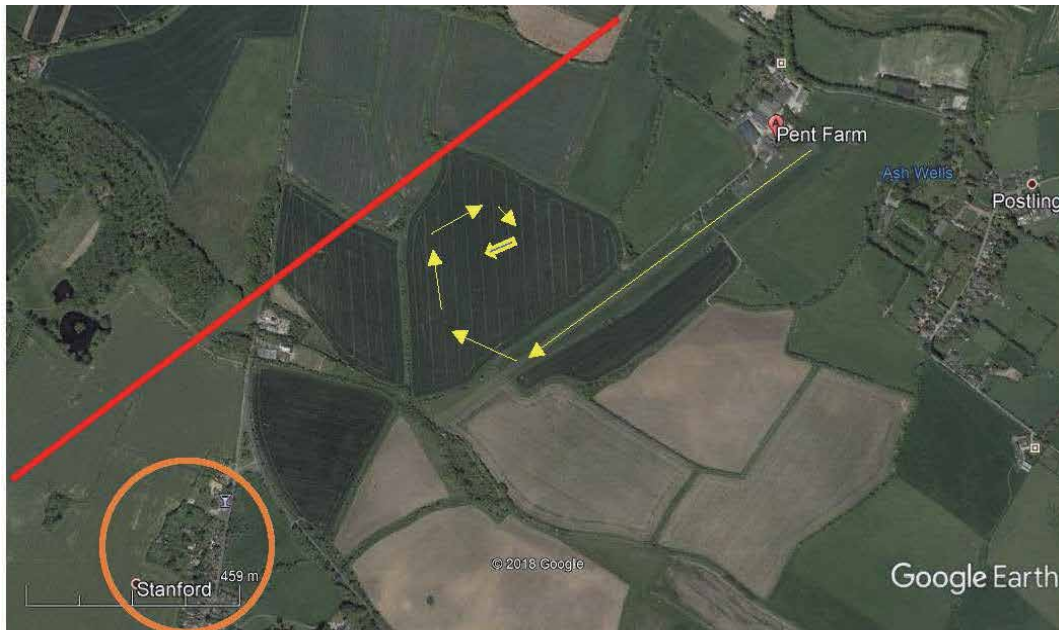
Figure 2

Pent Farm is a private airstrip 2.5 nm north-north-west of Hythe, Kent, with an elevation of 240 ft amsl. It has a single grass runway orientated 070°/250°, 1,000 m long and 25 m wide. There are high tension powerlines and 70 ft high pylons approximately 450 m to the north of and running parallel to the runway. There is high ground rising to 550 ft to the northeast and powerlines 25 ft high close to the Runway 25 threshold. Circuits are flown to the north, to the right from Runway 25, at 1,000 ft amsl. The village of Stanford on the extended centreline of Runway 25 is treated as an avoidance area. There is also a property to the north of Stanford to the west of the Runway 07 threshold which, although not part of the avoidance area, has horses and it would be normal to avoid overflying it, especially at a low height. The airfield and immediate surrounding area are shown at Figure 2.

Pent Farm airfield showing the avoidance area of Stanford, estimated aircraft track and accident site in yellow, with pylon wires in red

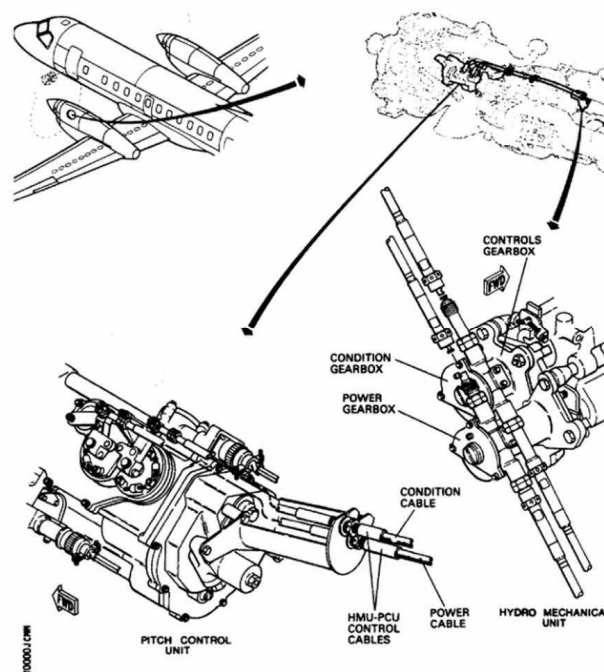
Figure 1

The aircraft was equipped with two General Electric (GE) CT7-9B turboprop engines, fitted with Dowty propellers. Engine control is provided by separate power and (propeller) condition levers, mounted on the control quadrant on the centre pedestal of the cockpit. Each power and condition lever are connected to the PCU and HMU fuel control gearbox on the respective engine, by a mechanical push-pull cable and a series of bellcranks and pulleys. The cables provide an adjustable, mechanical connection between the HMU and PCU units (Figure 1).

Figure from Saab 340 aircraft maintenance manual showing engine control cable routing between HMU and PCU
