AAIB Bulletin

9/2020

Published 10 September 2020

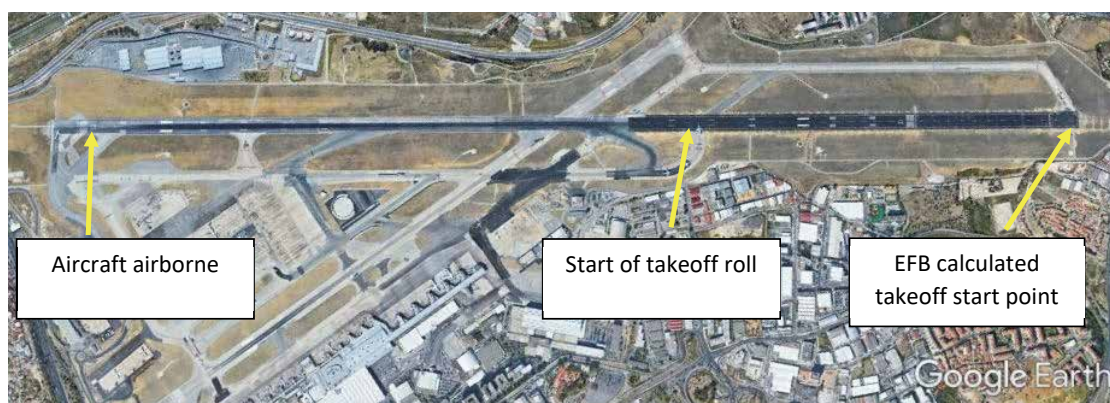
Figure 1

The takeoff distance available from U5 was 1,395 m less than that used for the performance calculation, and the aircraft became airborne with only 110 m of the runway remaining (Figure 1). During the flight the crew realised what had happened, and they reported it to the operator after landing.

Image of Lisbon Airport showing the calculated and actual takeoff points

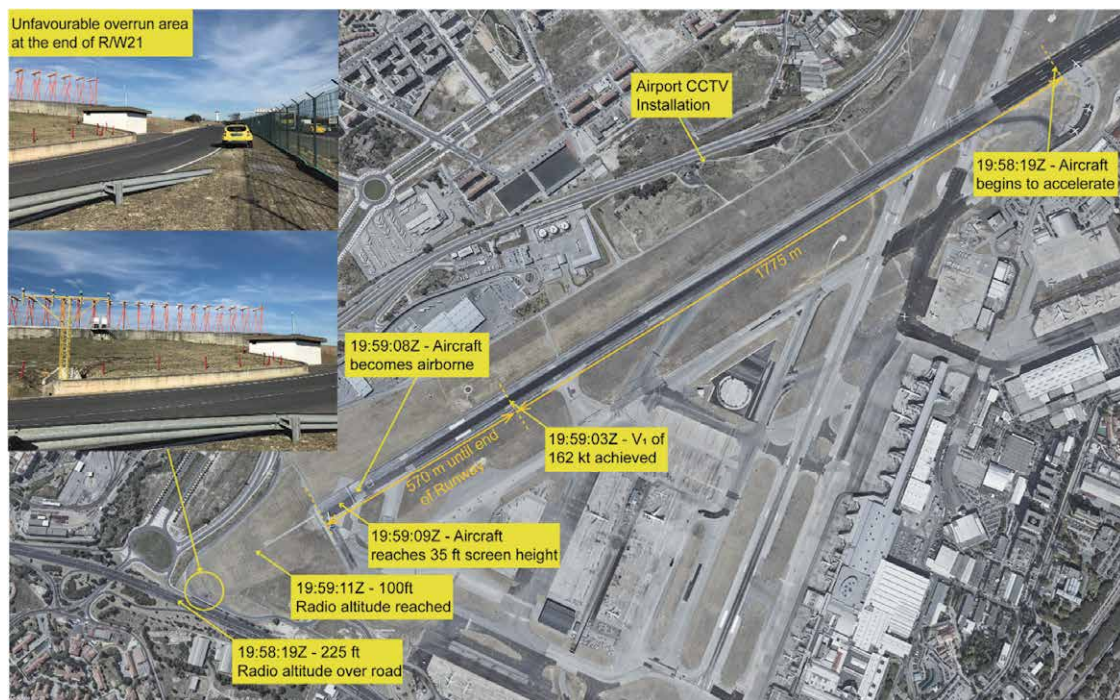
Figure 2

The QAR data (Figure 2) showed that the aircraft commenced its takeoff roll at 1958:19 hrs having entered Runway 21 from Taxiway U5. 44 seconds later, at 1959:03 hrs, after a ground roll of 1,775 m and with approximately 570 m of runway remaining ahead of the aircraft, a V_1 of 162 kt was achieved. Five seconds later, at 1959:08 hrs, the aircraft became airborne approximately 110 m from the end of Runway 21. At the speed the aircraft was travelling over the ground this distance would have taken approximately 1.3 seconds to cover. One second later, whilst still over the paved surface of Runway 21, the aircraft achieved the regulatory screen height of 35 ft, for a dry runway, and crossed the airport boundary at 225 ft radio altitude. TOGA thrust was not selected at any point.

QAR Data showing G-EZWE's takeoff roll

As shown in Figure 2, there are several obstructions beyond the runway that could have caused significant damage to the aircraft and its occupants should an overrun have occurred.

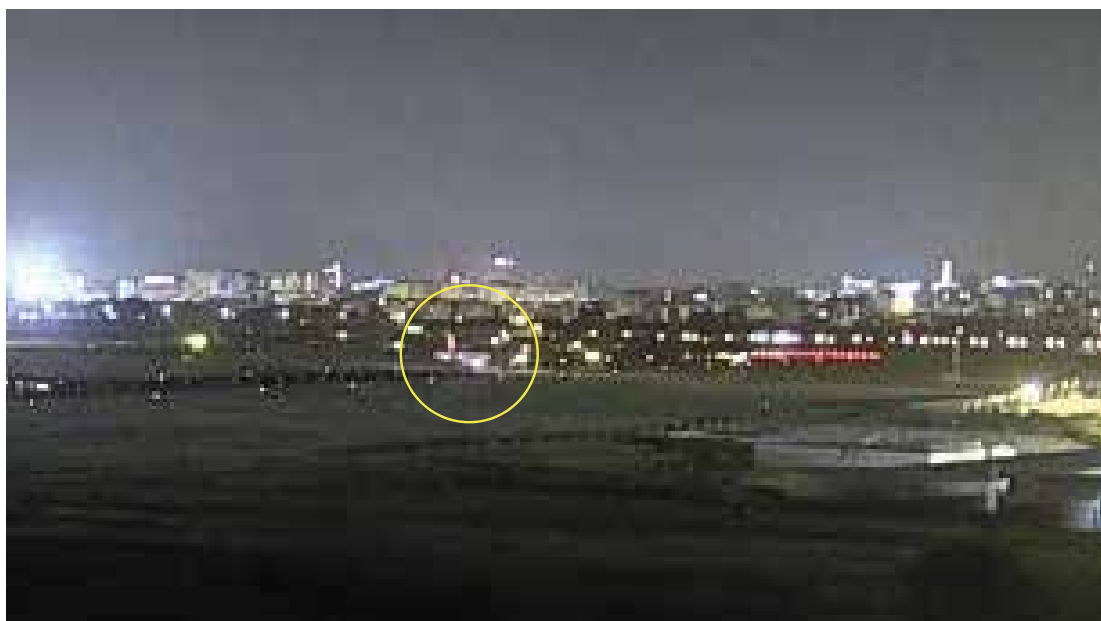
Figure 3

G-EZWE's takeoff roll was captured on several CCTV cameras around the airport. One of these cameras (situated as shown in Figure 2) covered the latter part of the aircraft's takeoff roll. The frame shown below (Figure 3), where the aircraft is highlighted by the yellow circle, was recorded just after the aircraft reached V_1 , and the end of the runway is indicated by the row of red lights towards the right of the image.

CCTV screenshot showing G-EZWE just after reaching V_1

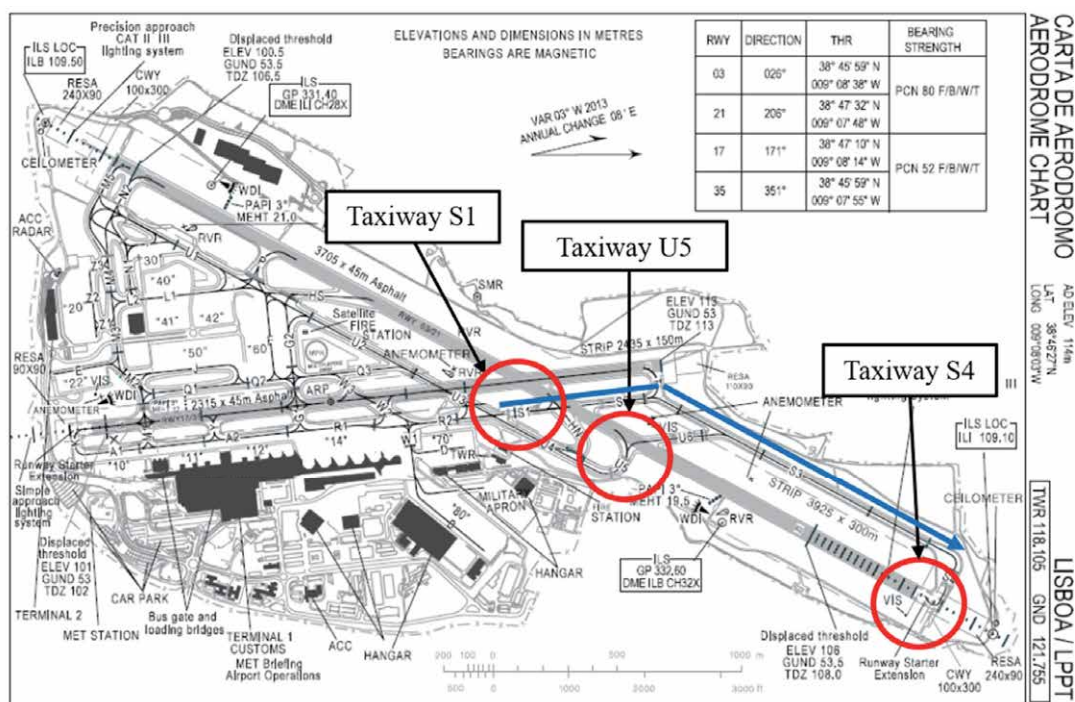
At the time of the incident Lisbon Airport had two runways which were orientated 03/21 and 17/35 (Figure 4). Runway 03/21 is the preferential runway for both takeoff and landing,

When Runway 21 is in use, the preferred departure point for all aircraft, except heavy jets, is ‘Position U’, which is the intersection of the runway with Taxiway U5. Pilots must advise air traffic control on start-up if they require the full length of the runway for departure. Full length departures are from holding point S4 which is known as ‘Position S’. At the time of the incident, Taxiway S began abeam Runway 17, before crossing Runway 21 at Taxiway S1, and then turning north-east to run parallel to Runway 21. This is marked on Figure 4 in blue. The taxiway ends at the threshold of Runway 21. There were therefore two points on Runway 21 where Taxiway S intersected the runway.

Plan of Lisbon Airport showing Taxiways S1, U5 and S4

It is recommended that ANA Aeroportos de Portugal discontinue the use of takeoff Positions at Lisbon Airport to minimise confusion concerning takeoff points.

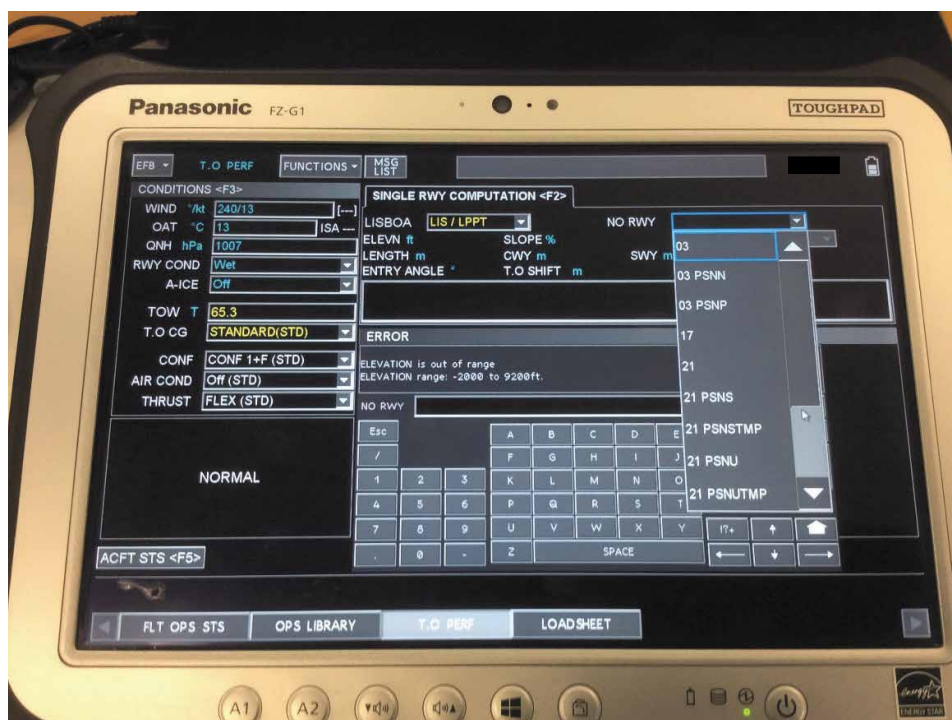
Figure 5

available for departure and, in the case of Lisbon Runway 21, two positions are available, Position U and Position S. These are named in the software as PSNU and PSNS. At the time of the incident, there was a NOTAM affecting the takeoff performance calculation (referring to an obstacle in the climb-out zone). This meant that the data supplier had inserted two further temporary selections for the two takeoff positions for Runway 21, which were labelled PSNUTMP and PSNSTMP as shown in Figure 5.

EFB drop-down menu showing the all the intersections available (not the actual incident data)

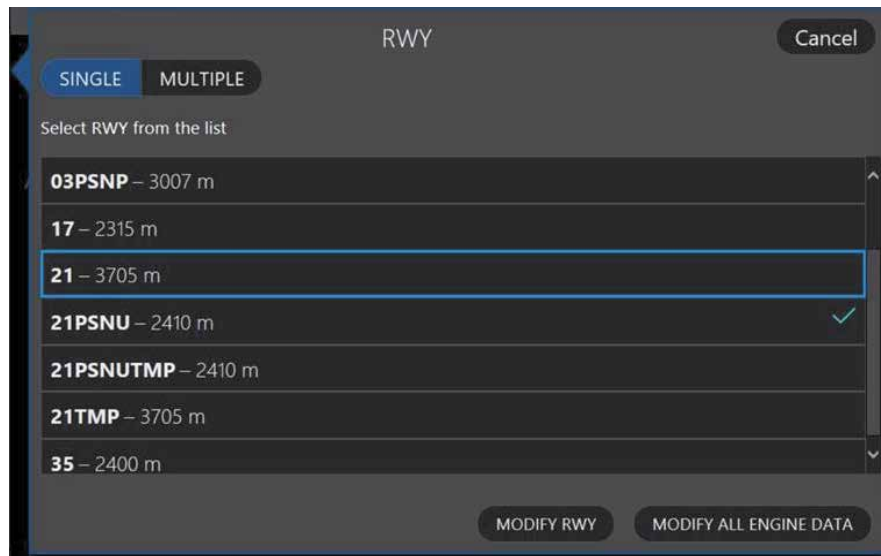
Figure 6

New nomenclature in EFB drop-down menu

As a result of this incident and the two previous cases, the operator changed the nomenclature in the EFB for Runway 21. This change eliminated the use of Position S, instead using merely '21' to indicate that this point is the full length of the runway. The new drop-down selection is shown at Figure 6.

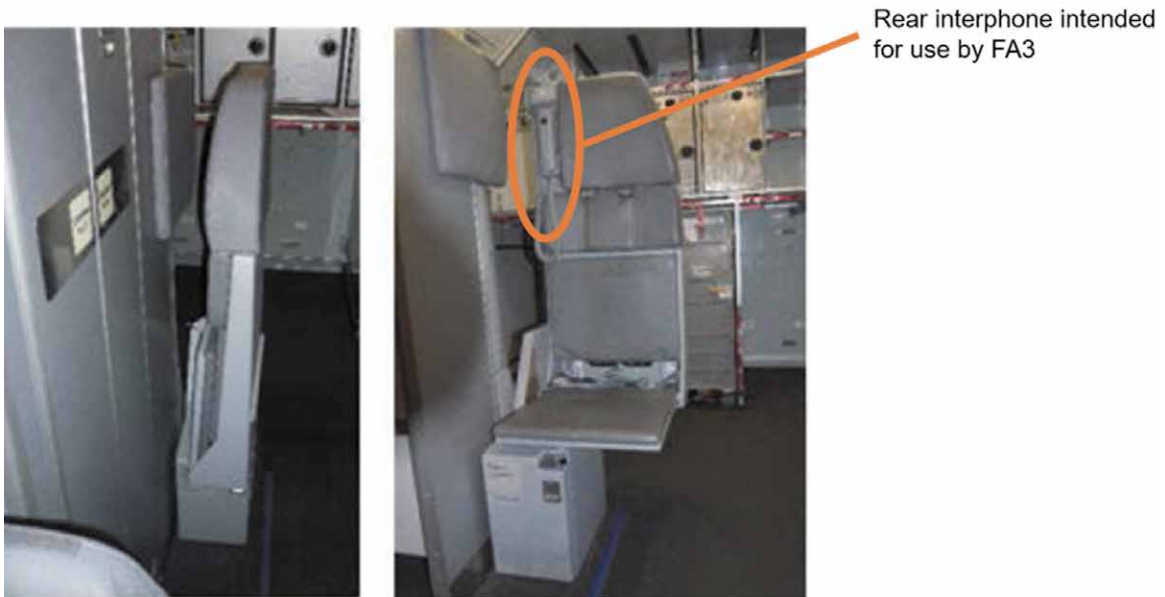
Figure 4

The SFA then tried to call FA3, in the rear of the aircraft, using the interphone, to check if everything was alright. However, when FA3 stood up, his crew swivel seat displaced the attached handset from its stowage and its cable became trapped in the now folded seat⁵. This caused the crew high/low chime⁶ in the cabin to be suppressed so it was difficult for the SFA to attract FA3's attention. There then followed an exchange between the SFA and FA3 which resulted in the SFA commanding an evacuation over the PA. See the *Flight attendants' comments* section for details of this exchange. Upon hearing the command, the FAs and passengers commenced the evacuation.

A rear aisle swivel seat folded away from the wall and locked into position to provide a forward-facing view into the passenger cabin. When the release latch was lifted, the seat automatically folded back into the stowed position (Figure 4).

Rear aisle swivel seat in stowed (left) and forward-facing (right) positions

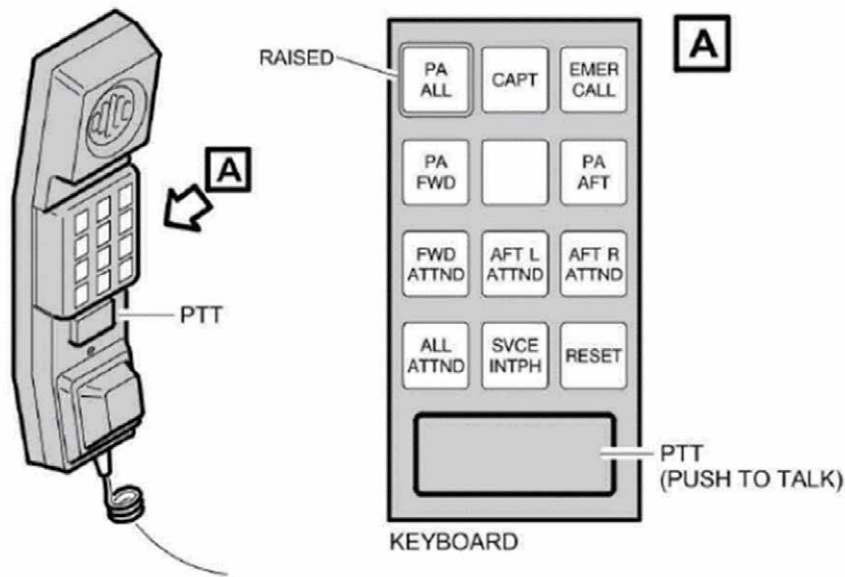
Figure 6
Interphone handset

Figure 6 shows the buttons available on the passenger cabin interphones. It was possible to call the FA3 interphone handset individually from the front handset using the AFT R[IGHT] ATTND [FLIGHT ATTENDANT] button or to call all handsets together using the ALL ATTND button. If the handset was called individually, and it was not fitted on its cradle, the attention getters of the chime and panel lights would not activate.

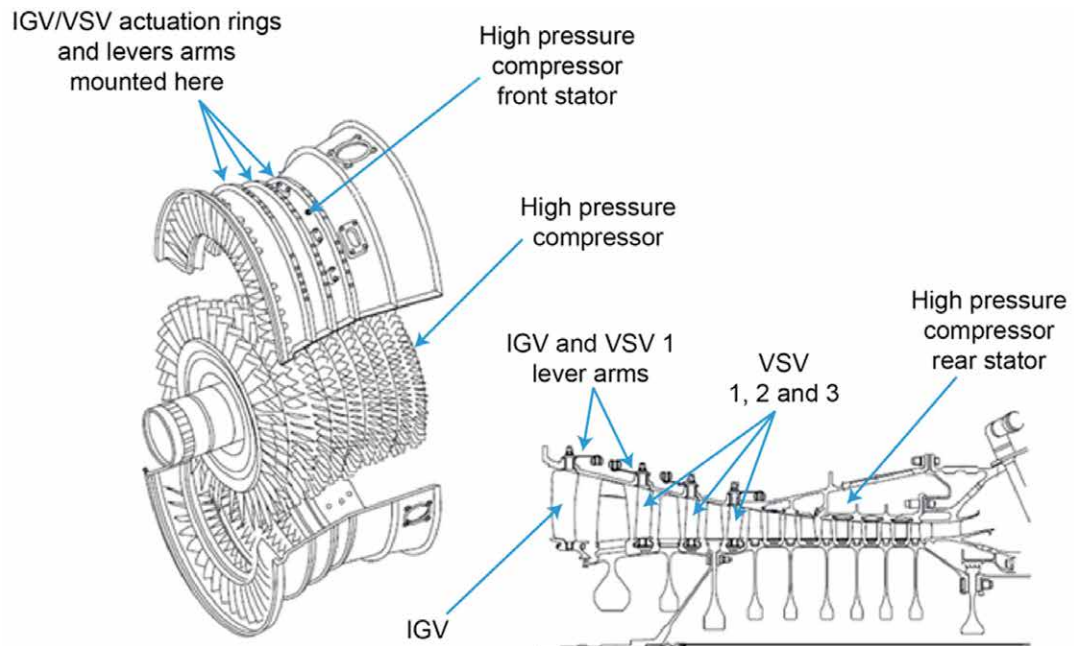
Figure 8

The HPC increases the pressure of the air as it passes from stage to stage, in order to supply the combustor section. It is comprised of a rotor, front stator and rear stator. The Variable Stator Vane (VSV) system, located at the forward end of the HPC (Figure 8), positions the Inlet Guide Vanes (IGV) and the stage 1, 2 and 3 stator vanes to the appropriate angle to optimise the airflow over the HPC rotor blades (Figure 9).

Section of High Pressure Compressor showing rotor, IGVs and VSVs

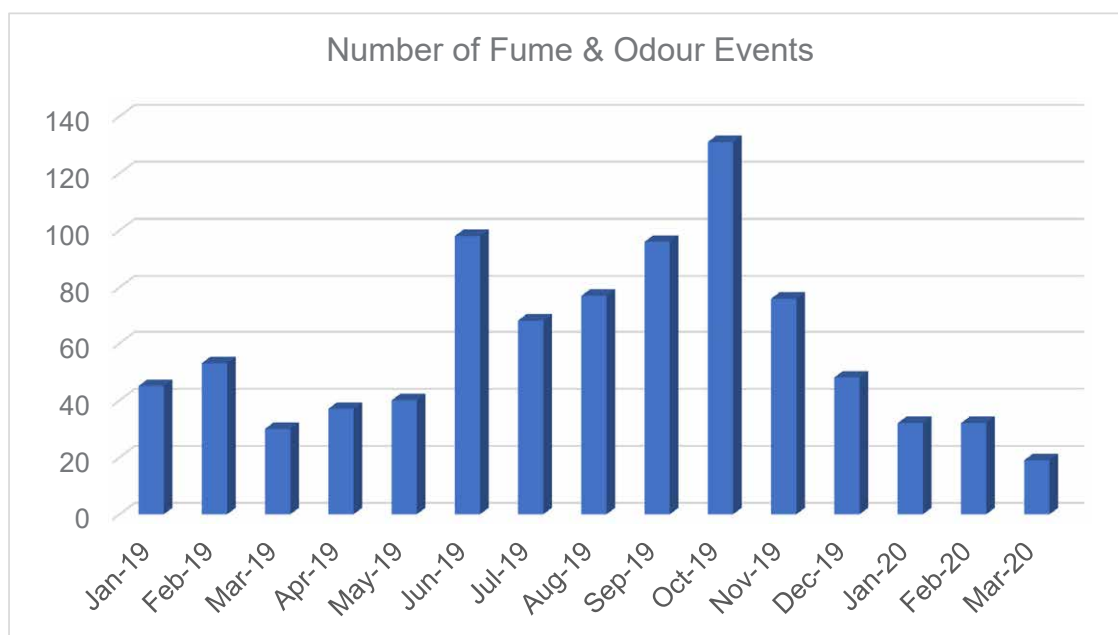
During the investigation into the circumstances surrounding G- EUYB, the operator reported many similar events on their Airbus A320 fleet⁸. Figure 3 shows the number of events reported during 2019 and the start of 2020. Summaries of five of these events, all of which occurred during the latter part of 2019, are included below to show the circumstances, the various outcomes and common factors.

Fume and odour events on the operator's Airbus A320 fleet in 2019 and early 2020

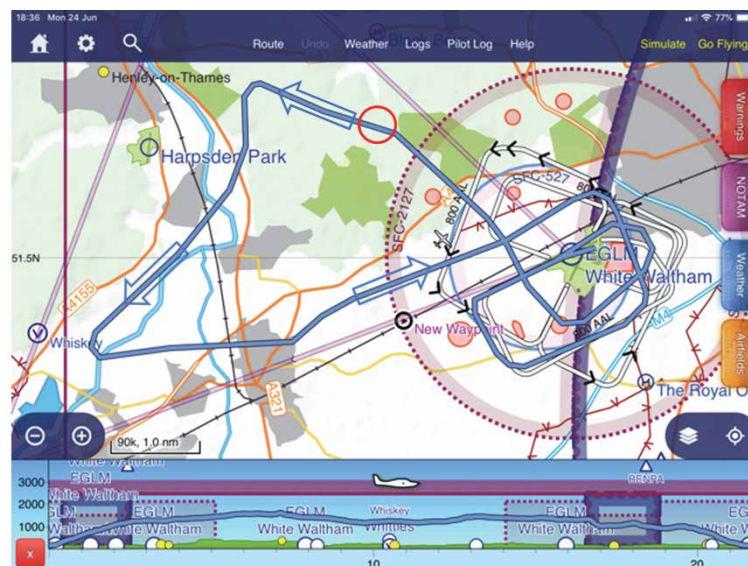
Figure 2

Once airborne the previously unsettled child became vocal. Fearing he may become physically disturbed again, the pilot decided to shorten the route by flying towards Henley-on-Thames, Oxfordshire. Shortly after leaving the Aerodrome Traffic Zone, while straight and level, the pilot noticed a bright red aircraft above, in his 8 o'clock position, converging on his aircraft. He then lost sight of it above and behind his aircraft's high-wing, becoming visual again when it was in his 1 to 2 o'clock position. It then was seen to descend before disappearing from his sight. He didn't have time to take avoiding action but filed an Airprox on White Waltham's A/G radio frequency. He continued the flight to Henley-on-Thames and Point Whiskey before returning to White Waltham without further event, landing at 1009 hrs (Figure 2).

G-BXGV's routing
(Red circle indicates approximate location of collision)

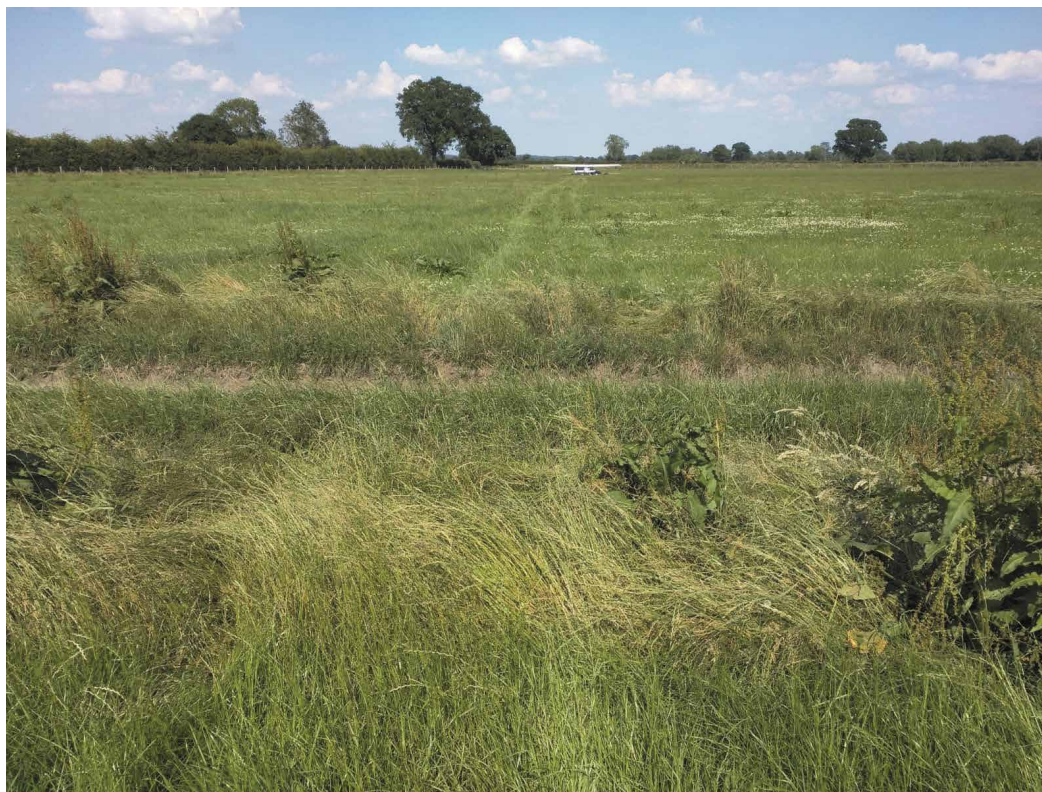
Figure 2

The pilot landed the aircraft with the flaps up in a slight crosswind. As the aircraft touched down he noticed a ditch crossing the aircraft's track and decided to pull back on the control column to pass over it. Once clear of the ditch he brought the aircraft to a halt and

G-BTAL ground track showing the ditch the aircraft crossed

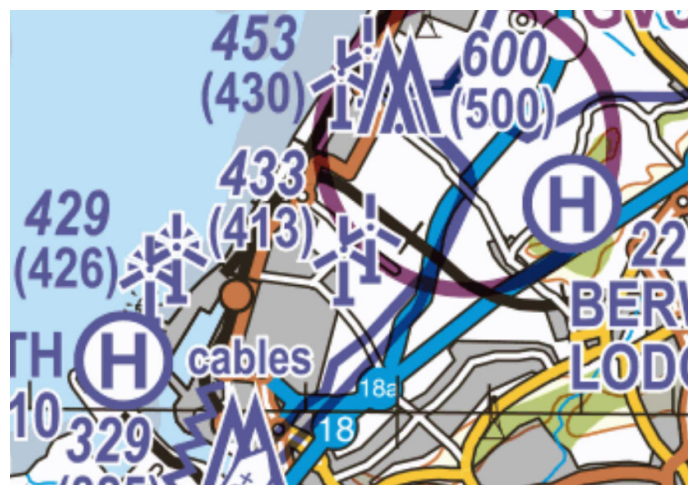
Extract from the CAA 250K aeronautical chart with the wind turbines at the sewage works in the centre of the image

Figure 1 shows the wind turbines, marked 433 (413)³, at the sewage works, as well as the powerlines (dark blue lines) on the southeast boundary of the works. The same information can be found on apps designed for VFR flying.

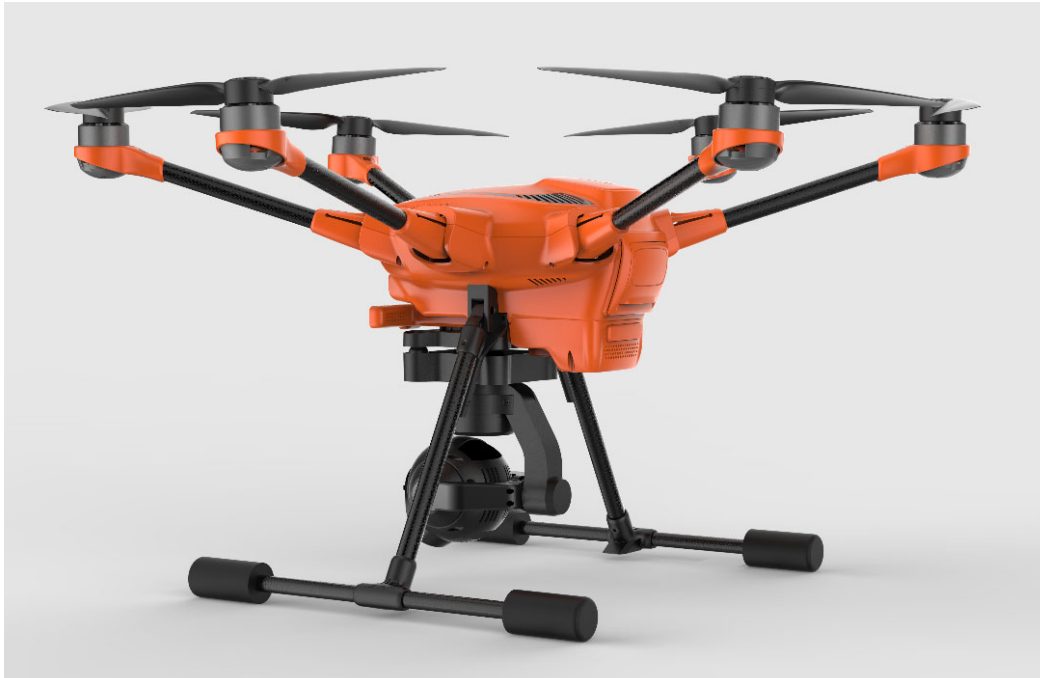
Figure 1

Yuneec H520 UAS hexacopter
(Photo courtesy of Yuneec)

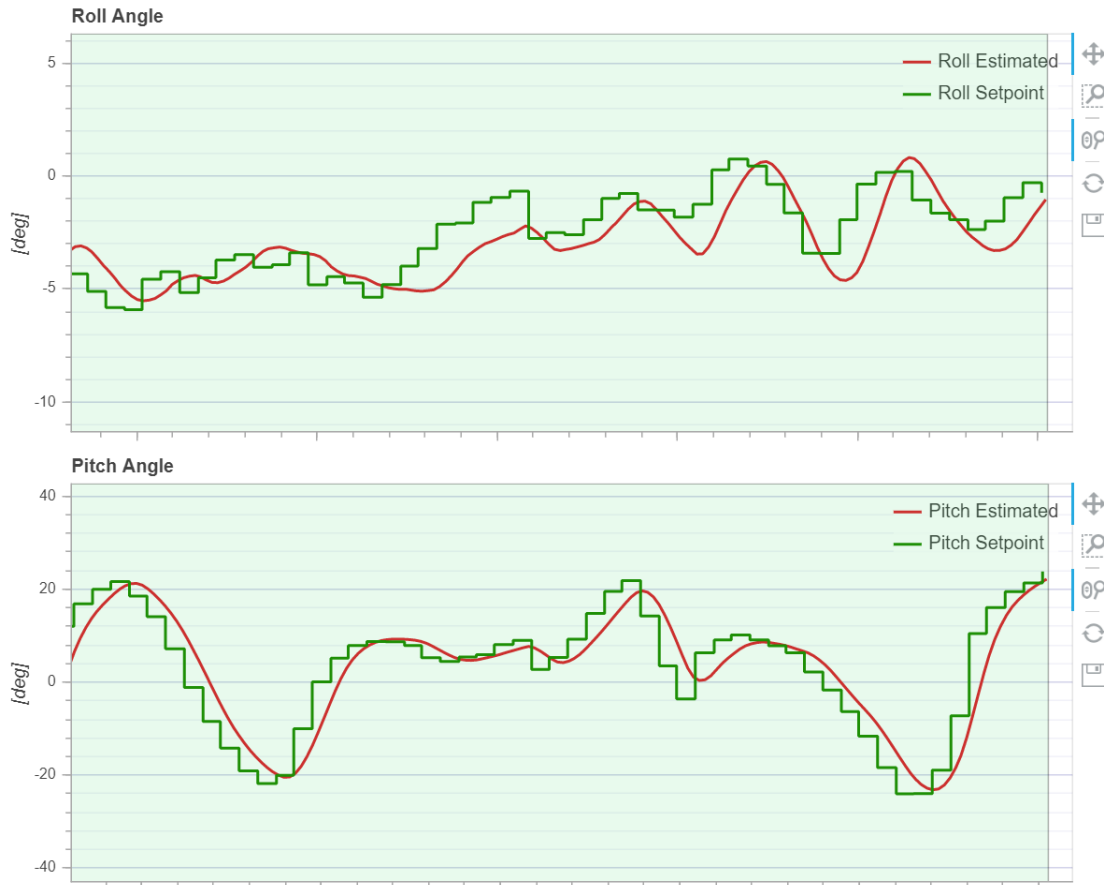
Figure 2

Aircraft pitch and roll for the last five seconds of controlled flight

The sudden loss of power to the motors from a battery that was almost fully charged was consistent with the battery disconnecting in flight. The data indicated that the aircraft was pitching through 6° and rolling through 46° as it maintained altitude while moving slowly forward, suggesting that the conditions were turbulent enough to dislodge the battery if it had not been properly secured in place, even though the pilot had checked to make sure it was.
