# Rail Accident Report

## **Collision between mobile elevating work platforms at Rochford, Essex 25 January 2020**

Report 08/2020  
September 2020

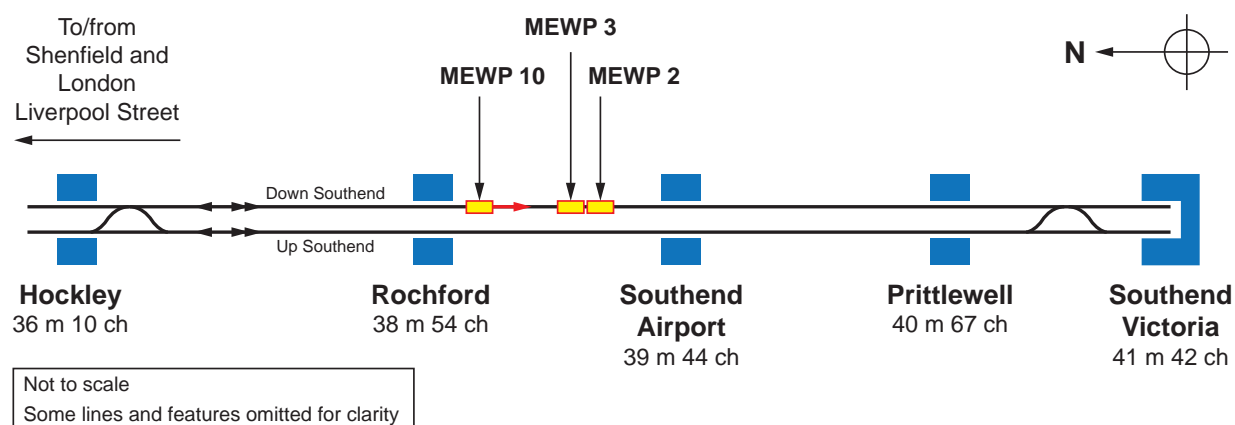
Figure 2: Layout of the track and location of the MEWPs involved in the accident

- 3 At 10:57 hrs on Saturday 25 January 2020, a mobile elevating work platform (MEWP), which was travelling on a section of the railway that was closed for engineering work to take place (known as a possession), collided with a stationary MEWP on which two people were working. The accident occurred near Rochford station, Essex (figures 1 and 2).

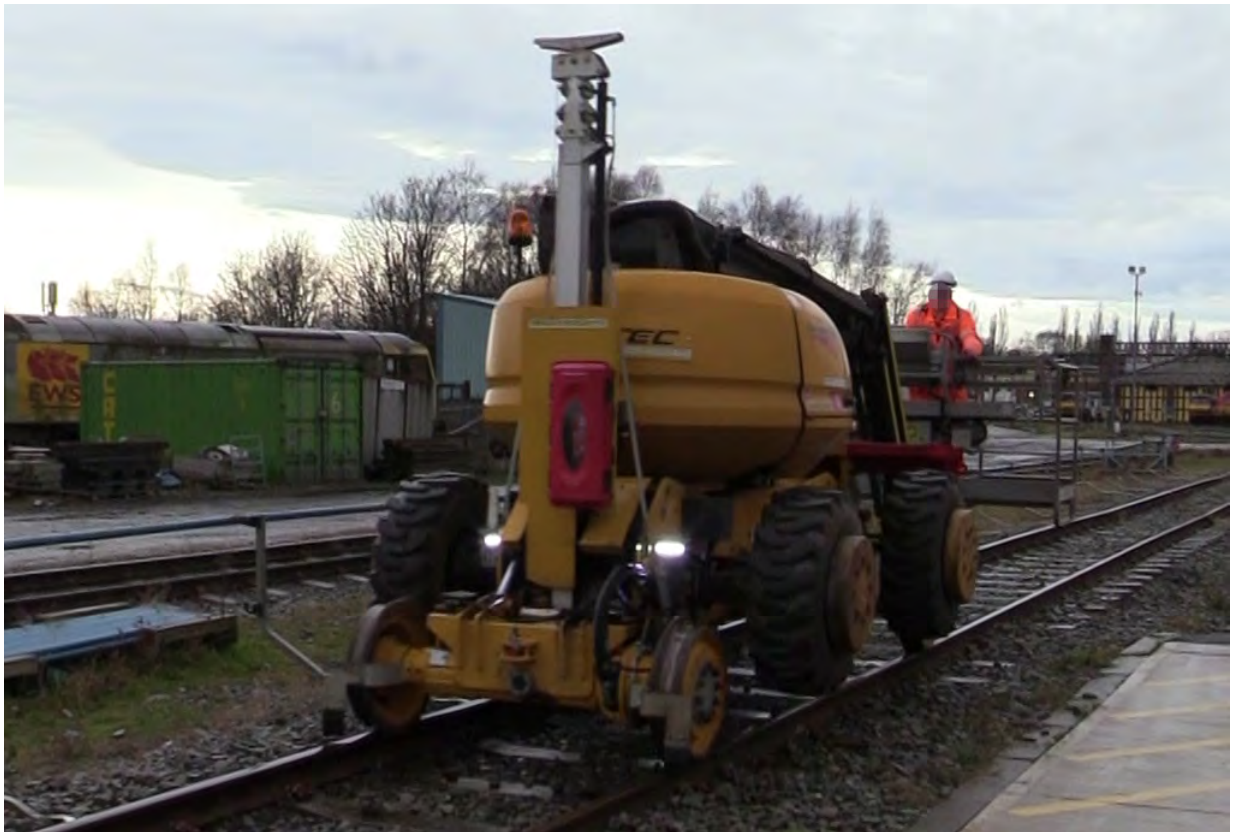
Figure 5: Skyrailer MEWP 10 involved in the accident

- 14 The work that was planned in work site D required nine on-track machines. Of these, eight were Skyrailer 440 MEWPs. When working on rails the Skyrailer 440 (figures 4 and 5) has four-wheel drive with independently driven wheels and a hydrostatic braking system. This is supplemented with drum service and parking brakes that are also applied when the emergency brake is deployed. The eight MEWPs were intended to work in four pairs of two, working back to back at each OLE stanchion. The remaining machine was a Giga crane.
- 15 Because of problems with documentation one MEWP could not be used, and the crane was found to be faulty when it was being put on the track. This left seven MEWPs available for the work, with one of these, MEWP 10, working on its own.

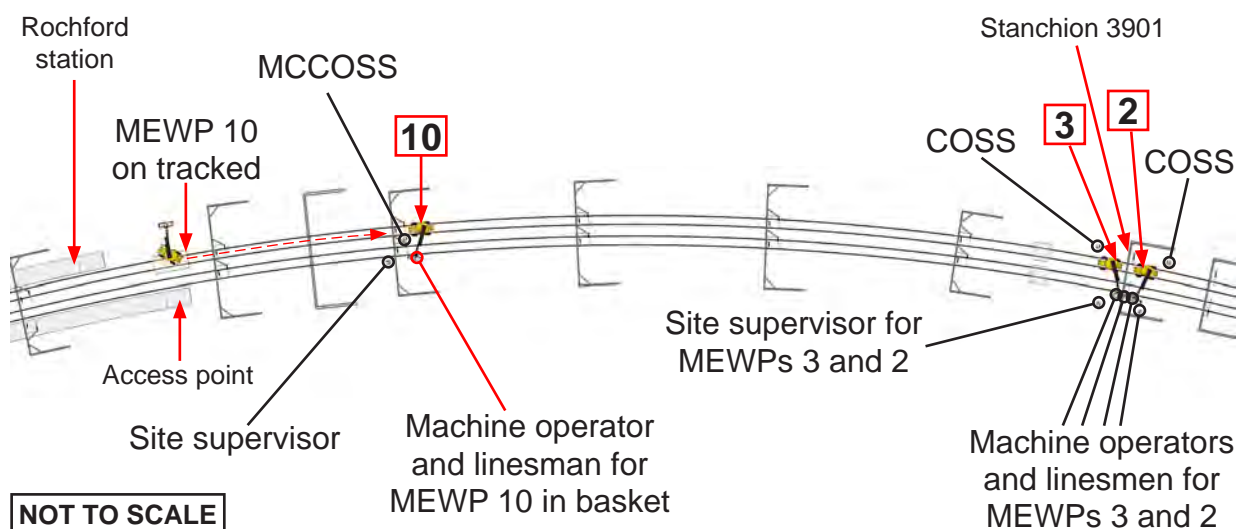
Figure 6a: Sites of work and locations of MEWPs 10, 3 and 2 with associated positions of the staff

- 24 At around 08:00 hrs, a shift changeover occurred. Around 09:30 hrs MEWP 10 was on-tracked onto the down line at the access point for work site D. During the on-tracking process the machine operator had difficulty in co-ordinating the movement of the MEWP to allow the deployment of the rail wheels, and the basket collided with the overhead line equipment. A site supervisor assisted the machine operator, and the MEWP was eventually on-tracked and a satisfactory brake test was performed.

- 25 The COSS briefing and the pre-work checklist for MEWP 10 were completed by MCCOSS. The associated paperwork was signed by the machine operator and endorsed by the POS representative. MEWP 10 then travelled a short distance from the access point towards Southend and commenced work (figure 6a).
- 26 At approximately 10:09 hrs, the machine operator working on MEWP 2 reported to his site supervisor that there was a fault with the platform sensor on the machine. The supervisor asked for the on-site fitter. The fitter arrived at the access point, and the site supervisor instructed the machine operator of the nearest machine, MEWP 10, to convey the fitter to the location where MEWPs 3 and 2 were working. The machine operator drove MEWP 10, with the fitter on board, for around 310 metres, travelling at a speed of 7 mph (12 km/h), until it had reached a point close to MEWP 2 (figure 6b).

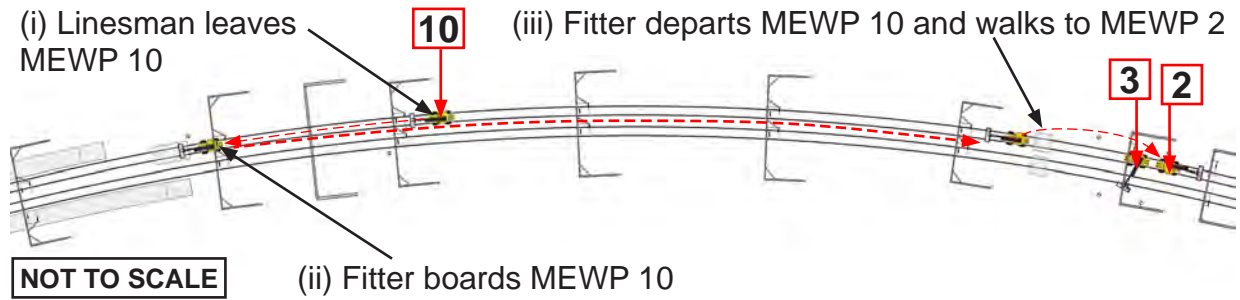
Figure 6b: Route taken by MEWP 10 to the access point to uplift and convey the on-site fitter to the site of work to attend to the fault on MEWP 2

27 The fitter alighted, and at 10:21 hrs MEWP 10 returned to its site of work, again travelling at 7 mph (12 km/h).

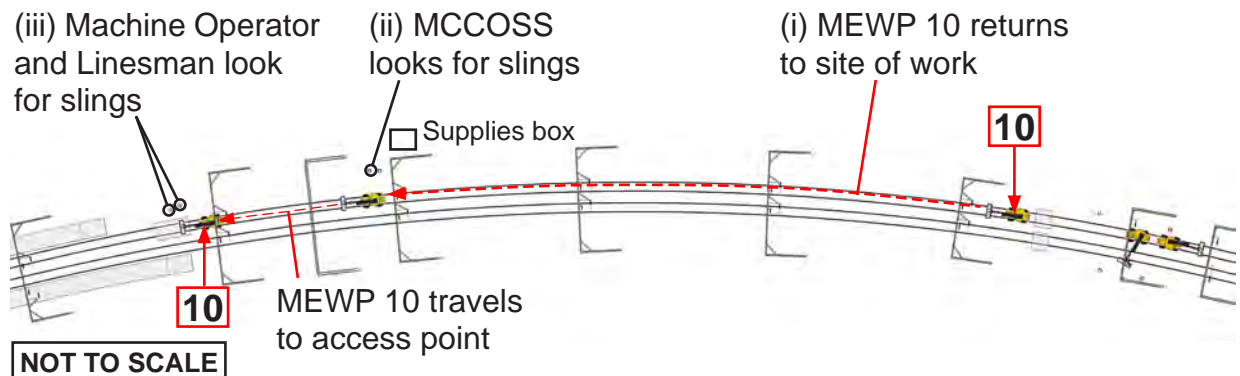
Figure 6c: Route of MEWP 10 back to its original site of work and onward travel to the access point

28 At approximately 10:50 hrs, the site supervisor for MEWP 10 told the machine operator and linesman to set up the machine for lifting OLE equipment. This task required two slings, which could not be found in the machine's basket. The machine operator, in company with the linesman, took MEWP 10 back to the access point, travelling at a speed of 6.4 mph (10 km/h). The machine operator and linesman then went separate ways to look for the slings. MCCOSS was aware that the site supervisor had made the request, but he decided to remain at the site of work (figure 6c).

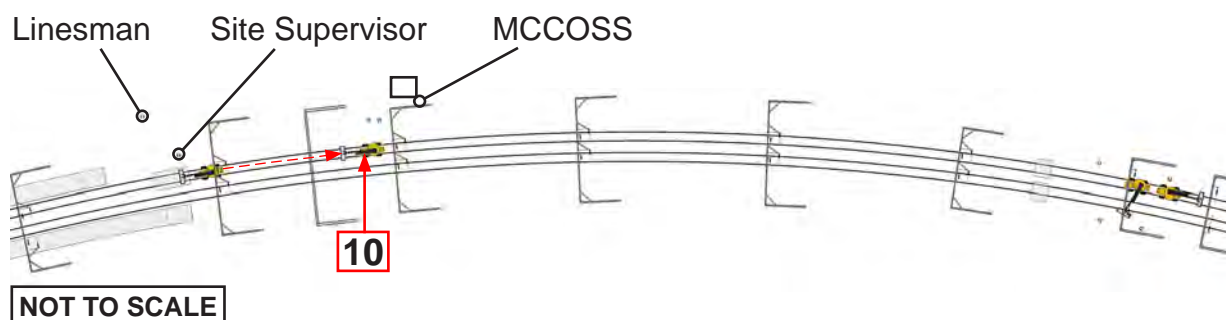
Figure 6d: Route of MEWP 10 back to its site of work

29 MCCOSS also looked for the slings in a supplies box located next to the down line, and at the same time, the site supervisor walked back to the access point. The machine operator told the site supervisor that as he could not find the slings, he would go and enquire if the staff working on MEWP 3 and MEWP 2 had spare slings, while the linesman continued looking around the site (figure 6d).

30 At 10:53 hrs, MEWP 10 travelled back to its site of work, a distance of approximately 120 metres, travelling at 10 mph (16 km/h). MEWP 10 was then stationary for between three and four minutes while the operator and MCCOSS looked for the slings (figure 6d).

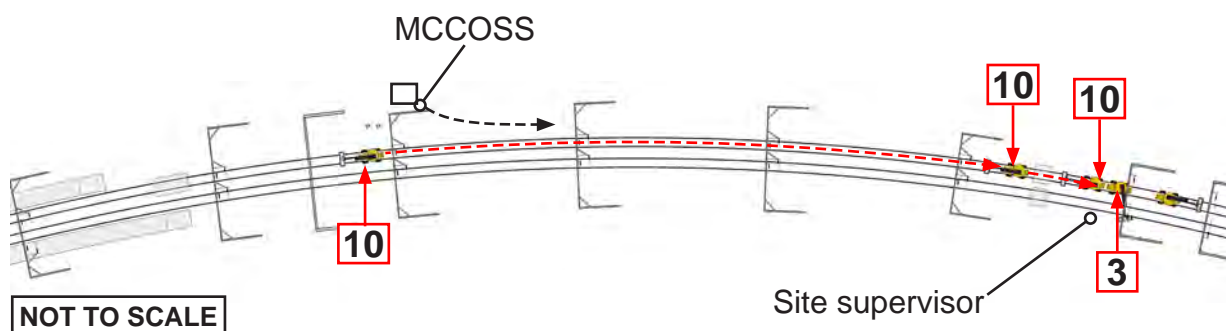
Figure 6e: Route of MEWP 10 as it approached MEWP 3

- 31 Around 10:56 hrs, the machine operator drove MEWP 10 away from its site of work to travel to the location of MEWP 3 and MEWP 2. The machine operator did not seek authority from MCCOSS, who was still looking for the missing slings. The horn was not sounded, and MCCOSS only became aware of the movement of MEWP 10 as the machine operator moved away from the site of work. MCCOSS has stated that, on hearing MEWP 10 moving off, he shouted several times at the machine operator to stop, and started to run after the MEWP, but he could not keep up (figure 6e) as it was now travelling at 10 mph (16 km/h).

- 32 The on-site fitter, who was still working on a platform sensor fault on MEWP 2, became aware of the high-pitched engine noise from the approaching MEWP 10. He commented to those around him that MEWP 10 was travelling quickly. The fitter reported that he could see the machine operator was positioned centrally within the basket and had his head lowered (figures 6e and 6f). The COSS / machine controller for MEWP 2 heard the fitter's comment and turned to look towards the approaching MEWP 10. Realising that MEWP 10 was showing no signs of braking, he shouted a warning to his colleagues on and around MEWP 3.
