SERIOUS INCIDENT

Aircraft Type and Registration:	Boeing 737-8K5, G-TAWG	
No & Type of Engines:	2 CFM CFM56-7B27E turbofan engines	
Year of Manufacture:	2012 (Serial no: 37266)	
Date & Time (UTC):	24 December 2019 at 0048 hrs	
Location:	Manchester Airport	
Type of Flight:	Commercial Air Transport (Passenger)	
Persons on Board:	Crew - 6	Passengers - 181
Injuries:	Crew - None	Passengers - None
Nature of Damage:	Bearing failure, separation of No 4 (right outer) mainwheel and severe damage to the associated brake unit	
Commander's Licence:	Airline Transport Pilot's Licence	
Commander's Age:	41 years	
Commander's Flying Experience:	6,709 hours (of which 246 were on type) Last 90 days - 68 hours Last 28 days - 27 hours	
Information Source:	AAIB Field Investigation

Synopsis

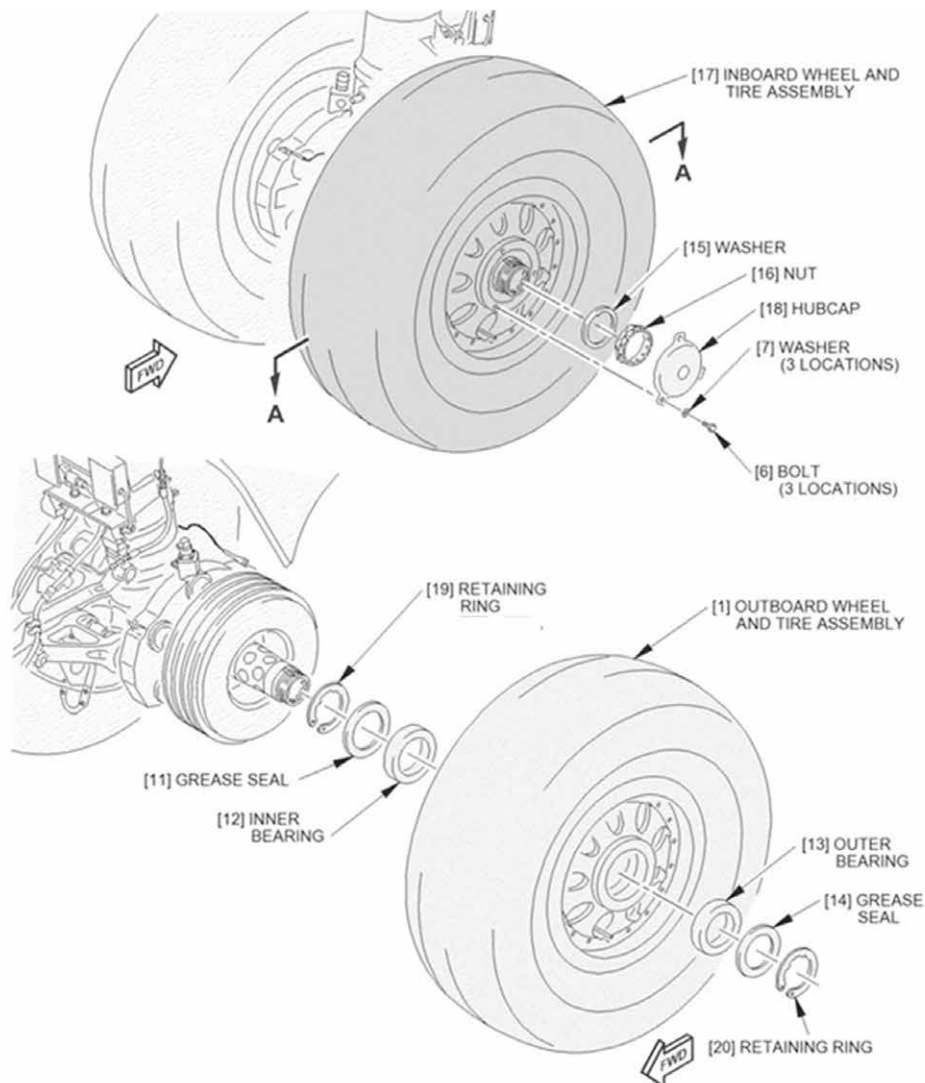
Figure 2

The wheels are of a split hub design with the hubs containing the inboard and outboard tapered roller bearings (Figure 2). The outer bearing component is known as the cup and the inner bearing component as the cone. The cup bearing raceway is an interference fit within the hub, and the cone is a sliding fit on the stub axle. The rollers run on tracks in the cone and cup. The track on the cone is defined by a rib around its edges; there are no ribs on the cup. The inboard and outboard bearing assemblies are fitted with external grease seals which are held in place by spring steel retaining rings located in grooves in the wheel hub. The general arrangement of the inboard and outboard bearings is shown in Figure 3.

Landing gear mainwheel general arrangement (courtesy of Boeing)

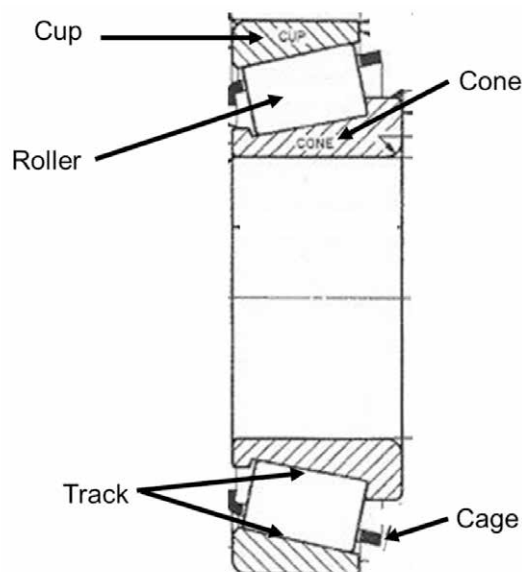
Figure 3

Bearing general arrangement (courtesy of Timken)

The bearings are provided as part of the wheel assembly. When fitted to the axle, a nut and washer are used to apply pressure to the bearings, which is known as the preload. The preload ensures the bearing cups and cones are correctly seated, and the rollers correctly aligned. This is achieved by applying a torque to the nut using a suitable torque wrench. Once the bearing assembly has been preloaded, the nut is loosened slightly, whilst maintaining a tight contact between the cup, cone and rollers, then retightened to its service torque, which is usually about 20-25% of the preload torque. Both these procedures are done whilst slowly rotating the wheel clockwise to ensure that the large roller ends are seated against the cone rib.

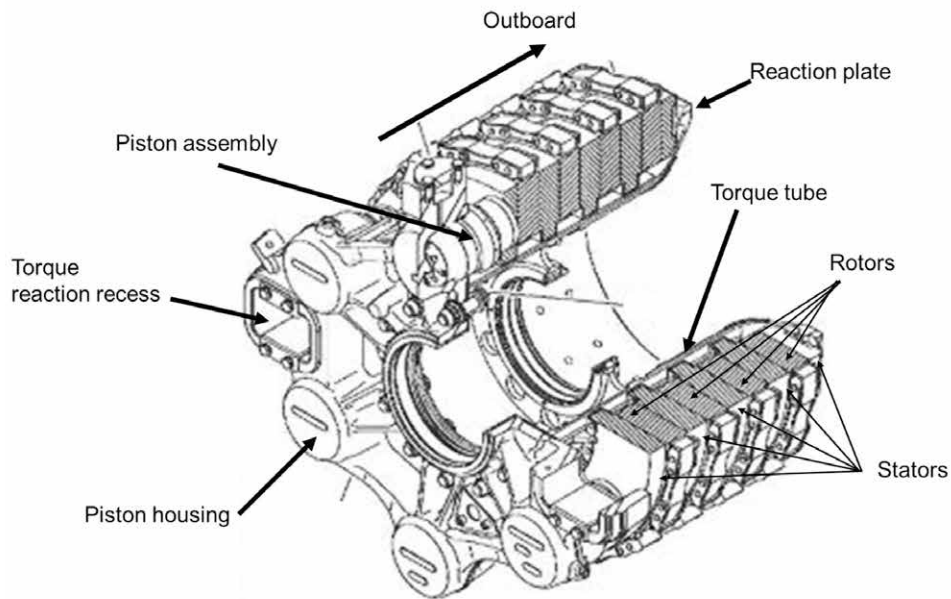
Figure 4
Brake assembly components

The torque tube and reaction plate, which constitute the main frame of the brake pack, are fixed to the lower part of the landing gear axle boss (Figure 4). A set of friction stators are positioned on the outside and between each of the rotors and are prevented from rotating by locking in ridges radially spaced around the torque tube.

When hydraulic pressure is applied to the brake pack, a set of six pistons, equally spaced around the brake housing, impart a compressive force against the reaction plate on the end of the torque tube. This creates a braking effect between the rotors and stators. The brake reaction loads are imparted into the landing gear structure via the torque reaction recesses.
