ACCIDENT

Aircraft Type and Registration:	Colibri MB2, G-BUDW	
No & Type of Engines:	1 Volkswagen 1834cc piston engine	
Year of Manufacture:	1992 (Serial no: PFA 043-10644)	
Date & Time (UTC):	15 December 2019 between 1228 and 1328 hrs	
Location:	Northfield Farm, Spilsby, Lincolnshire	
Type of Flight:	Private	
Persons on Board:	Crew - 1	Passengers - None
Injuries:	Crew - 1 (Fatal)	Passengers - N/A
Nature of Damage:	Aircraft destroyed	
Commander's Licence:	Private Pilot's Licence	
Commander's Age:	55 years	
Commander's Flying Experience:	1,300 hours (of which 221 were on type) Last 90 days - 11 hours Last 28 days - 1 hour	
Information Source:	AAIB Field Investigation

Synopsis

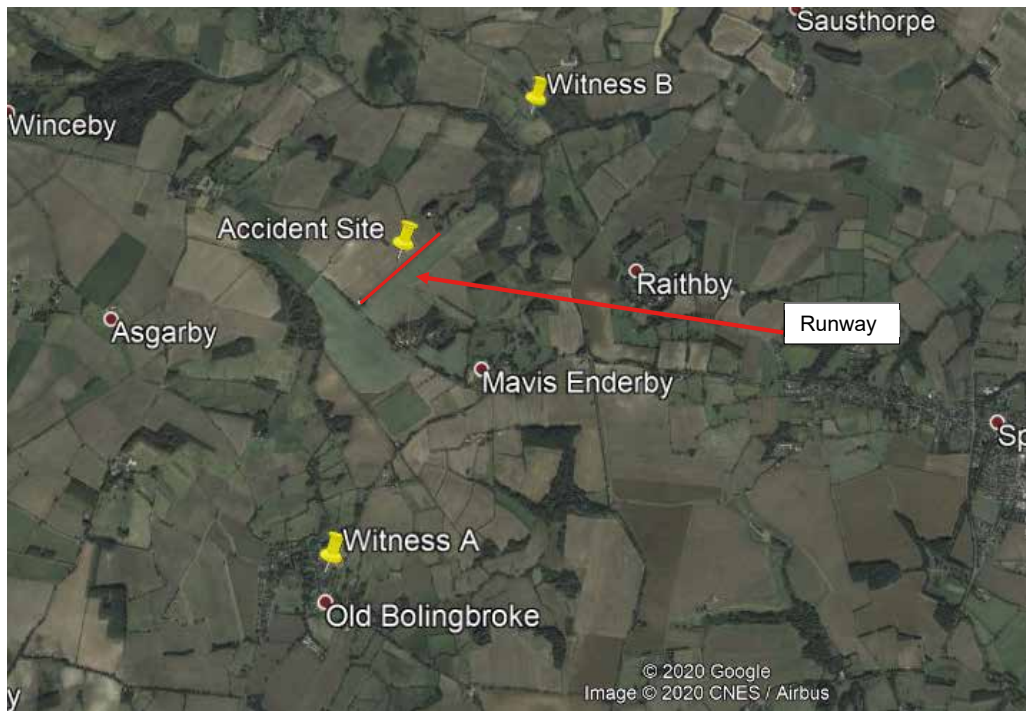
Figure 1
Location of witnesses

Two other people witnessed parts of the aircraft's flight. One witness, who was to the south of the airfield (Figure 1 - Witness A), saw the aircraft track east to west then saw it turn to the north. He reported the engine sounding rough, describing it as "stuttering a bit" and making a "putt, putt, putt" sound. A second witness, to the north-east (Figure 1 - Witness B) of the airfield reported hearing the aircraft starting its takeoff. He reported that the aircraft sounded "lovely, smooth and sweet".

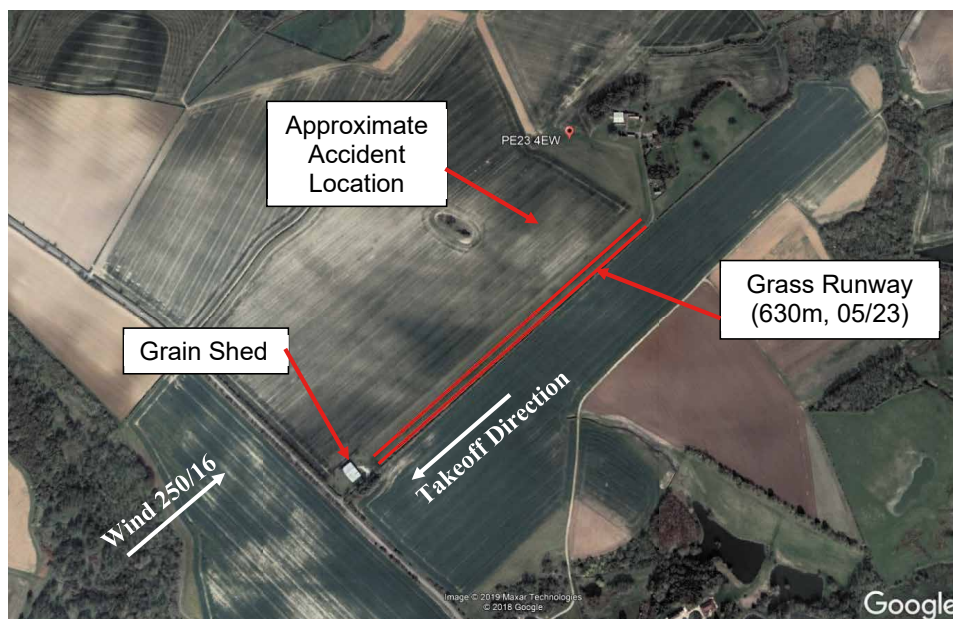
Figure 2
Farm strip showing the accident site location

The aircraft wreckage was discovered approximately 50 m to the north of the grass runway and from the ground marks it was apparent that the aircraft was heading in a south-south-westerly direction. The accident site was hidden from the grain shed due to the ground rising and falling around the midpoint of the runway.
