Report on the investigation of
the collision between two
fire and rescue service boats
resulting in one fatality

River Cleddau, Milford Haven, Wales

17 September 2019

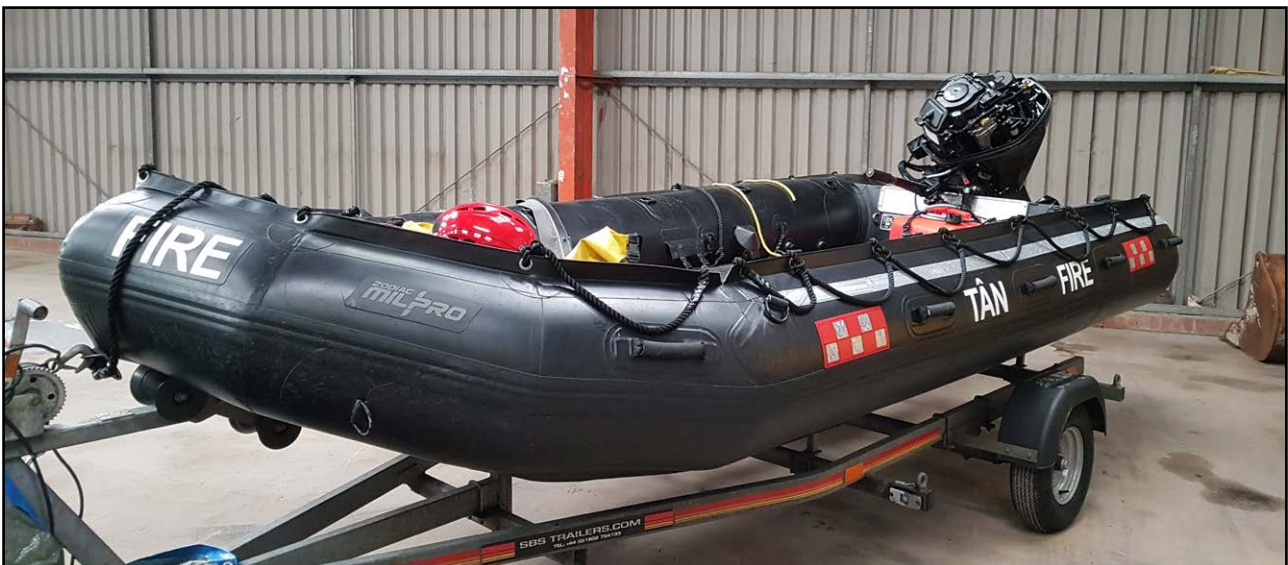
Figure 1: *N207* (Zodiac Milpro FC470)

The Mid and West Wales Fire and Rescue Service (MWWFRS) was required by Welsh Assembly legislation to provide a flood rescue service within its operational area. Its Milford Haven fire station had two rescue boats: a 4.7m Zodiac Milpro inflatable boat, callsign N 207 (*N207*) (**Figure 1**), which was used principally for flood rescue; and a 6.4m Delta rigid inflatable boat (RIB), callsign Rescue 1 (*Rescue 1*) (**Figure 2**), which was used primarily to assist firefighters in the event of an emergency at the local oil and gas terminal jetties.

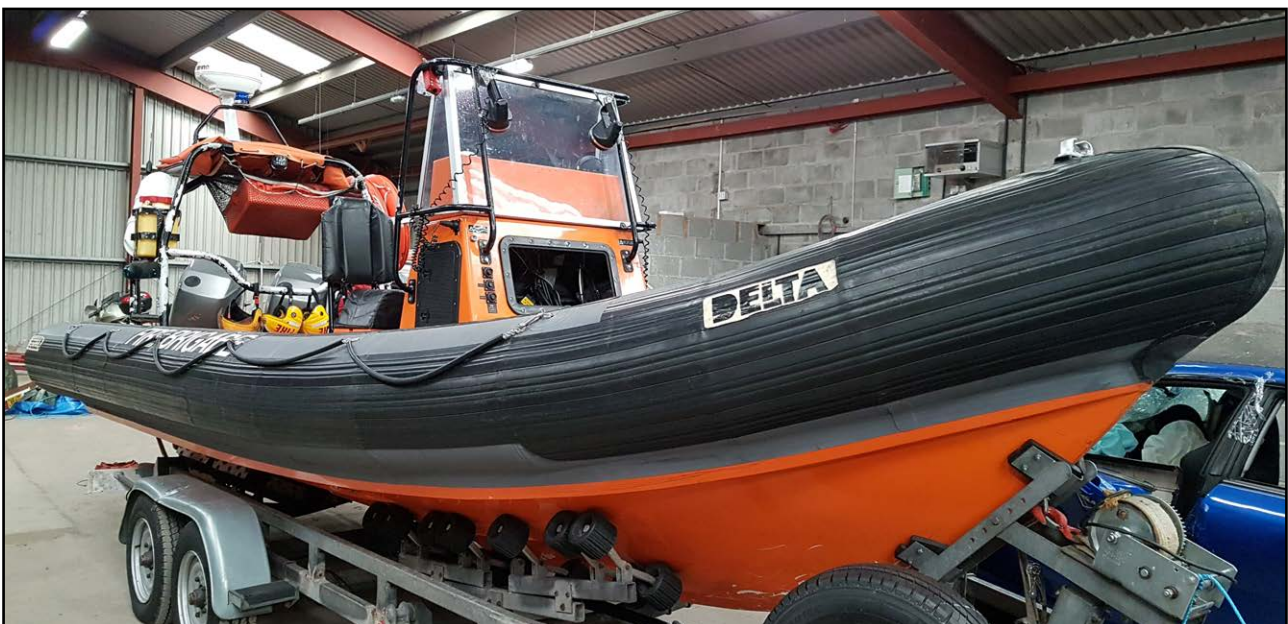
Figure 2: *Rescue 1* (Delta 6.4 RIB)

Rescue 1 was a Delta 6.4m RIB that came into service with MWWFRS in 2001 to replace a boat that had come to the end of its service life. It was fitted with twin 90hp two-stroke engines, which were not fitted with propeller guards, and was stored on a trailer at the fire station. The engine throttles and gauges were to the right of the steering wheel in the middle of the console in front of the crew (**Figure 7**). A large windscreen was mounted on top of the console, which was surrounded by a tubular framework (**Figure 8**). When standing astride the boat's jockey seat, the helmsman's view was not obstructed by the windscreen and framework. However, when standing, the helmsman partially obstructed the seated crewman's field of view to port.

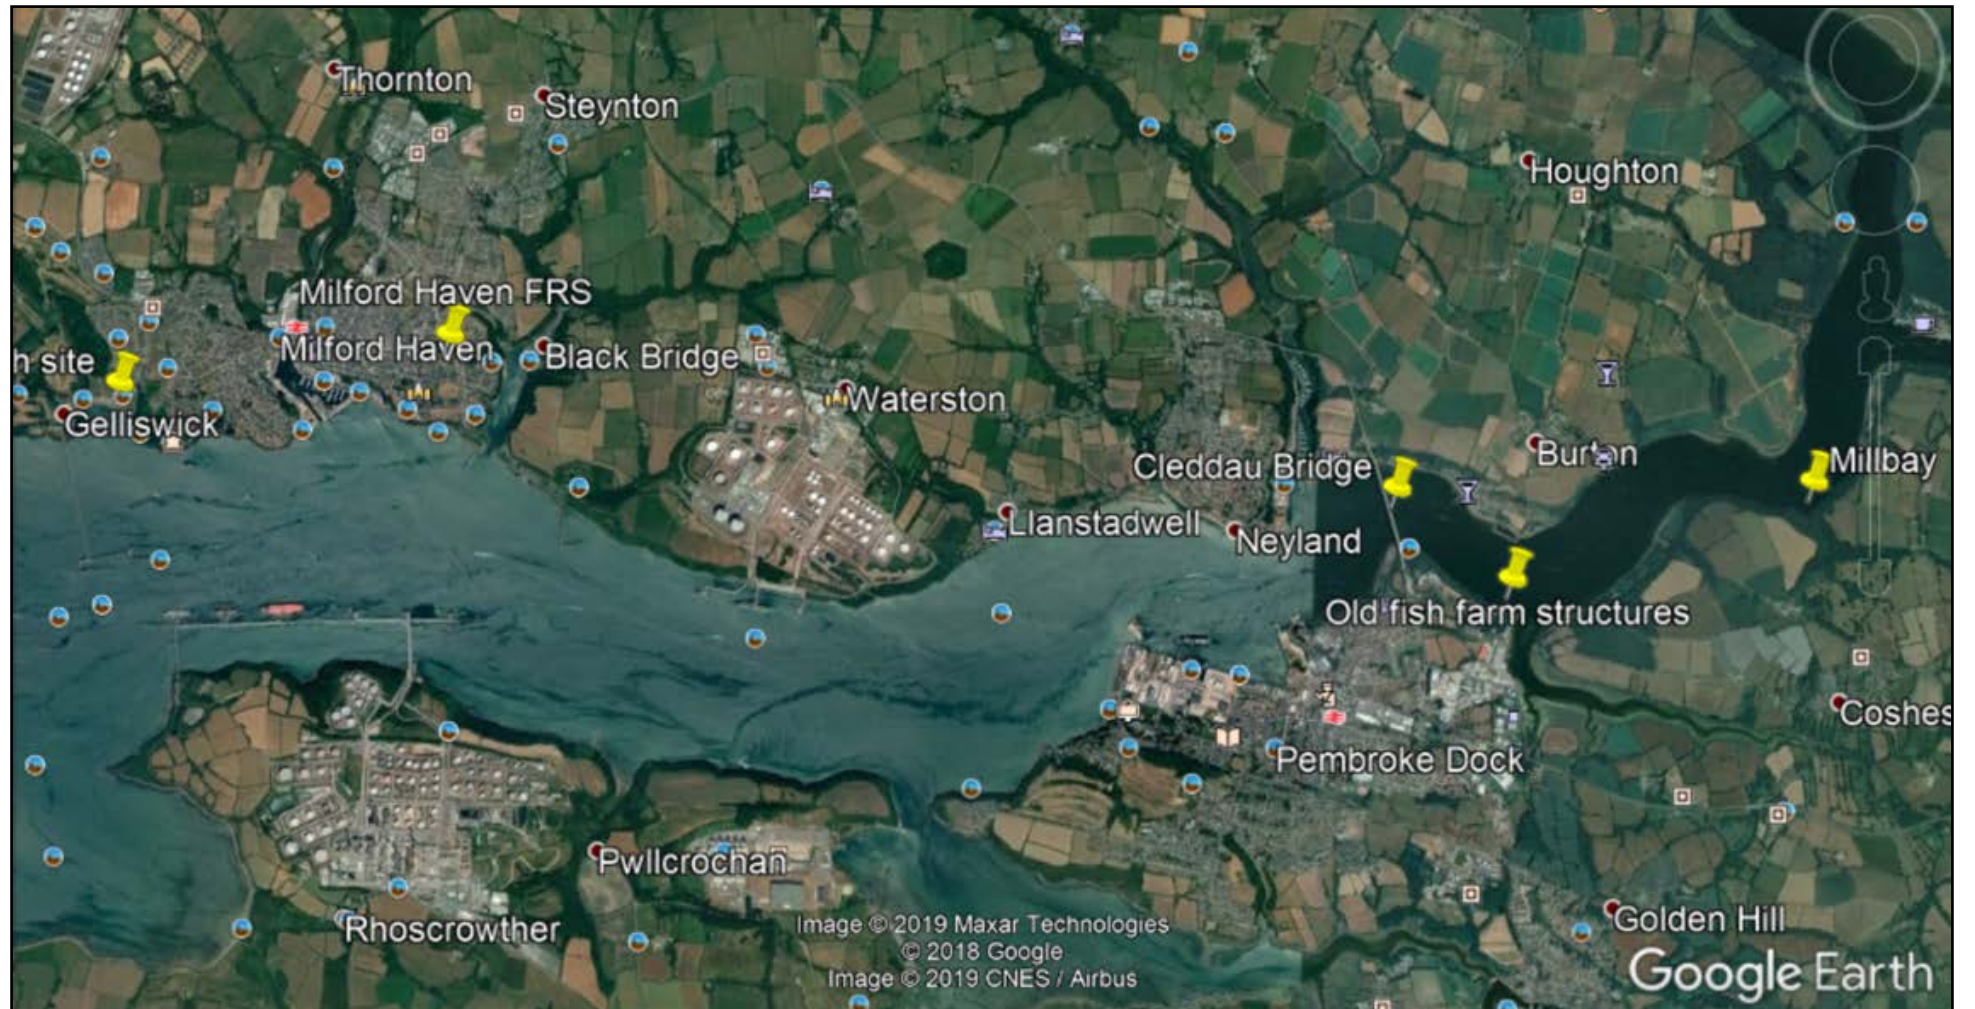
Figure 3: Milford Haven and River Cleddau

N207 was made ready at the fire station, then towed down to a launch site at Gelliswick (**Figure 3**). When they arrived, the three firefighters donned their dry-suits, boots and Palm Rescue 800 buoyancy aids. The boat was equipped with Nitro XT water safety helmets, but they were not worn by the crew. At 0938, the firefighters launched and boarded *N207*. One of the firefighters secured the engine kill-cord to his wrist and took the helm; the trainer positioned himself in the middle of the boat and the other firefighter sat in the bow. In the meantime, the towing vehicle and trailer returned to the fire station to collect *Rescue 1*.

Rescue 1's helmsman steered the RIB eastwards, under the Cleddau bridge, and met up with *N207* at the disused fish farm structure. During a shouted discussion between the two boat crews it was agreed that each would make their way independently upstream, practising operating the boats at high speed, and rendezvous again at Mill Bay on the south shore (**Figure 3**).
