SERIOUS INCIDENT

Aircraft Type and Registration:	Bombardier BD-700-1A10 Global 6000, 9H-VJM	
No & Type of Engines:	2 Rolls-Royce BR710A2-20 turbofan engines	
Year of Manufacture:	2013 (Serial no: 9630)	
Date & Time (UTC):	11 December 2019 at 0550 hrs	
Location:	Liverpool Airport	
Type of Flight:	Commercial Air Transport (Passenger)	
Persons on Board:	Crew - 3	Passengers - 1
Injuries:	Crew - None	Passengers - None
Nature of Damage:	None	
Commander's Licence:	Airline Transport Pilot's Licence	
Commander's Age:	53 years	
Commander's Flying Experience:	11,506 hours (of which 3,864 were on type) Last 90 days - 104 hours Last 28 days - 48 hours	
Information Source:	AAIB Field investigation

Synopsis

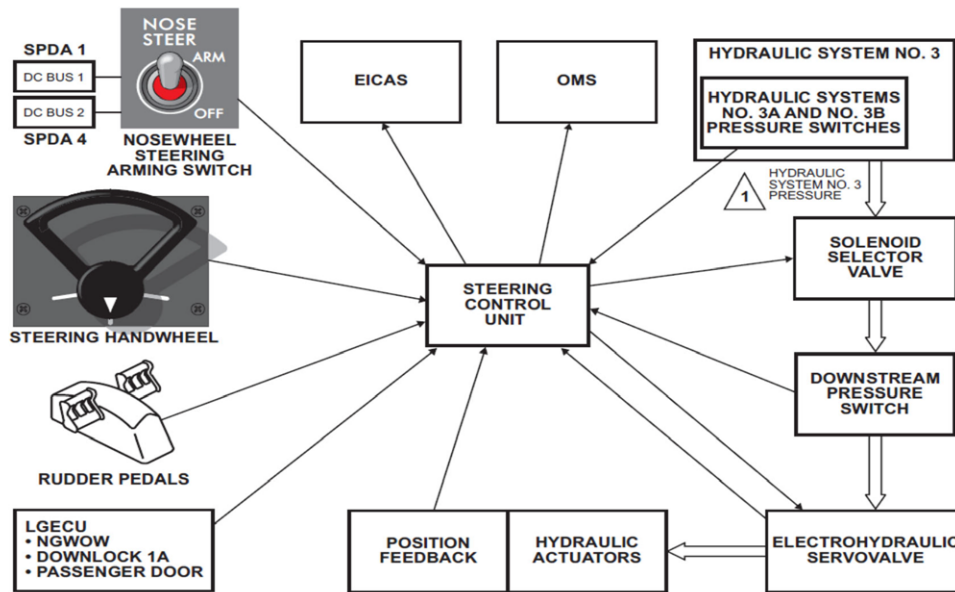
Figure 4
NWS schematic

NWS faults are indicated as NOSE STEER FAIL on the EICAS. A fault code to aid fault diagnosis and rectification can be downloaded from the SCU if required.

The following set of conditions are required for the NWS system to operate using either the rudder pedal or the steering handwheel. The nose landing gear should be down and locked, the weight-off-wheel switches should be 'open'⁴ and the NWS switch set to the ARMED position. Then, providing the BIT is satisfactory, the SCU energizes a solenoid selector valve and hydraulic pressure from the gear down system is reconfigured to provide steering. When a steering input is received from the rudder pedals or handwheel and summed with the feedback signal, an electrohydraulic servo valve (EHSV) allows pressure to the actuators to rotate the nosewheels towards the required position. As this position is approached, the LVDT feedback signal is received by the SCU which then signals a cessation of movement via the servo valve. Figure 4 shows a schematic of the NWS.

With NWS selected OFF, or in a failure condition, the nosewheel reverts to free caster. In this condition, hydraulic pressure is blocked to the actuators, but free flow is provided between the actuator supply and return thus allowing unrestricted actuator piston extension and retraction. Nosewheel shimmy damping is provided through a hydraulic compensator that maintains pressure on both sides of the steering actuators when the steering is off.
