Rail Accident Investigation Branch

Rail Accident Report

Collision and derailment at Neville Hill 13 November 2019

Report 13/2020
November 2020

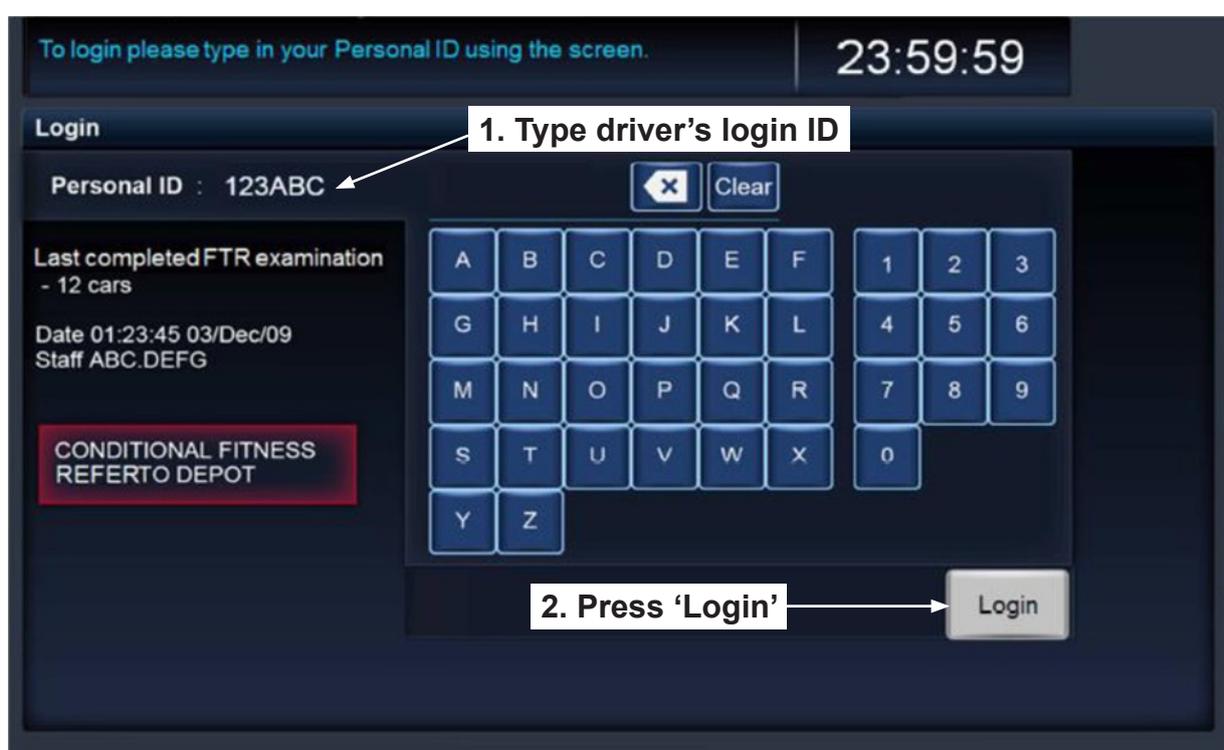
Figure 6: TMS login screen

- 64 When setting up a train for an upcoming journey in the TMS, a driver is presented with a series of screens. The driver enters their driver login ID on the first screen (figure 6) and then the train headcode on the second screen (figure 7). Upon pressing ENTER after typing the headcode, the TMS displays the journey's time, origin and destination stations for the driver to check.

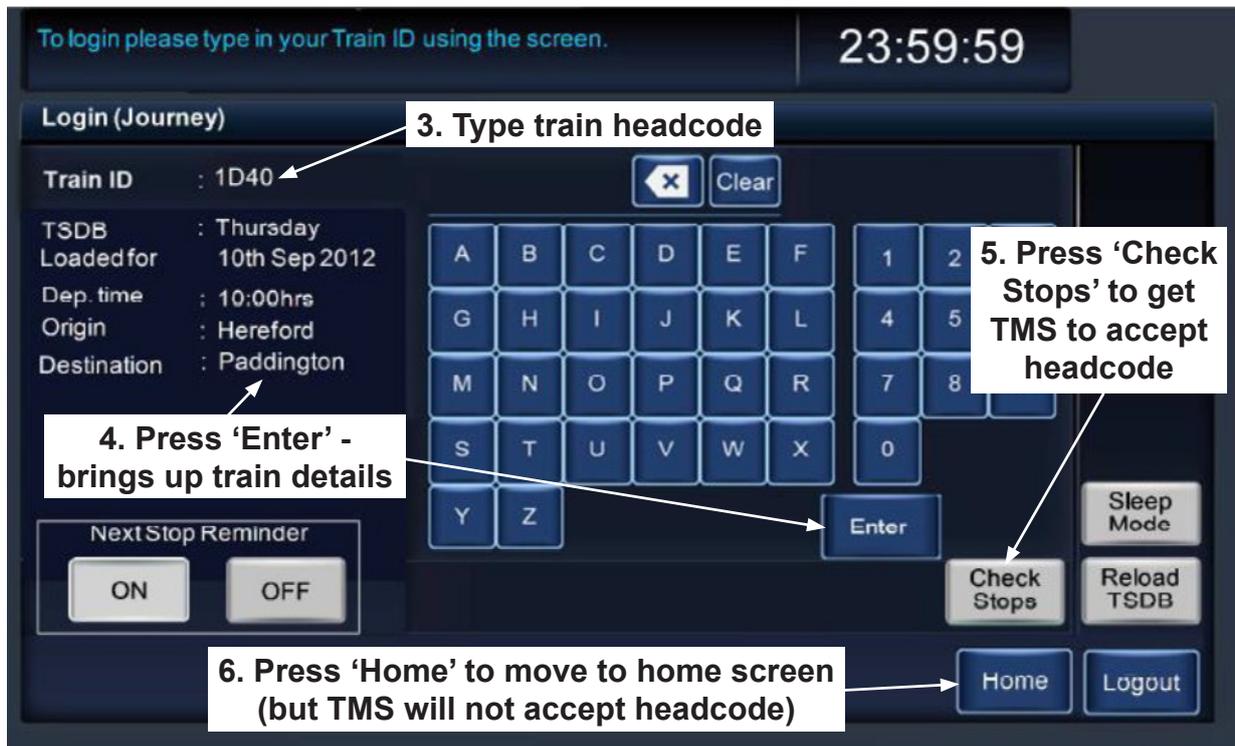
Figure 7: TMS headcode screen

- 65 When satisfied that the correct headcode has been entered, a driver has the choice between two buttons to take the TMS to the home screen, which is the default screen during a journey. The HOME button takes the TMS to the home screen but does not cause the TMS to accept the entered headcode. The CHECK STOPS button takes the TMS to a screen where the driver can check the stops for the intended journey, before reaching the home screen. It is the pressing of this CHECK STOPS button which causes the TMS to accept the entered headcode.

- 66 LNER trained its drivers that pressing CHECK STOPS would allow a driver to check the station stops for the journey ahead. The driver operating instructions identified this as a step in the cab setup process. LNER also trained its drivers that pressing HOME on the headcode screen would take the TMS to the home screen with the headcode having been accepted. This was the method used by the driver on the night at Leeds station. LNER did not understand that CHECK STOPS had to be pressed for the headcode to be accepted.

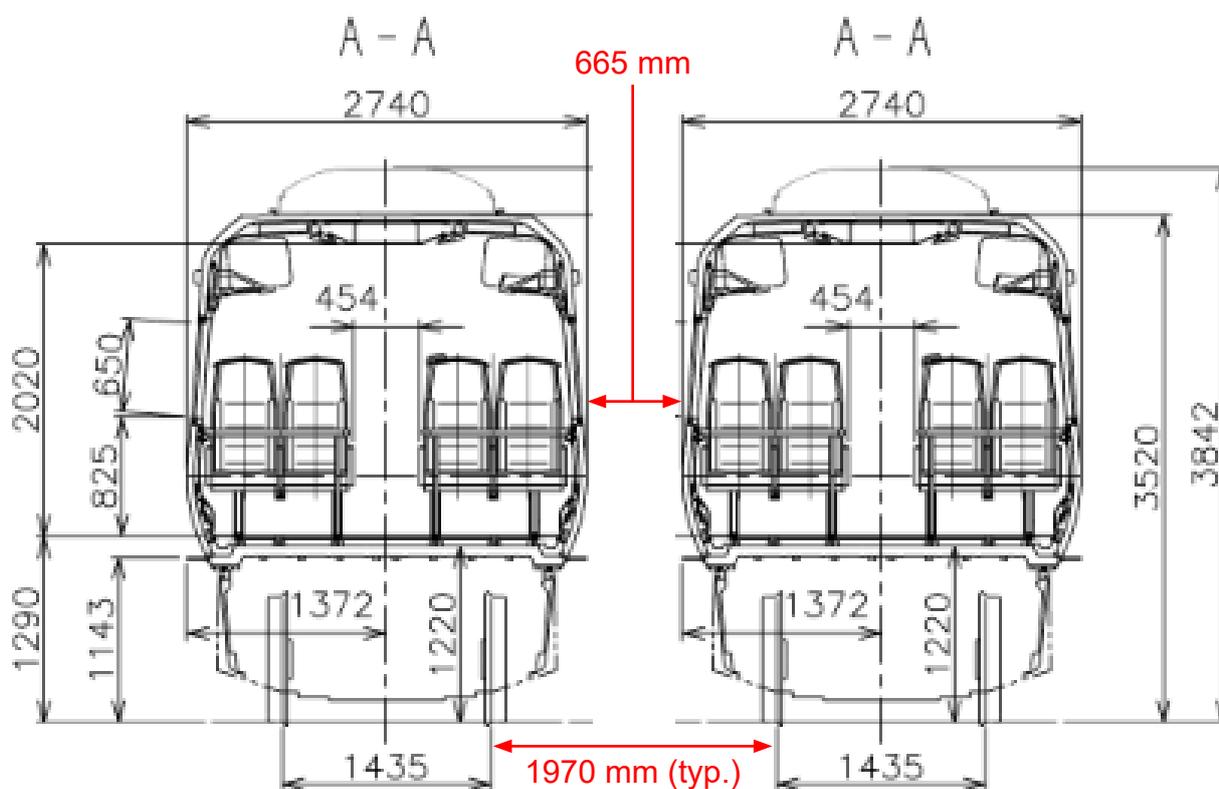
Figure 10: Typical passing clearance between two IETs on adjacent tracks

89 The trailing bogie of the second and third vehicles and the trailing wheelset of the fourth vehicle on the IET, derailed to the right in the direction of travel as a result of the collision. Figure 9 shows the lateral movement of the vehicles during the collision as witnessed by the marks left by the couplers on the vehicle structures. The extent of the derailment (up to 1.25 metre of lateral displacement on the second vehicle) would have been sufficient to significantly infringe the swept path of a vehicle travelling on an adjacent line, assuming a typical gap between adjacent running lines (known as the 'six-foot'), as shown in figure 10.

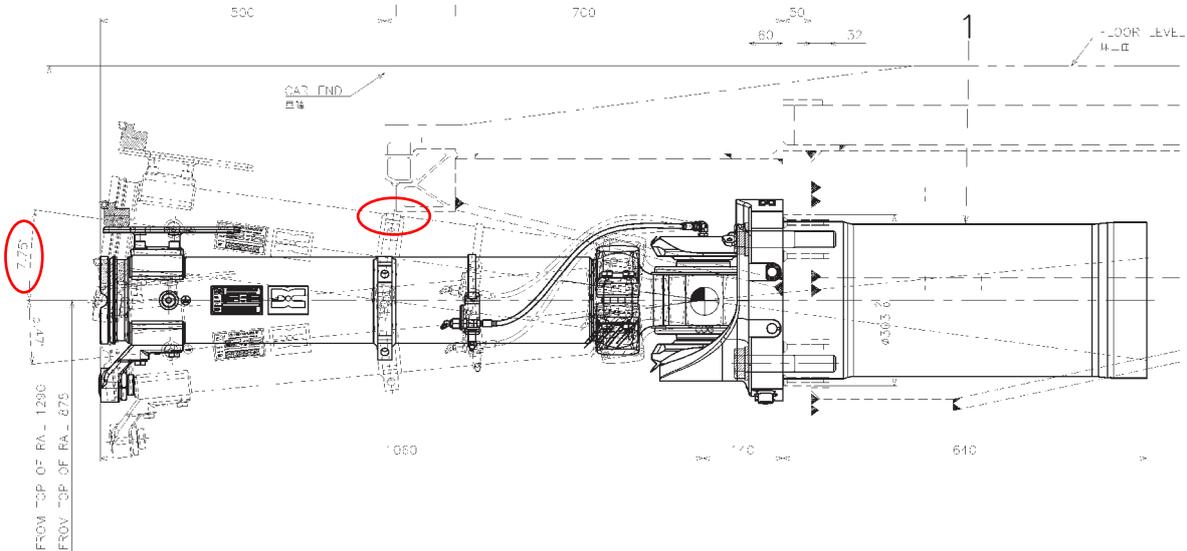
Figure 11: Coupler pitch up movement and limit due to coupler contacting the carbody (courtesy of Hitachi)

- An inter-vehicle coupler on an IET can pitch unrestrained until either of the following occurs: the coupler shank contacts the vehicle structure (figure 11), or contact between parts of the coupler itself prevents further movement. However, when a coupler starts to collapse, internal contact reduces the freedom of movement in pitch (figure 16). The representation of the inter-vehicle couplers was improved to model this variable restraint (figure 12).

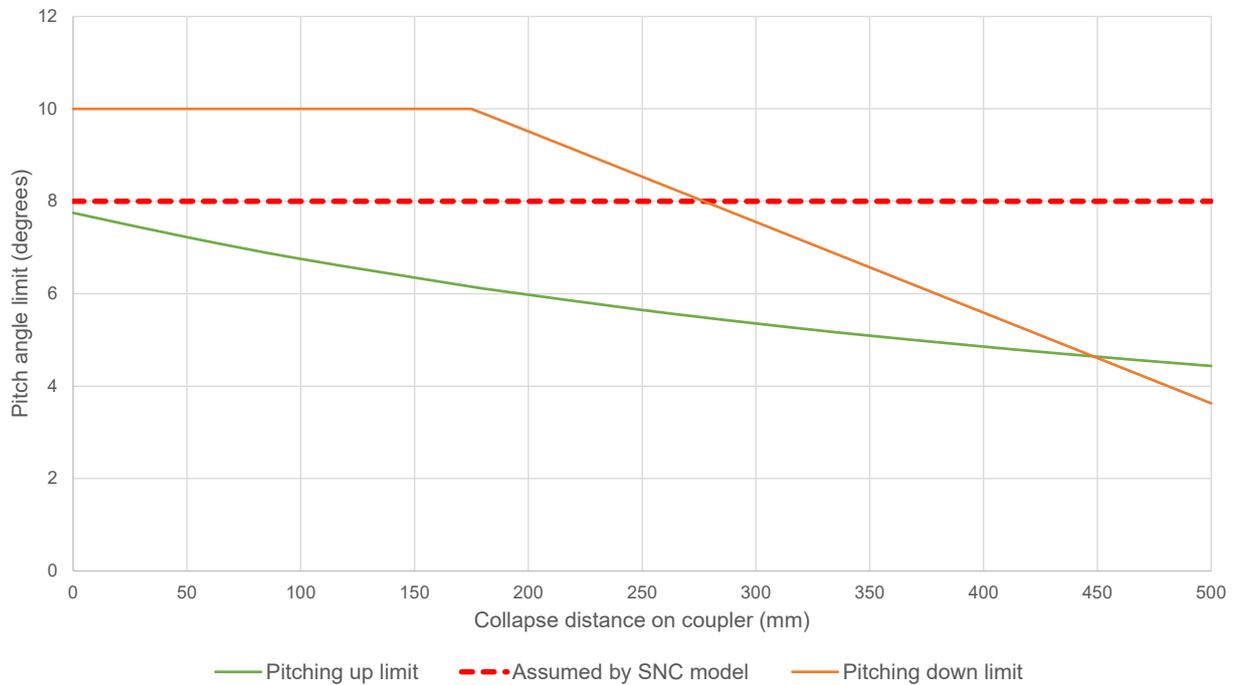
Figure 12: Graph showing how the pitch limits change as the inter-vehicle coupler collapses¹²

¹² Each coupler half can collapse by up to 500 mm. The inter-vehicle gap is 1000 mm.

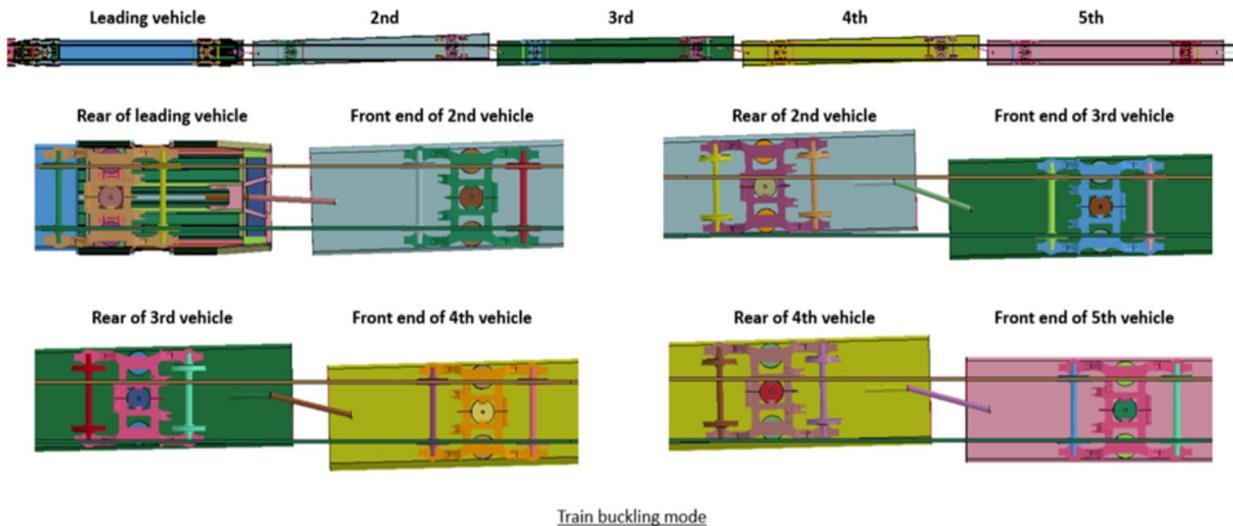
Figure 14: Output from collision and derailment simulation – bird's eye view (courtesy of Hitachi)

- 98 Figure 13 shows the results from the 3D simulation at the relative collision speed of 10 mph (16 km/h). The amount of deformation on the class 43 power car and at the leading end of the IET was checked to ensure that it was representative of what had been experienced during the accident. As shown on figure 13, the trailing bogies of vehicles 2, 3 and 4 on the IET were predicted in the simulation to lift up above the railhead during the collision.
- 99 Figure 14 shows the predicted lateral displacement on the first five vehicles. The trailing bogies of vehicles 2, 3 and 4 were predicted in the simulation to derail to the right during the collision. Vehicle 5 was predicted to remain guided by the rails.

100 The Hitachi 3D model predicted that the leading couplers of the HST and IET would deflect each other sideways during the collision. This generated yaw movement on the leading vehicle which was then transferred to the other vehicles. Overall, the Hitachi 3D model predicted vertical and lateral displacements on all vehicles which were consistent in magnitude and direction with the observations on site.
