Aircraft Type and Registration:	Boeing 737-8K5, G-TAWG	
No & Type of Engines:	2 CFM CFM56-7B27E turbofan engines	
Year of Manufacture:	2012 (Serial no: 37266)	
Date & Time (UTC):	24 December 2019 at 0048 hrs	
Location:	Manchester Airport	
Type of Flight:	Commercial Air Transport (Passenger)	
Persons on Board:	Crew - 6	Passengers - 181
Injuries:	Crew - None	Passengers - None
Nature of Damage:	Bearing failure, separation of No 4 (right outer) mainwheel and severe damage to the associated brake unit	
Commander's Licence:	Airline Transport Pilot's Licence	
Commander's Age:	41 years	
Commander's Flying Experience:	6,709 hours (of which 246 were on type) Last 90 days - 68 hours Last 28 days - 27 hours	
Information Source:	AAIB Field Investigation

Shortly after a normal touchdown, the right outer (No 4) mainwheel separated from its axle and was seen, by the pilots, to pass down the right side of the aircraft. The aircraft vacated the runway and was safely brought to a halt on the taxiway. The wheel separated as a result of a failure of the inboard wheel bearing which led to the failure of the outer bearing. The exact cause of the initial failure to the inboard bearing could not be determ

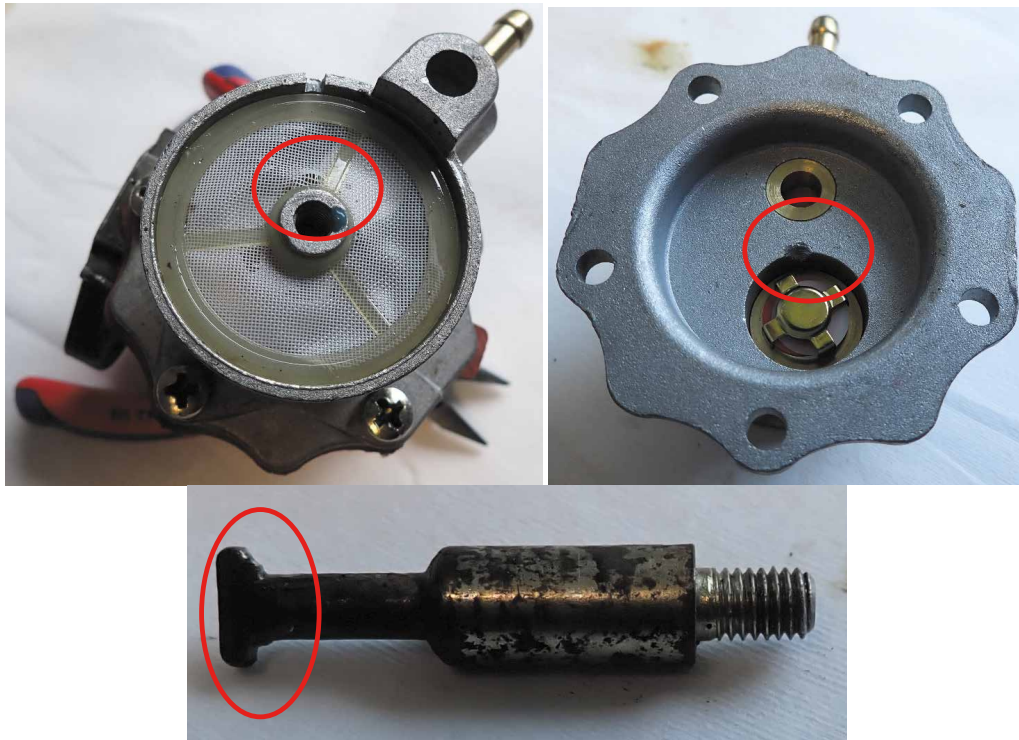
Figure 6

The mechanical fuel pump was driven by an auxiliary engine shaft and quill drive. It was a diaphragm pump and records show that the diaphragm and springs were replaced in August 2018. The pump and the fuel priming system functioned correctly and there was a small quantity of fuel remaining in the pump. An internal filter mesh had a small tear (Figure 6 left), it is thought probable that this happened during removal of the mesh when the pump was overhauled. The drive components were examined and found to be worn (Figure 6 lower) to the extent that part of the pump had clashed with the housing (Figure 6 right). This would have limited the volume of fuel pumped on each stroke.

Mechanical fuel pump –
Filter damage, housing damage and drive component wear

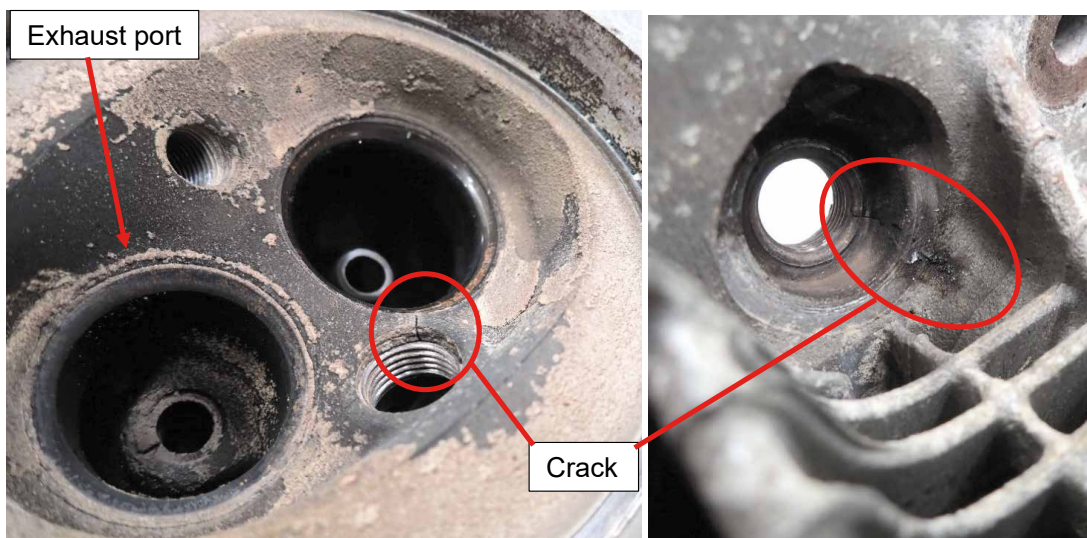
Figure 12

The valve seats were examined, and it was noted in cylinder 2 there were crushed light brown deposits on the valve seat sealing face and in the exhaust port. A crack was identified between the inlet port and the larger spark plug hole (Figure 12) with carbon deposit on the exterior surface. All spark plug holes had a helical threaded insert fitted.

Deposits and crack in cylinder 2

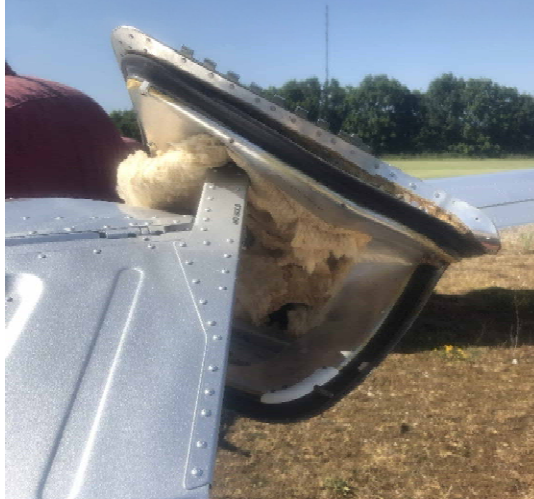
Figure 2

Baggage door on the tailplane right tip, as found after landing, looking forward

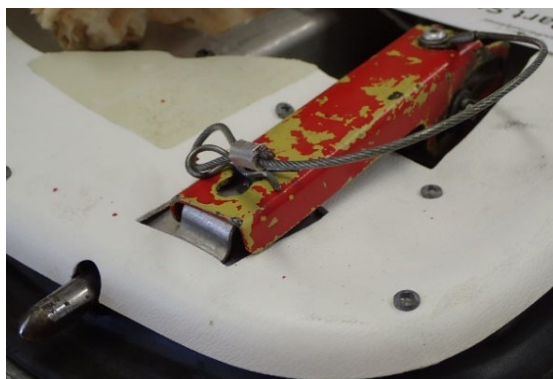
Figure 3

Internal emergency handle correctly closed and secured by secondary locking clip
(Image shows accident door, placard and cover are missing)

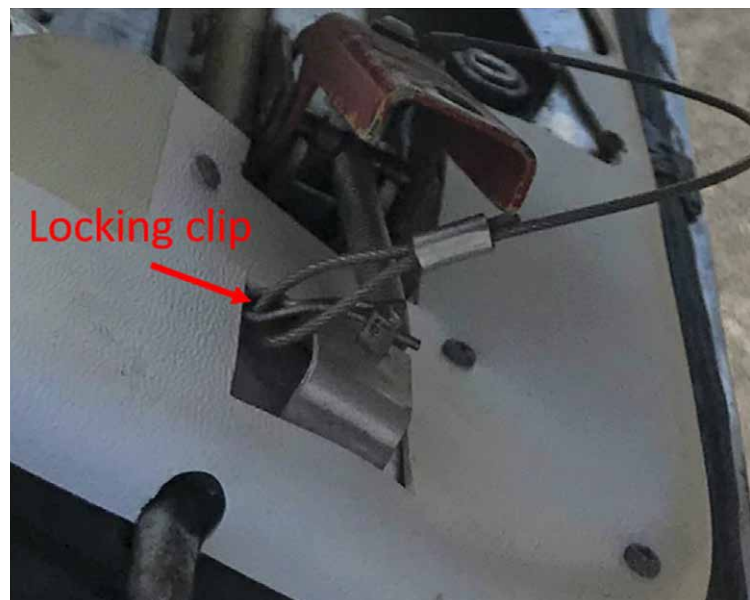
Figure 6

The internal handle had the secondary locking clip installed in the clevis pin, but this was installed under the handle rather than over it, so it did not provide a secondary locking feature. The locking clip is also bent suggesting the handle had been forced down on to the locking clip onto the locking clip (Figure 6). This may have made it appear as though the operating handle was in the correct closed position.

Closer inspection of the clevis pin found that it was loose in its mounting plate rather than the push fit specified. This meant that it was free to drop down which made it impossible to install the locking clip until it had been lifted to the correct position.

Bent locking clip and partially open internal handle

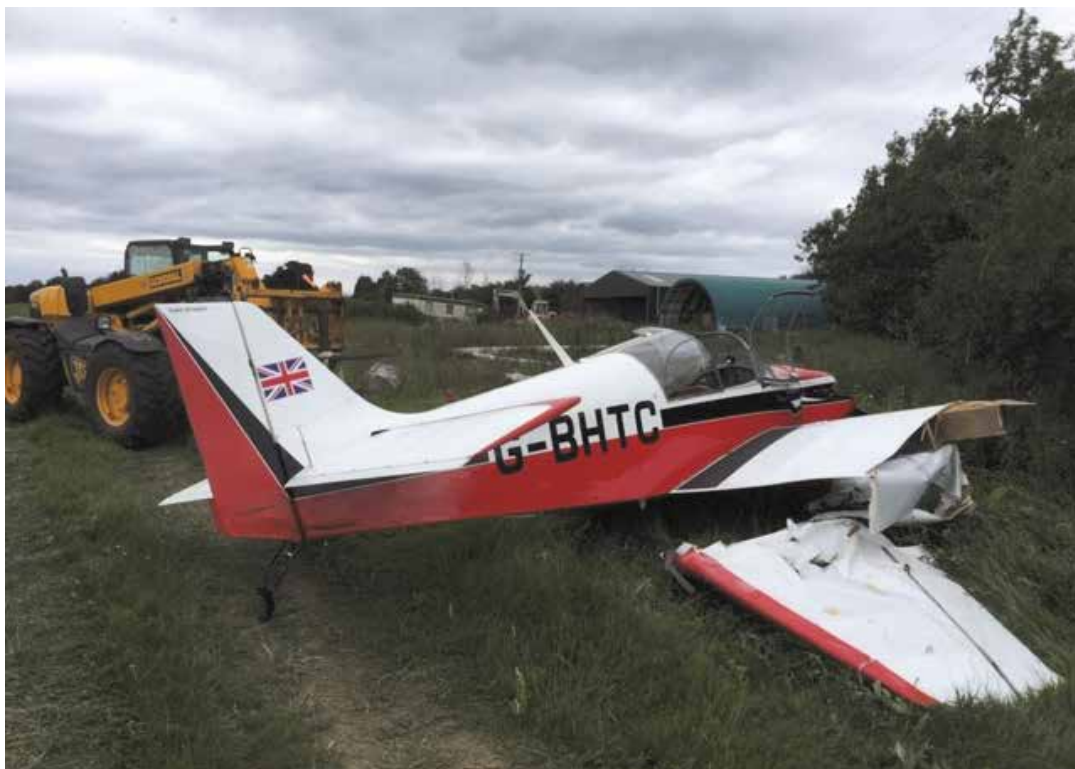
Figure 1

However, at about two metres agl, the aircraft rolled 30° to the right and, despite rapid application of stick and rudder, the aircraft contacted the ground and bounced upwards about one metre, and the right main wheel rolled over the left edge of a rubble bank at the side of the runway. Directional control had then been lost and the right wing hit a large bush. The impact broke the outer cranked portion of the right wing off (Figure 1), the aircraft swung to the right and came to a stop. Neither of the crew were injured, the aircraft was made safe and they were able to vacate the aircraft normally. Inspection of the aircraft found that the left main spar, fuselage and propeller had also been damaged.

Damage to the right wing

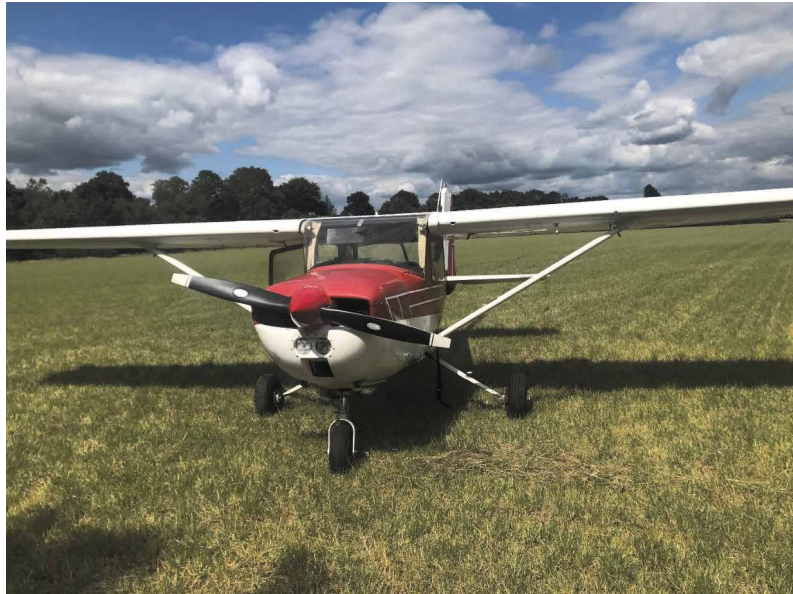
Figure 2

After landing no fuel could be seen visually in either fuel tank. It was subsequently discovered that the dipstick the pilot had used was calibrated for a Cessna 172 so showed a greater quantity of fuel than was actually present.

G-CSBM after the precautionary landing

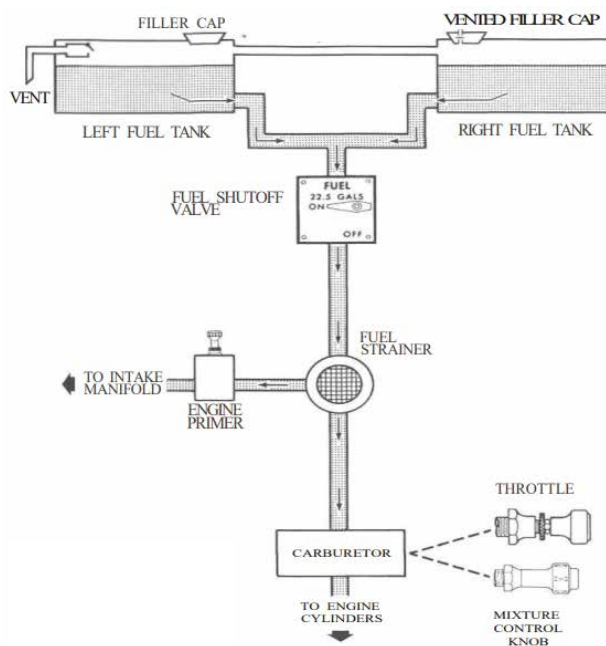
Figure 3

The Cessna 150 has two interconnected fuel tanks, one in each wing. Fuel is gravity fed to the engine (Figure 3). The tanks can hold 26 US gal of fuel but 3.5 US gal is unusable, giving a total usable capacity of 22.5 US gal.

Although the fuel tanks are interconnected, it was reported that it is not uncommon for the fuel to be imbalanced after flight. This can be caused by several banked turns in the same direction prior to landing causing the fuel to migrate to one side.

Cessna 150 fuel system

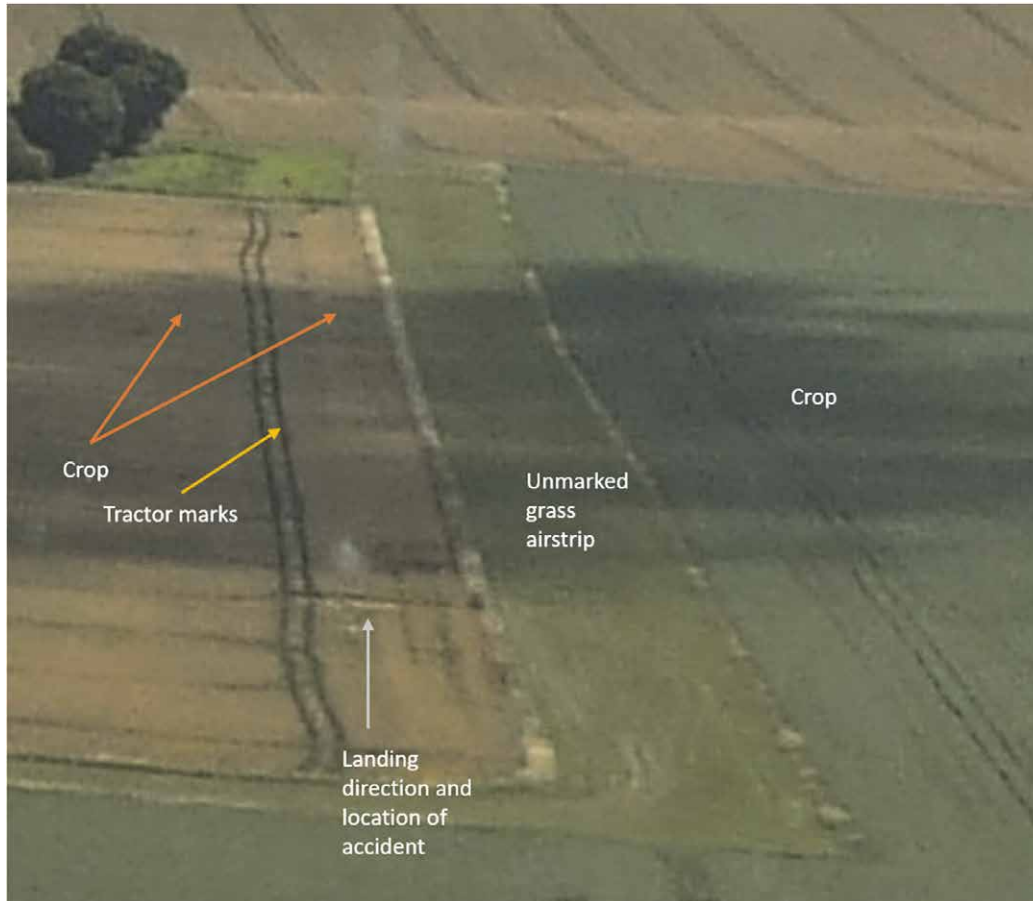
Figure 1

overhead may have reduced the contrast between the grass strip and the crops, contributing to the reduced conspicuity of the grass airstrip.

The approach to the grass airstrip;
(picture taken the following day)

The pilot reported that the runway has since been marked out with white chalk lines.

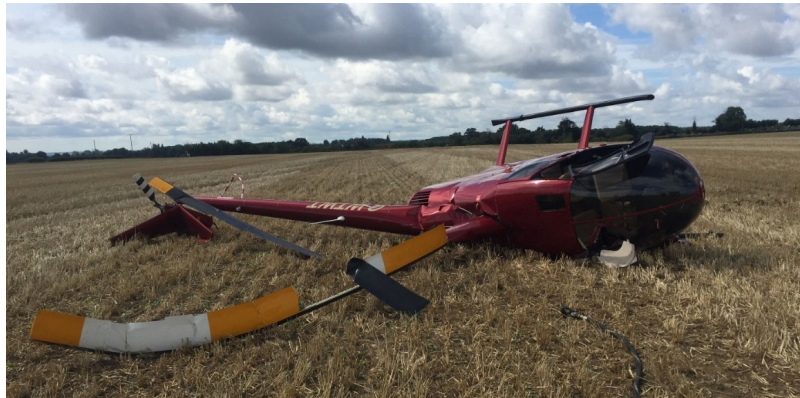
Figure 2

The helicopter stuck the ground with the right skid first. The skid dug in and the helicopter rolled onto its right side (Figure 2). The pilot and front seat passenger were able to climb out of the left front door and helped the two rear seat passengers exit. Emergency services arrived shortly afterwards.

G-WTWT after the accident

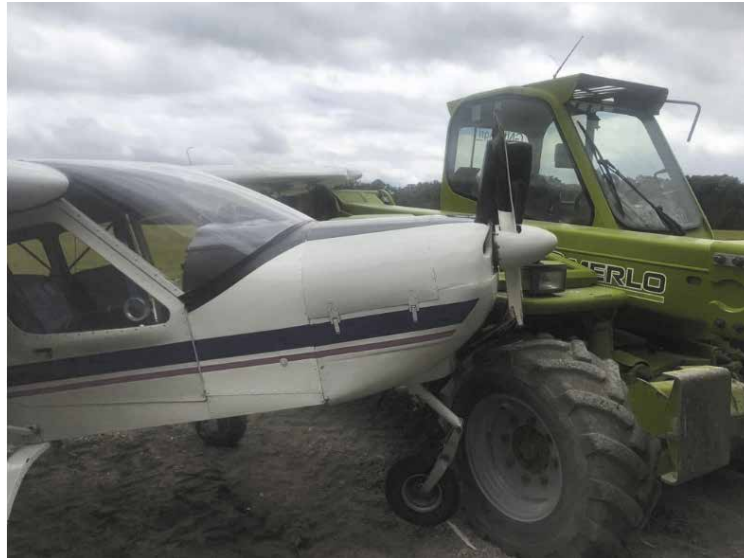
Figure 1

Whilst taxiing back to the hangar, the left wing struck a stationary telehandler parked alongside the taxiway. The aircraft pivoted to the left and came to a stop wedged against the telehandler (Figure 1). The impact dented the left wing leading edge near the wing tip, displaced the wing and distorted the flap. The propeller was severely damaged, and the lower engine cowl was dented. The pilot and a construction worker, who was standing close to the telehandler at the time, were uninjured.

Aircraft and telehandler following the collision
