HMS Daedalus, Lee-on-Solent Land Quality Assessment

Phase Two: Radiological Investigation
Project No 05502

Draft Report

8 April 2003

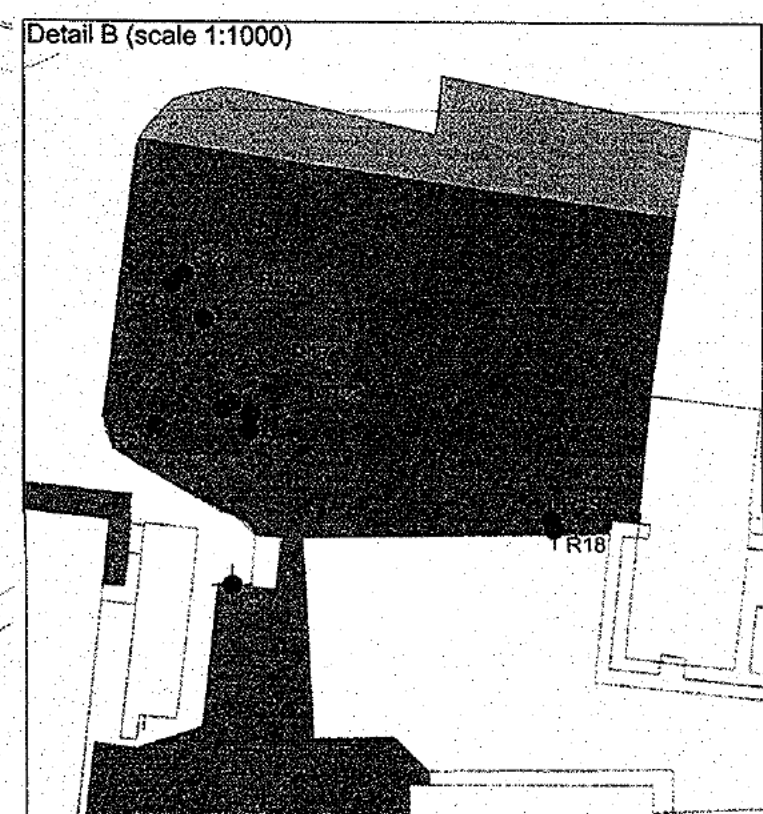
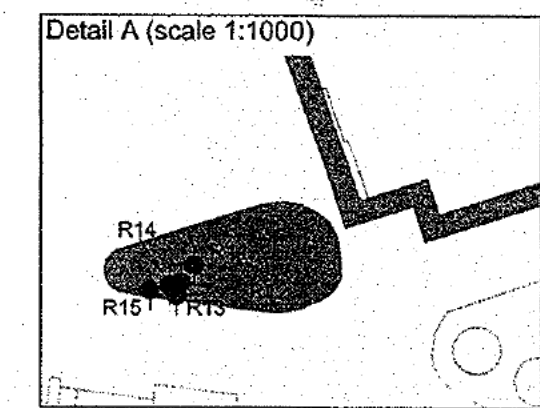
I.D. Point	Count Rate (c.p.s)	Comment/ Location
R1	530	Former burning zone
R2	2400	Former burning zone
R3	307	Adjacent to hanger side door, suspected to be point
R4	340	Near to hanger, suspected to be point
R5	350	Building 289 point source
R6	750	Building 289 point source
R7	358	Building 289 point source
R8	380	Building 289 point source
R9	278	Between building 291 and 301, elevated above background and change topography/veg possible buried waste
R10	900	Building 68 point source
R11	1188	Corner of building 73 in grass verge.
R12	1500	Point sources
R13	1200	
R14	3000	
R15	1200	
R16	300	Corner of building 73 in small soil mound, possibly arising from service trench nearby.
R17	530	Grass area near building 134 point sources.
R18	1075	
R19	900	
R20	450	
R21	550	
R22	600	
R23	330	
R24	330	Grass area near building 134 point sources
R25	200	
R26	1400	
R27	215	Possible point sources at depth
