RADIATION WALKOVER SURVEY AT DAEDALUS

19 APRIL 2017 COMMERCIAL IN CONFIDENCE

Report Title:	Radiation walkover survey at Daedalus		
Customer Contact:	Reg 13(1) Campbell Reith		
	Raven House,		
Customer	29 Linkfield Lane,		
Address:	Redhill, Surrey		
RH1 1SS			
Telephone:	: 01737 784 500		
Date:	09/05/17		
Reference:	AHP/CMB/REP/17/01		
Please Contact:	Reg 13(1)		
Telephone: Reg 13(1)			
Mobile:	Reg 13(1)		
Email: Reg 13(1)@aurorahp.co.uk

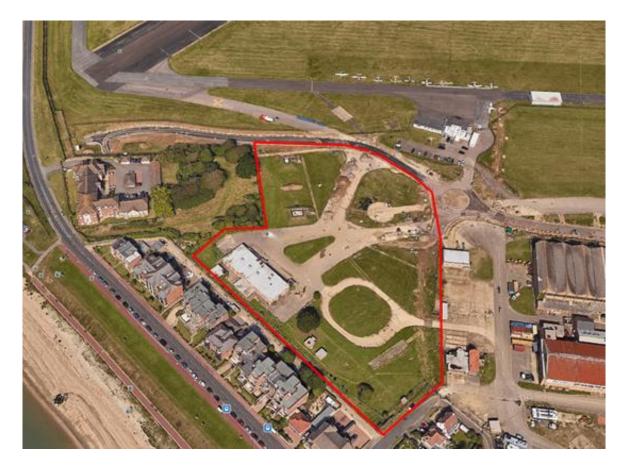
Figure 2. Plan view of the area surveyed within red line boundary.

The survey collected 34,586 data points ranging between 92 and 434 counts per second (cps). The average reading on the site was 241 cps with a standard deviation of 50 cps. There were no areas of the site with statistically significant elevated count rates. The results of the RadSurvey can be seen as a surface picture in Figure 3.
