Report on the investigation of  
the enclosed space accident  
on board the fishing vessel  
***Sunbeam (FR487)***  
in Fraserburgh, Scotland  
on 14 August 2018  
resulting in one fatality

*Sunbeam (FR 487)*

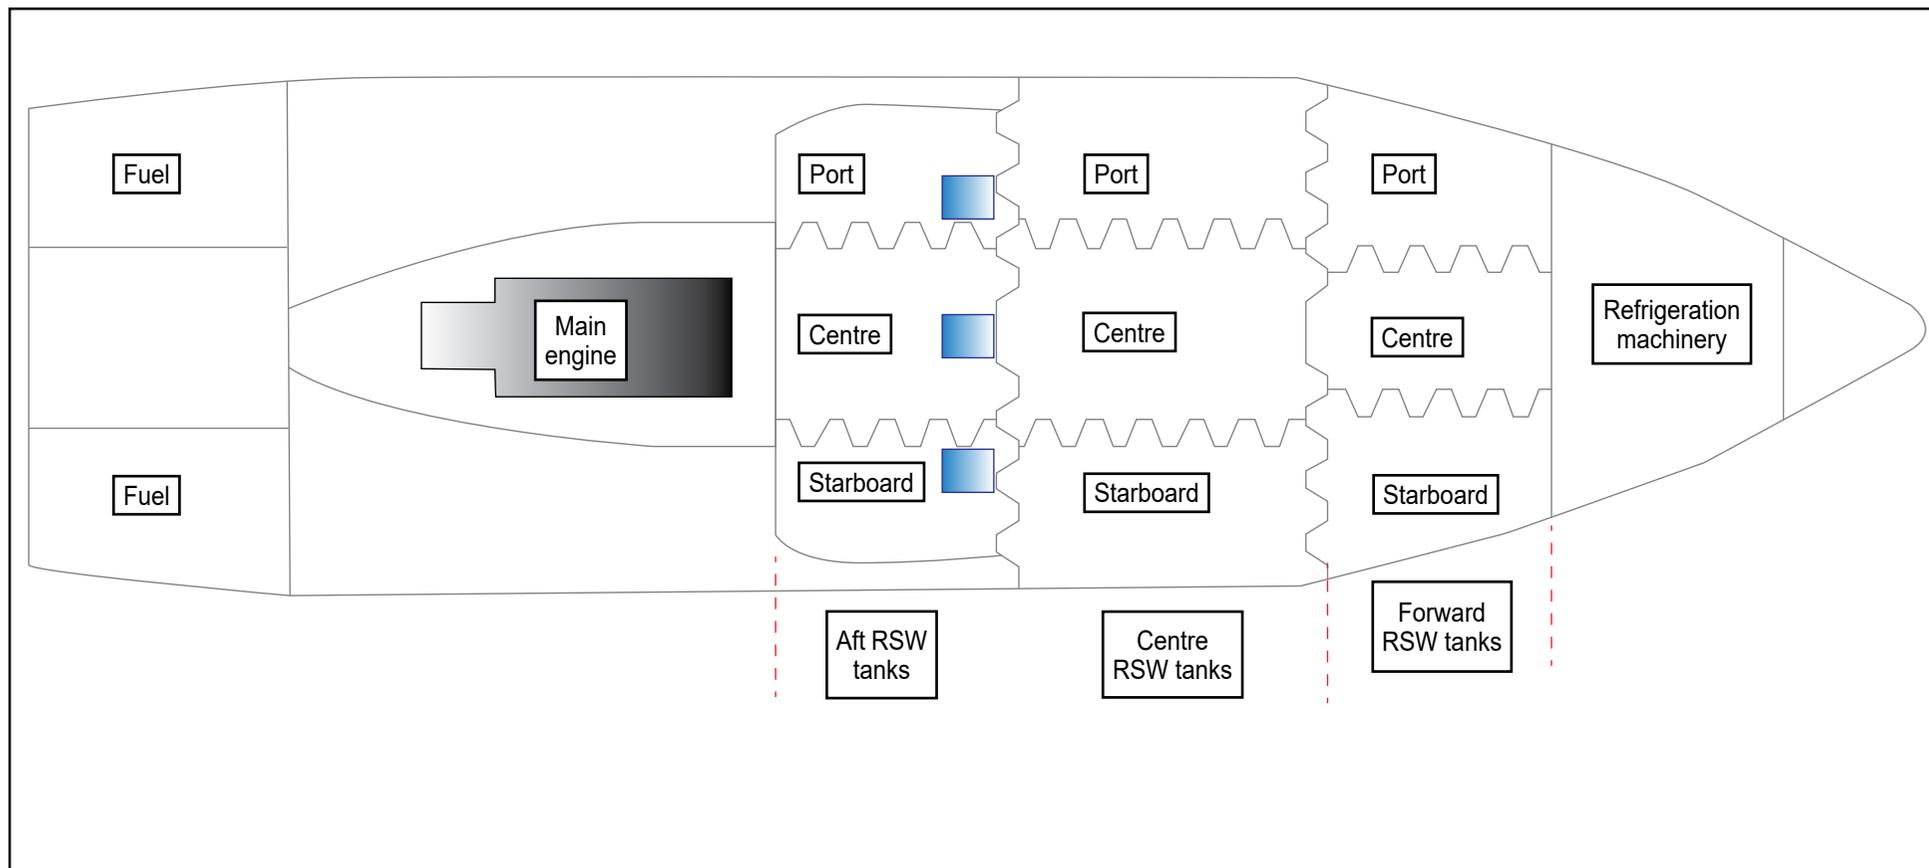
**Figure 1:** *Sunbeam* - general arrangement showing the layout of RSW tanks, access hatches and the refrigeration plant forward

*Sunbeam*'s nine RSW tanks were arranged in three rows forward to aft (**Figure 1**). The tanks' purpose was to store and preserve caught fish in chilled water. The aft centre RSW tank had an internal volume of approximately 154m<sup>3</sup>. There was no forced ventilation in the RSW tanks, and each had a single point of entry / exit at main deck level (**Figure 2**). Seawater for the RSW tanks was chilled by two refrigeration plants. The RSW system (**Figure 3**) functioned as follows:

*Sunbeam* was fitted with two refrigeration plants in a dedicated compartment forward of the RSW tanks (**Figure 1**). The refrigeration plants could be operated individually or in parallel to chill seawater. The refrigeration plants (**Figure 4**) were designed and manufactured by Technotherm A/S of Halden, Norway, and had been installed at build. The main components of each refrigeration plant were a

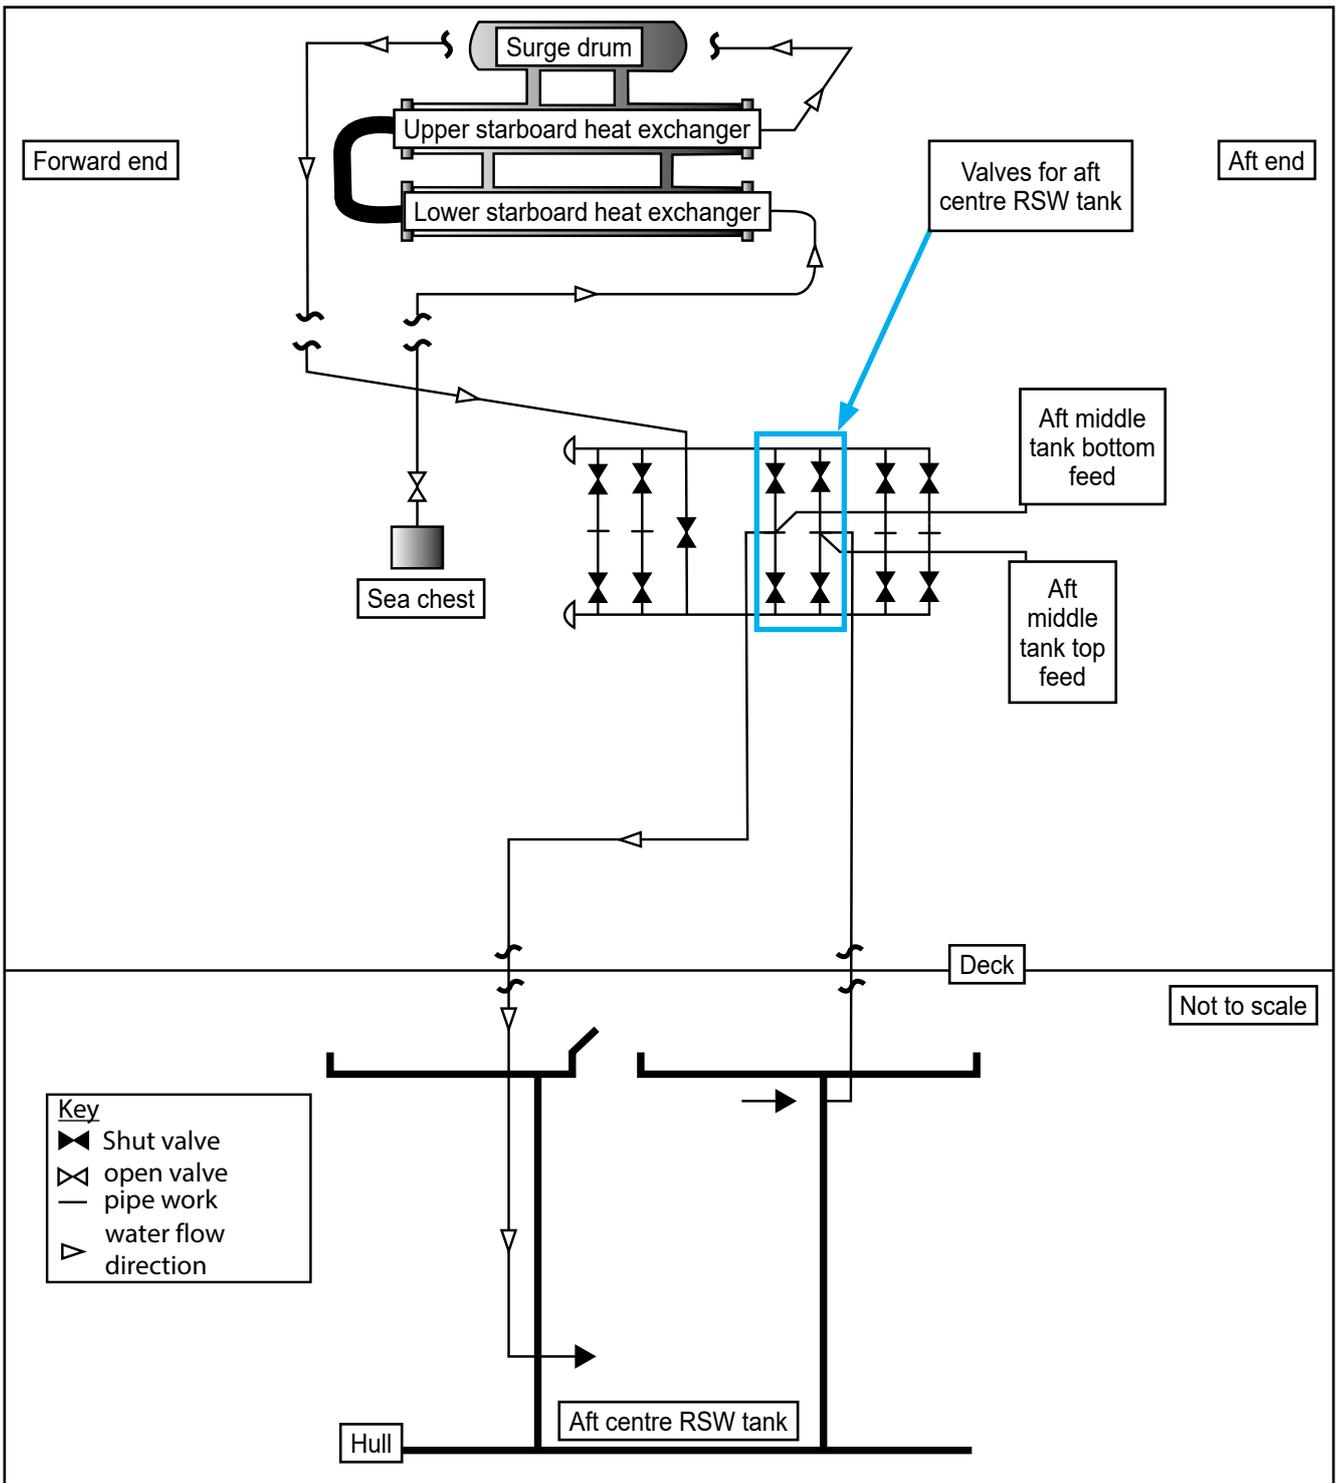
RSW tank suction and discharge isolating valves were fully lugged pattern marine butterfly valves; when in the shut position, they were designed to be watertight but not gastight. At the time of the accident, all of *Sunbeam*'s RSW tanks were empty and all pipework was drained of seawater (**Figure 3**).

**Figure 3:** Schematic diagram of *Sunbeam's* RSW system

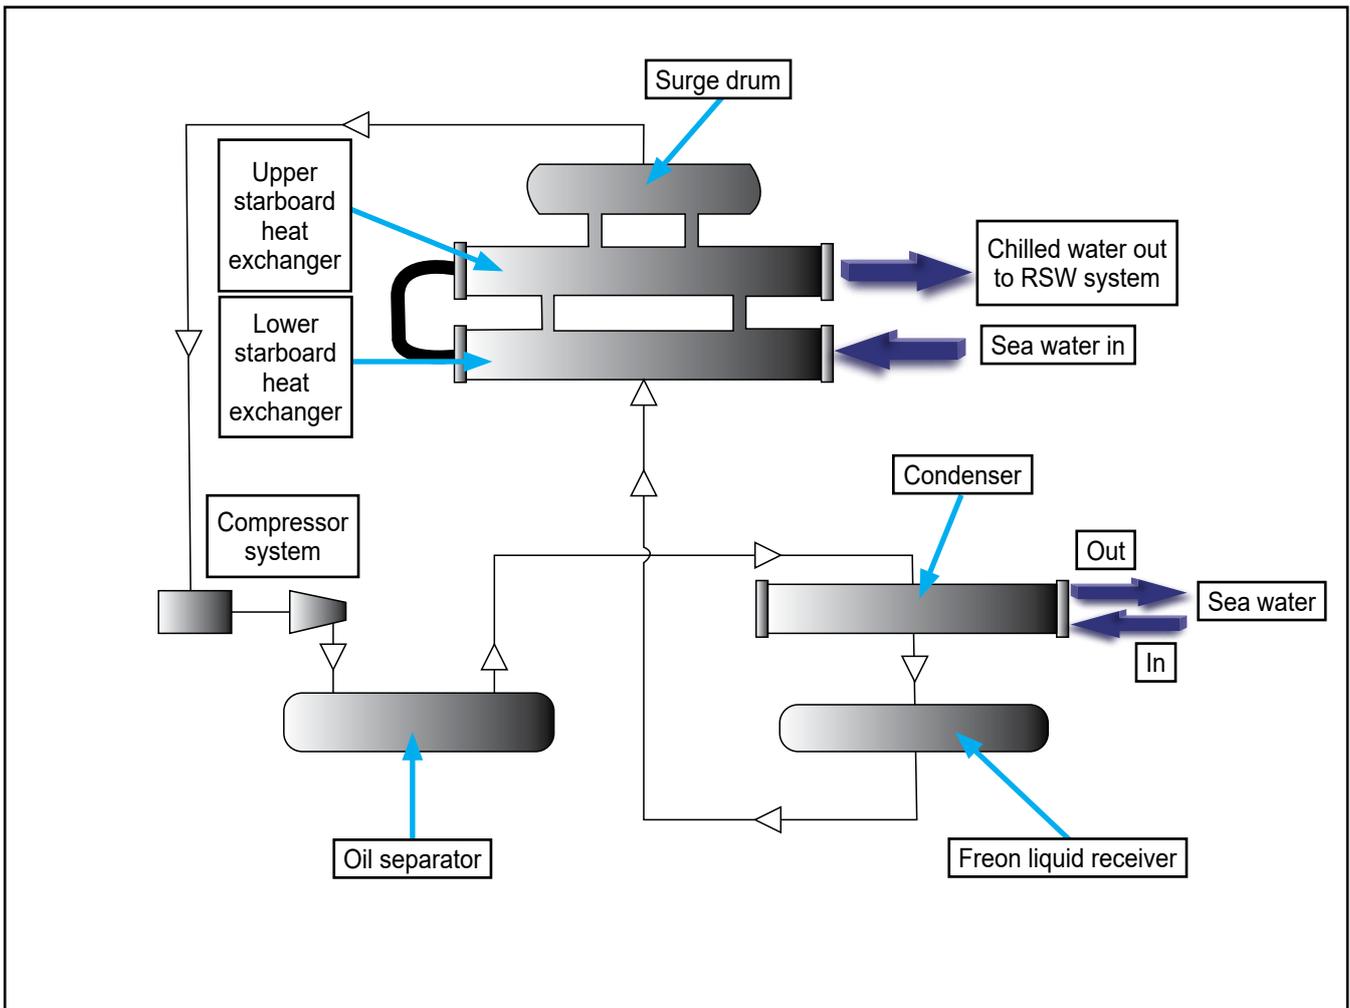
compressor, a condenser, a liquid receiver and an evaporator. Each evaporator comprised two 'shell and tube' heat exchangers mounted horizontally, and each heat exchanger contained 142 corrosion resistant aluminium-brass alloy<sup>6</sup> tubes. Seawater was chilled as it passed through the evaporators' tubes with the liquid Freon refrigerant evaporated on the shell side.

**Figure 4:** Schematic diagram showing one of *Sunbeam's* two refrigeration plants
