Report on the investigation of
the capsize and full inversion of the self-righting keelboat

RS Venture Connect sail number 307

resulting in the death of a disabled sailor
on Windermere, Cumbria

12 June 2019

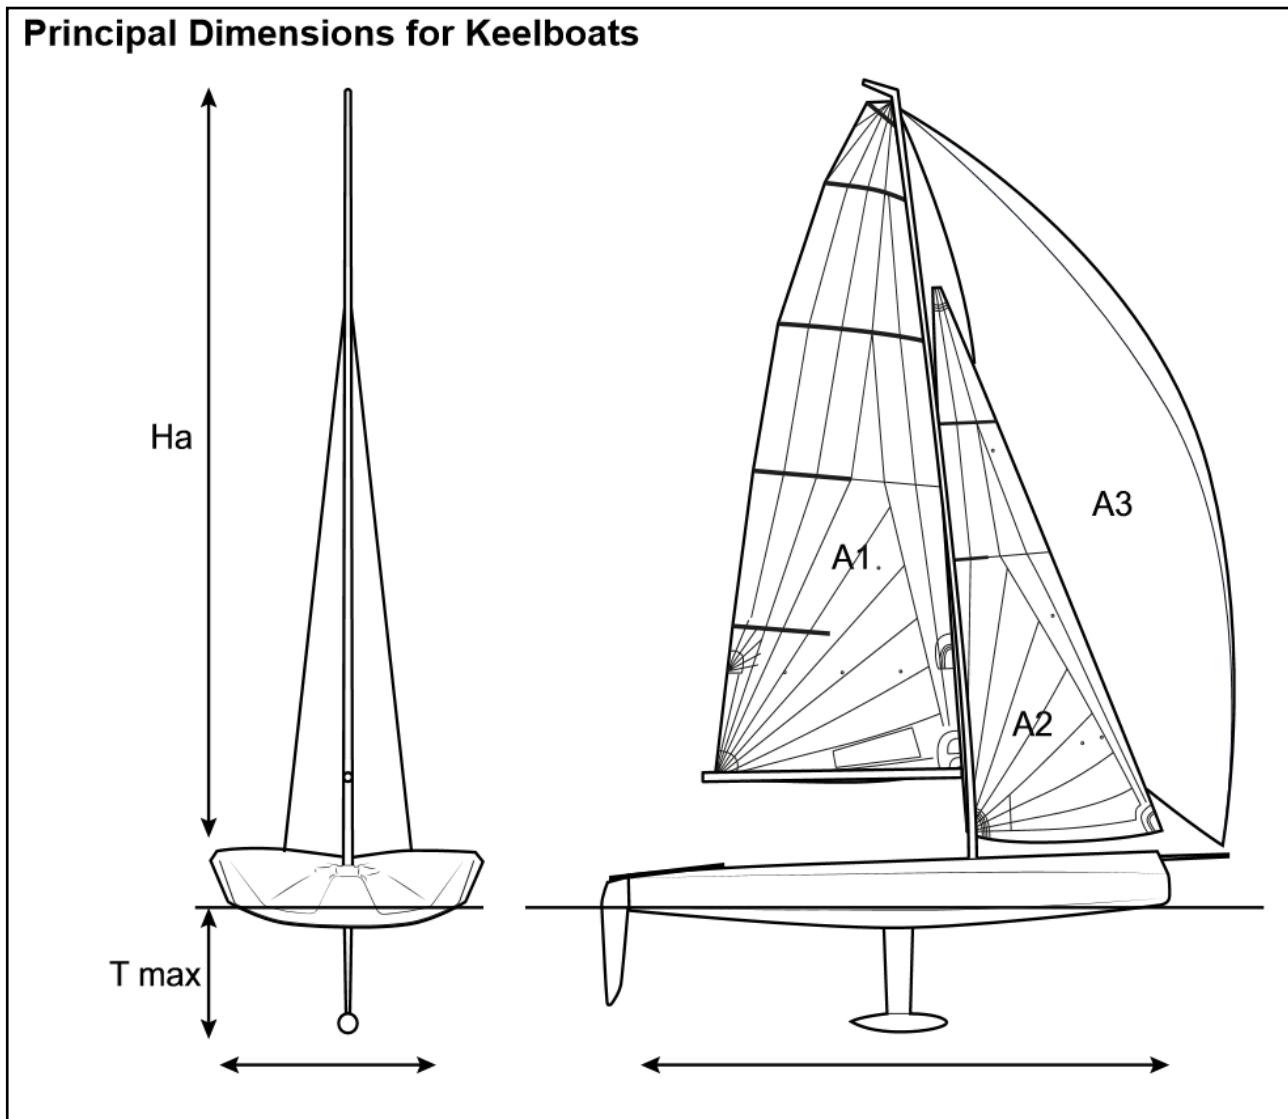
Figure 7: Diagram of an RS Venture Connect

RSVC 307 was an self-righting RS Venture Connect. The hull (**Figure 7**) was constructed from woven layers of glass-reinforced plastic (GRP) under a double layered gel coat. It was 4.9m long, had twin rudders and was rigged with two forward facing seats for para sailing. The purchase of the boat was partly funded by Stephen Hague, and his mother's name had been painted onto the hull. However, the boat was known at the centre as "the RS".

The RS Venture Connect's keel had a bulb weighing 125kg, and was housed in a sleeve that allowed it to be retracted for transport, or deployed when sailing. When *RSVC 307* was not in use, it would be moved to a shallower berth, which required the keel to be raised. When deployed the keel should have been locked in place using the boat's Velcro™ restraint strap (**Figure 8**). When an RS Venture Connect is knocked down and capsizes onto its side, the weight of the extended keel bulb should create a righting moment sufficient to cause the boat to return upright.

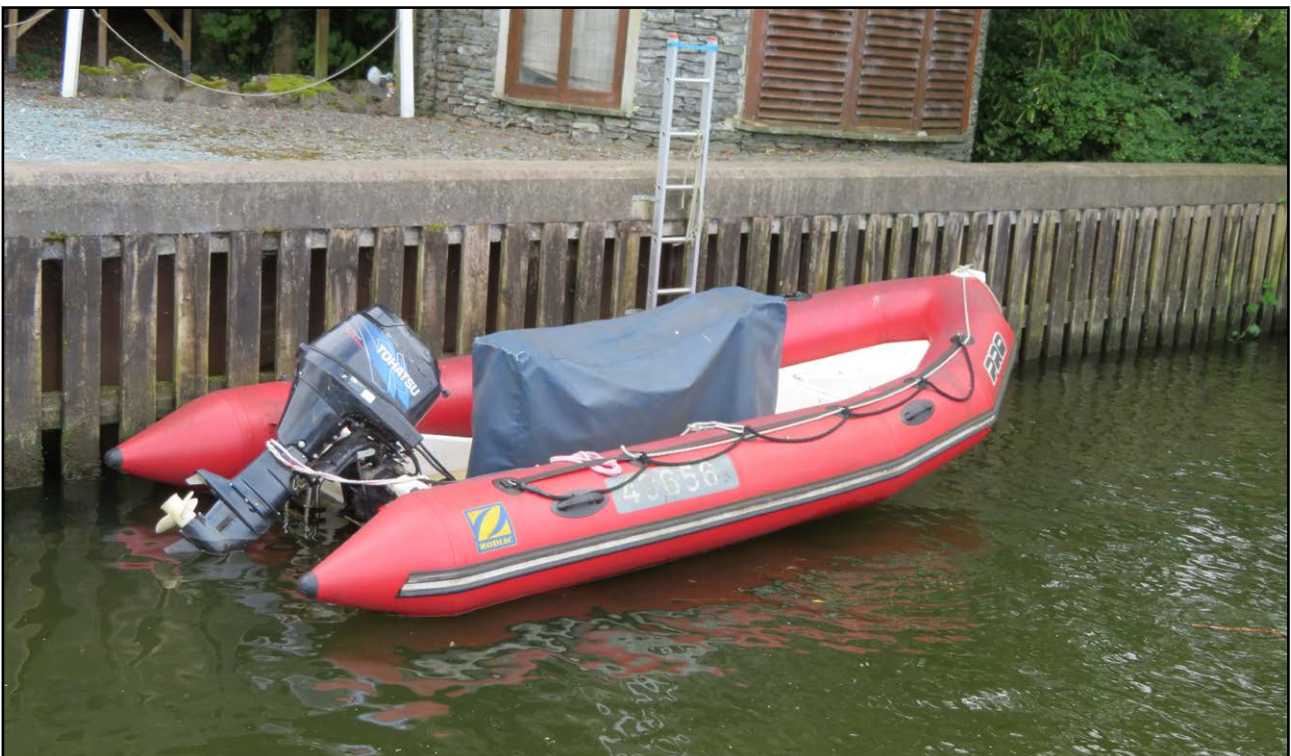
Figure 11: Blackwell Sailing's safety boat

Blackwell Sailing's safety boat was a 4.7m Zodiac PRO 500 RIB (**Figure 11**). It was purchased in 1999 and was fitted with a Tohatsu 30 horsepower (22.1 kilowatt) four-stroke outboard engine. The RIB had a central console with a single seat and was equipped with a small boarding ladder on its port transom.

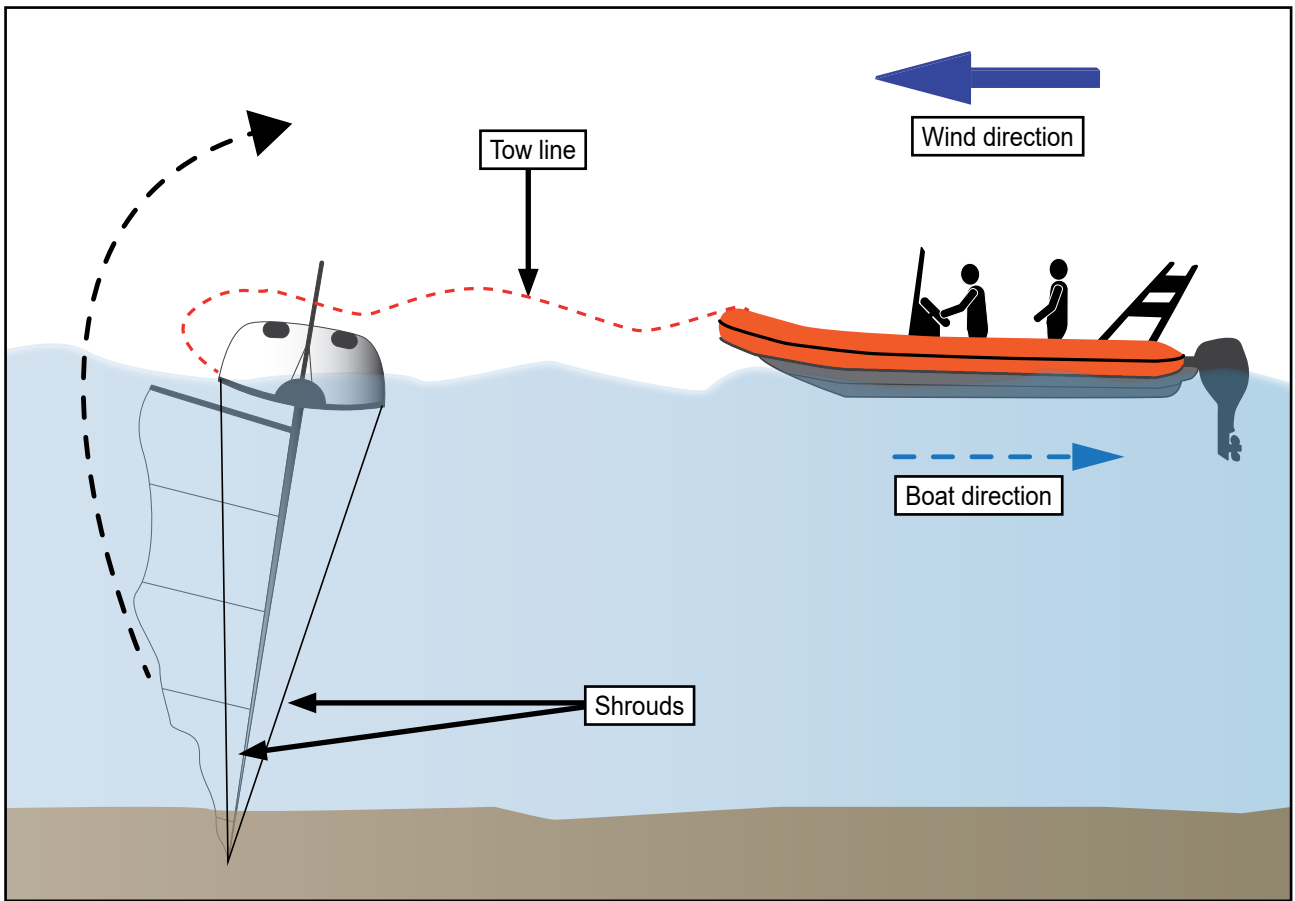
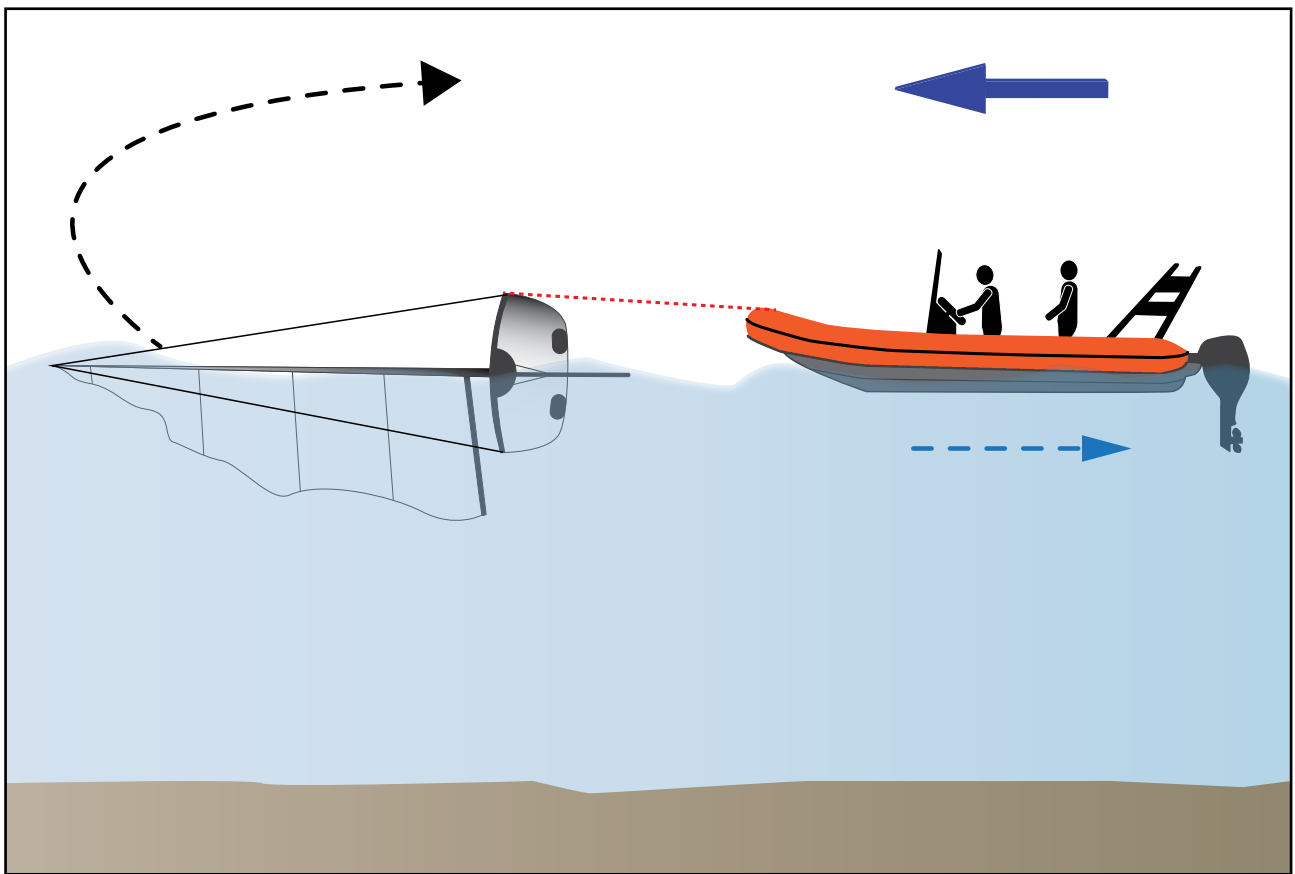
Figure 14: Diagram showing righting a boat using the shroud

The Safety Boat Handbook's guidance on inverted dinghies (**Annex E**) identifies two methods of righting an inverted boat. For smaller boats where the centreboard is accessible, it may be possible to right the boat by standing on the gunwale of the inverted boat and using weight on the centreboard to create a righting moment. For larger boats, the handbook recommends the use of the safety boat to pull the inverted boat upright. To achieve this, a towline is passed over the hull and attached to the far side shroud (**Figure 14**). The safety boat helmsman should then apply reverse power to pull the boat upright.
