**SERIOUS INCIDENT**

<b>Aircraft Type and Registration:</b>	Sportstar Max, G-TMAX	
<b>No &amp; Type of Engines:</b>	1 Rotax 912ULS2 piston engine	
<b>Year of Manufacture:</b>	2010 (Serial no: 2010 1305)	
<b>Date &amp; Time (UTC):</b>	25 May 2020 at 1340 hrs	
<b>Location:</b>	White Ox Mead Farm Airstrip, near Bath, Somerset	
<b>Type of Flight:</b>	Private	
<b>Persons on Board:</b>	Crew - 1	Passengers - 1
<b>Injuries:</b>	Crew - None	Passengers - None
<b>Nature of Damage:</b>	Propeller damaged	
<b>Commander's Licence:</b>	Private Pilot's Licence	
<b>Commander's Age:</b>	73 years	
<b>Commander's Flying Experience:</b>	287 hours (of which 120 were on type) Last 90 days - 5 hours Last 28 days - 2 hours	
<b>Information Source:</b>	Aircraft Accident Report Form submitted by the pilot, and further enquiries by the AAIB

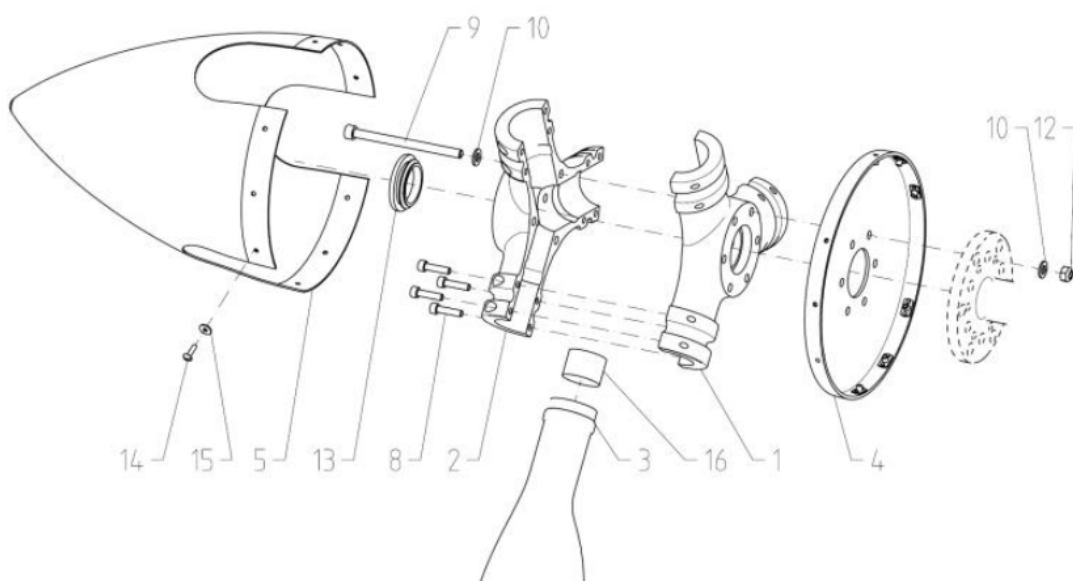
**Figure 2**

The aircraft was fitted with a three-bladed Woodcomp Klassic 170/3/R propeller and the blades were numbered 1, 2 and 3, with Blade 2 being the blade which failed in flight. The propeller blades are moulded from carbon and glass fibres embedded in a polymer matrix and are clamped between two aluminium alloy half-hubs to form the propeller assembly (Figure 2). The blade pitch may be adjusted by rotating the blade roots within the hub, when the hub screws are suitably loosened. The propeller is attached to the engine reduction gearbox drive flange by six bolts.

Propeller assembly (courtesy Woodcomp)
