SERIOUS INCIDENT

Aircraft Type and Registration:	Cessna Citation CJ1+, N680KH	
No & Type of Engines:	2 Williams FJ44-1AP turbofan engines	
Year of Manufacture:	2008 (Serial no:525-0680)	
Date & Time (UTC):	13 April 2019 1422 hrs	
Location:	Bournemouth Airport	
Type of Flight:	Private	
Persons on Board:	Crew - 1	Passengers - 3
Injuries:	Crew - None	Passengers - None
Nature of Damage:	None reported	
Commander's Licence:	Airline Transport Pilot's Licence	
Commander's Age:	73 years	
Commander's Flying Experience:	4,400 hours (of which 3,200 were on type) Last 90 days - 17 hours Last 28 days - 13 hours	
Information Source:	AAIB Field investigation

Synopsis

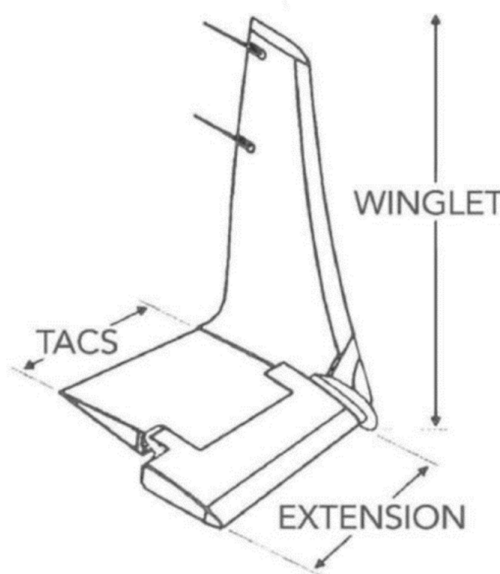
Figure 1

The pilot had recently bought the aircraft, which had been fitted during its previous ownership with 'Active Technology Load Alleviation System'¹ (ATLAS) wing extensions and winglets (Figure 1). He was intending to fly himself and three friends from Bournemouth to Rotterdam. The pilot, who operated the aircraft in a single pilot² capacity, occupied the front left seat. One friend occupied the front right seat, and the other two were seated in the passenger cabin.

Overview of ATLAS winglet installation

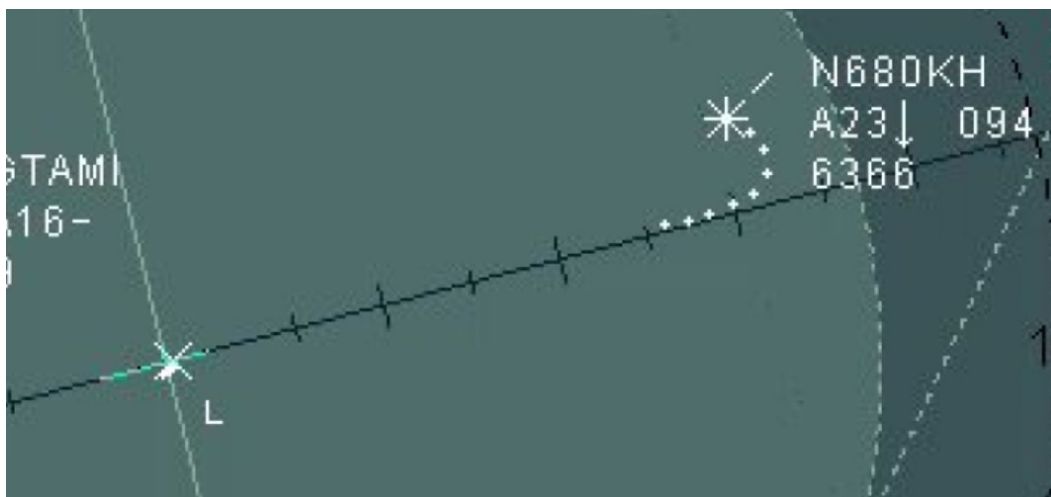
Figure 3

The pilot recalled feeling light vibration, then a button on the left of the instrument panel labelled 'ATLAS' illuminated (Figure 2), displaying the text 'ATLAS INOP LIMIT 140 KIAS' in red. At 1418:39 hrs, when the aircraft was around 6 nm east of the airport, at 3,000 ft amsl and 258 KIAS, the aircraft rolled left with a rate the pilot described as "very quick"⁴. ATC described N680KH turning "sharply... left and descending" (Figure 3)⁵. As it rolled through 45° the autopilot disengaged automatically.

ATC radar screenshot at 1419:14 hrs⁶

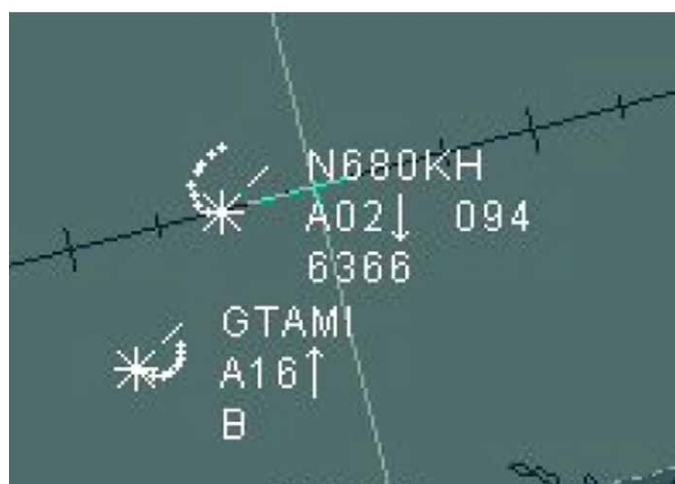
Figure 4

After descending from 900 ft to 300 ft amsl during the downwind leg, the aircraft turned on to base leg above a sports field. The pilot reported using continuous full right aileron and some right rudder until landing. Less right rudder was required as airspeed reduced, and he achieved lateral control by modulating his right foot pressure. By reducing that pressure the aircraft turned continuously through left base on to a 1 nm final approach, right of the runway centreline at 200 ft amsl (Figure 4). The tower controller described the turn as so tight that the aircraft appeared to be "on its side". He and several colleagues believed the aircraft would crash short of the airfield. At the landing speed of 105 KIAS the pilot believed he could land the aircraft straight so used "less right foot" to straighten the approach and, when over the runway, applied full flap. The aircraft landed at 1423 hrs.

ATC radar screenshot at 1422:31 hrs

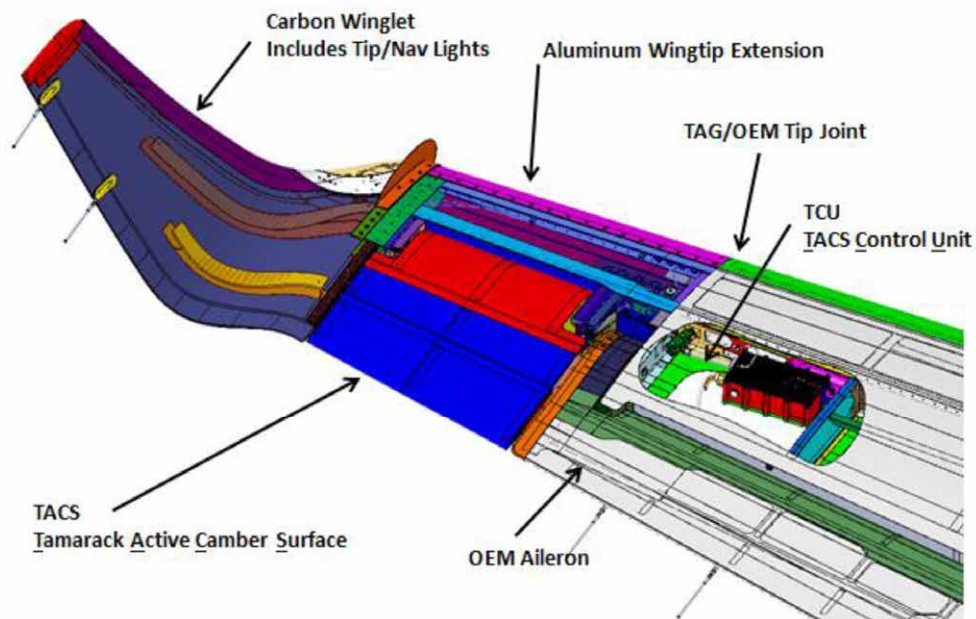
Figure 6

To install the system on a Cessna Citation CJ1+, the original wing tips are removed and 22 inch extensions, incorporating the winglets, are attached (Figure 6). Active aerodynamic control surfaces are positioned in the horizontal section of these extensions. These control surfaces (known as Tamarack Active Camber Surfaces, or TACS) are automatically activated in high positive or negative g situations to unload the wing and keep the wing loading within the original envelope.

Cessna 525 wing with ATLAS installed

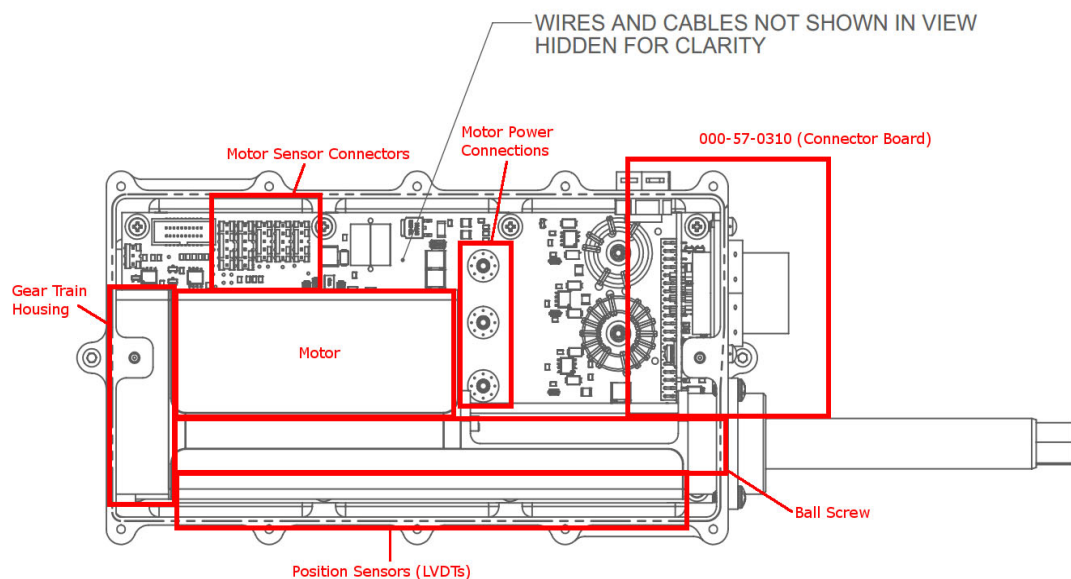
Figure 7

A TACS Control Unit (TCU) is mounted in each wing. The TCU comprises analogue control circuitry, an electric motor, gearing and a ball screw actuator module (Figure 7). This drives each TACS mechanically as shown in Figure 8. The TCUs are controlled by an ATLAS Control Unit (ACU), which is mounted close to the aircraft centre of gravity. The ACU houses two accelerometers which monitor the aircraft's movement in the vertical axis. When aircraft vertical acceleration exceeds specified positive or negative values, the ACU activates both TCUs symmetrically to aerodynamically unload the wings.

Internal layout of TCU

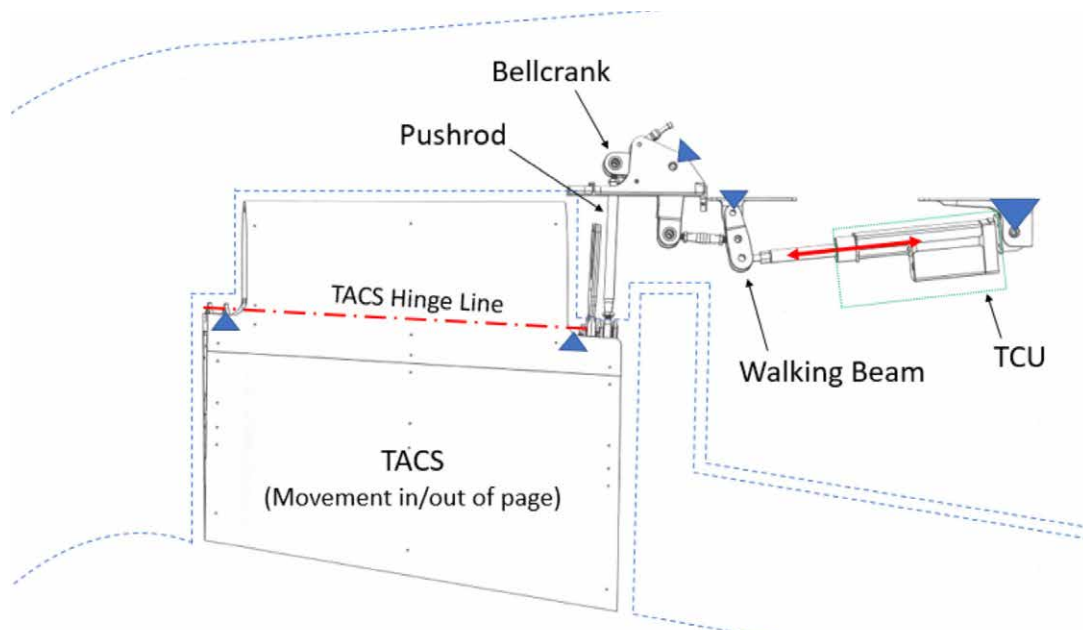
Figure 8

Top view of mechanical linkages of ATLAS.
Note: blue triangles indicate hinge points

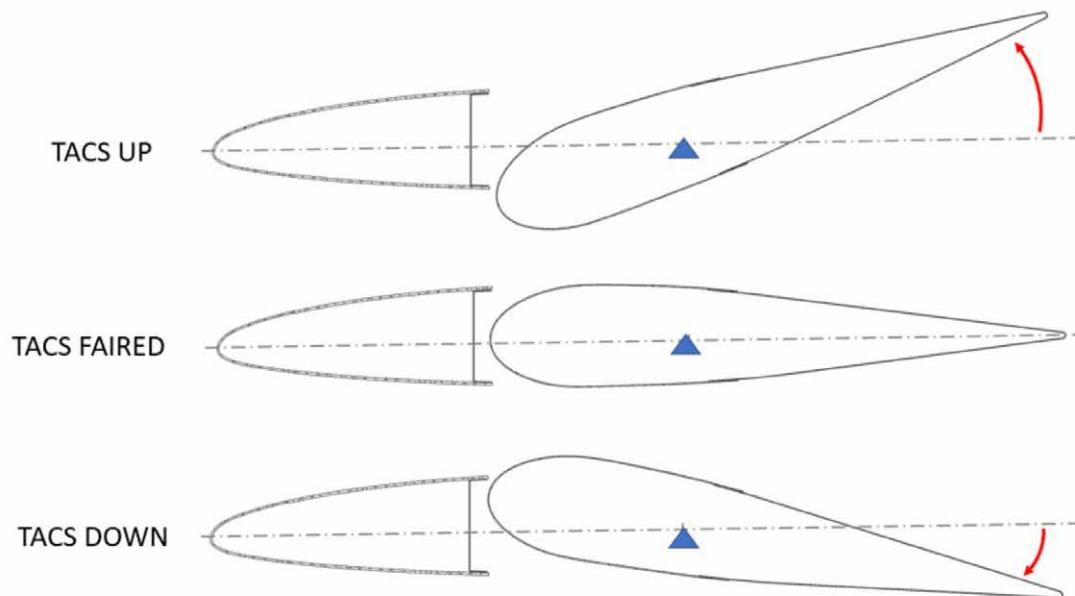
**Figure 9**

The TACSs are designed to travel above and below the neutral point (faired) to relieve both positive and negative wing loads (Figure 9) and will travel to these positions in 0.1 seconds when commanded. The actuators can be back driven by hand when de-powered.

Section view of TACS positions

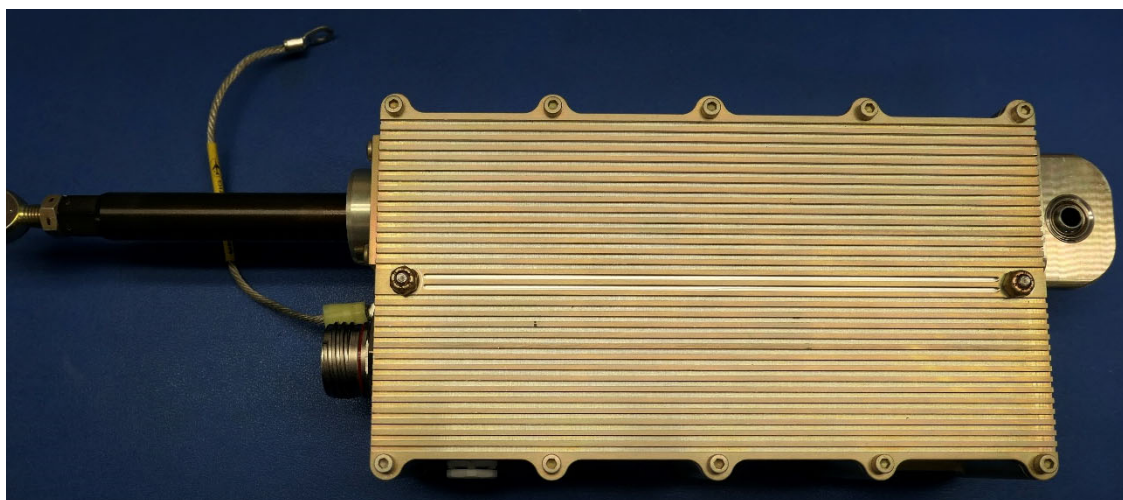
The right TCU (s/n 1014) passed all functional test and was therefore not subjected to any further assessment. Figure 10 shows an image of TCU s/n 1014.

TCU s/n 1014 after initial assessment
