ACCIDENT

Aircraft Type and Registration:	Pitts S-2A Pitts Special, G-ODDS	
No & Type of Engines:	1 Lycoming AEIO-360-A1E piston engine	
Year of Manufacture:	1980 (Serial no: 2225)	
Date & Time (UTC):	24 August 2019 at 1304 hrs	
Location:	Stonor, Oxfordshire	
Type of Flight:	Training	
Persons on Board:	Crew - 2	Passengers - None
Injuries:	Crew - 2 (Fatal)	Passengers - N/A
Nature of Damage:	Aircraft destroyed	
Commander's Licence:	Private Pilot's Licence (Class Rating Instructor)	
Commander's Age:	35 years	
Commander's Flying Experience:	Approximately 710 hours (of which about 172 hours were on type) Last 90 days - 35 hours Last 28 days - 12 hours	
Student's Flying Experience:	197 hours (of which 1 hour 25 minutes were on type) Last 90 days - 34 hours Last 28 days - 8 hours	
Information Source:	AAIB Field Investigation

Synopsis

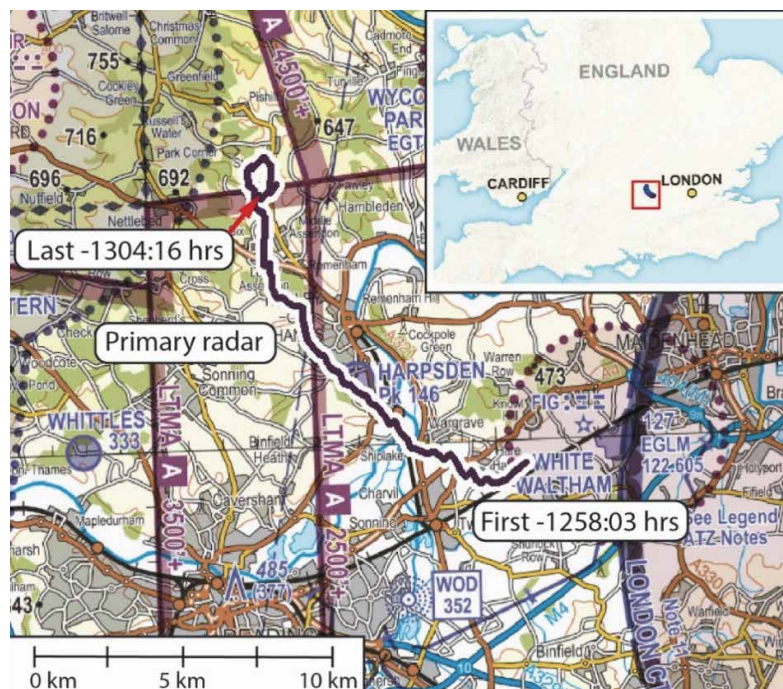
Figure 2
Radar data

The only sources of data relating to the flight were primary radar recordings (Figure 2). This provided the aircraft flight path but no altitude information. Radar contact was lost at 1304 hrs.

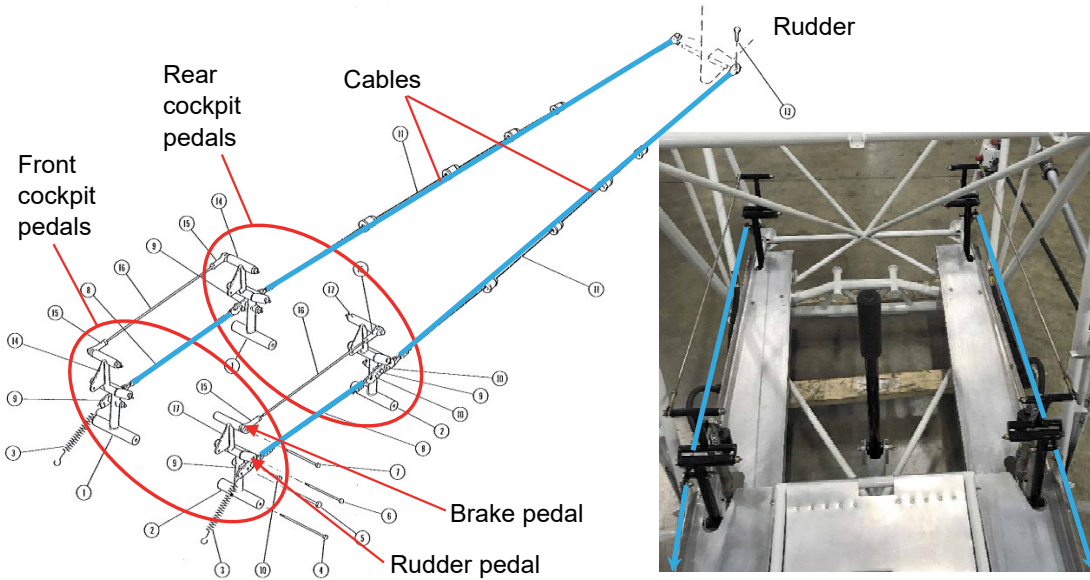
The rudder is operated by two steel cables running the length of the aircraft, which are connected to two sets of pedals, one set in each cockpit. When the left pedal is pushed forward, the cable pulls on a lever attached to the rudder and moves the rudder to the left, and visa-versa. As the left pedal is pushed forwards, the right pedal will be pulled backwards, with the pedals in both cockpits moving simultaneously. Figure 4 shows the system with an inset view, looking forward on the front cockpit, from an exemplar aircraft.

Rudder control system schematic and cockpit view looking forward in an exemplar aircraft

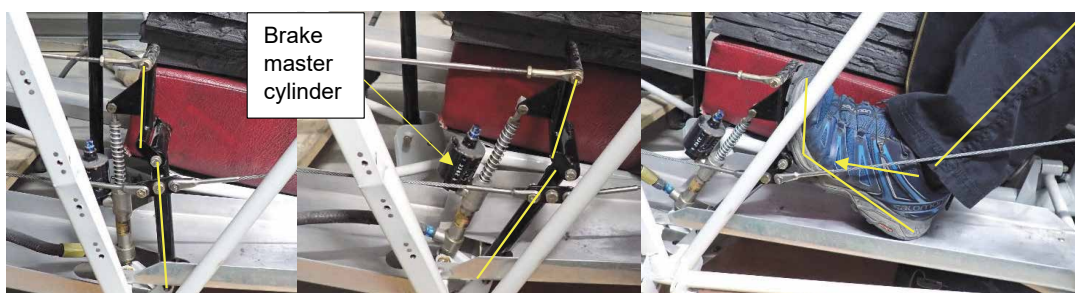
Figure 8

The geometry of the brake master cylinder and pedal connecting linkages means that, as the rudder pedal moves towards the rear of the aircraft, the brake pedal does not move as much (Figure 8 left and middle). The brake pedal position influences the pilot's foot posture and, with soft soled shoes as both pilots were wearing, extension of the toes would result in an optimal direction of force applied to the rudder pedal (Figure 8 right) with minimal force applied to the brake pedal. However, it has been stated that, whilst flying aerobatic manoeuvres, it is not uncommon for pilots to inadvertently apply the wheel brakes. Despite this small application of the brakes, the main application of force is through the rudder pedal.

Rudder / brake pedal relative movement and foot posture

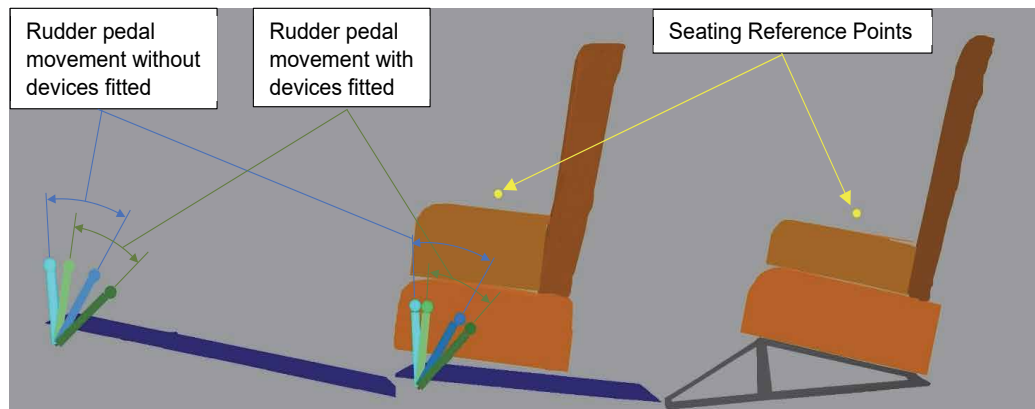
Figure 13

Where required body dimensions were not available, the anthropometric consultants estimated figures based on other known proportions and photographs⁹. The measurement data was then imported into the System for Aiding Man Machine Interaction Evaluation (SAMMIE) Digital Human Modelling software tool and a digital mannikin was created for each pilot. Using the scanned digital cockpit environment and the H-point machine, the SAMMIE digital mannikins were then positioned in the cockpit and the Seating Reference Points (SgRP) were defined (Figure 13).

SgRPs and rudder pedal movement
