# Hammersmith Bridge

Review of Recent Documents and  
Summary of Existing Condition

**Prepared for:**

**Prepared by:**

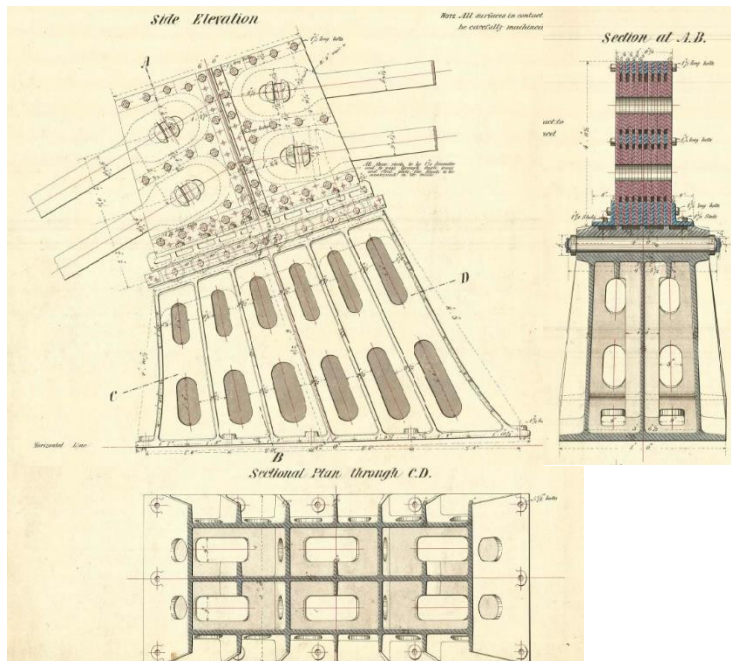
Figure 2.1: Original drawing of pedestal, saddle and roller assembly (source: LBHF)

The pedestals are cast iron castings forming a hollow cellular box. (Refer to Figure 2.1 above.) Each comprises three longitudinal webs with linking end plates and two intermediate diaphragms. The webs have full-height stiffeners. The upper plate has a machined top surface for the rollers and the bottom plate is fixed to foundation stones via 12 vertical bolts. There are elongated openings in each of the faces (except the upper plate), largely to facilitate the casting process and permit the sand mould to be removed after casting. The pedestals are believed to be made from flake grey cast iron using sand moulds. These would have been large complex castings for the time, and it is evident that defects and discontinuities were formed in the material during the casting process.

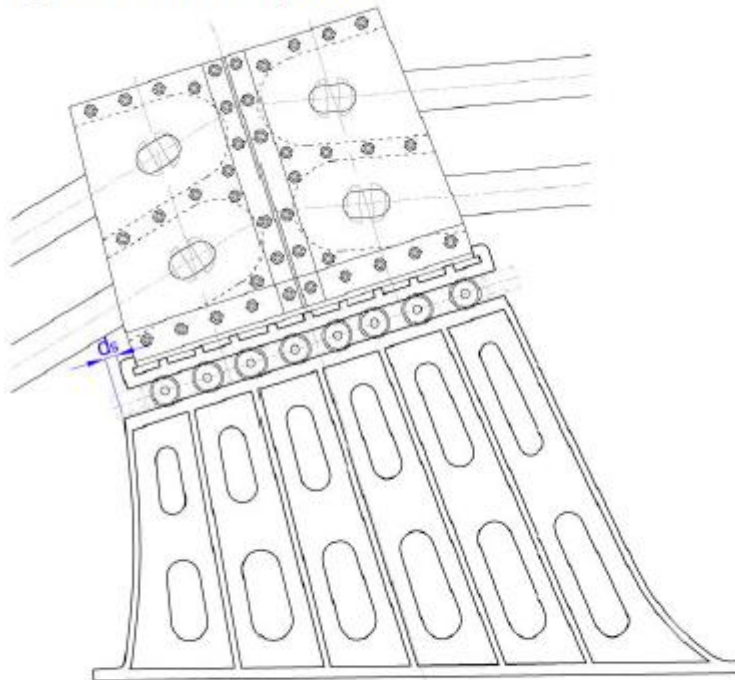
Figure 4.1: Extract from MM report showing definition of  $d_s$

The report summarises the results of the site investigations and NDT findings in the NW and SW pedestals. The report includes a section on the relative position of the saddle to the pedestal and from this analysis, and based on this, various conclusions are drawn relating to the direction of the restraining force at each pedestal as shown in the extract below in Figure 4.1 below, with a definition of  $d_s$ . Table 4.3 below is an extract from the report showing the measured value of  $d_s$  which gives the relative position of the saddle.

The position of the saddle at time of construction is not known but for the saddle positioned centrally with respect to the pedestal,  $d_s = 38\text{mm}$ . Refer to Table 1 for a summary of measured relative saddle positions.

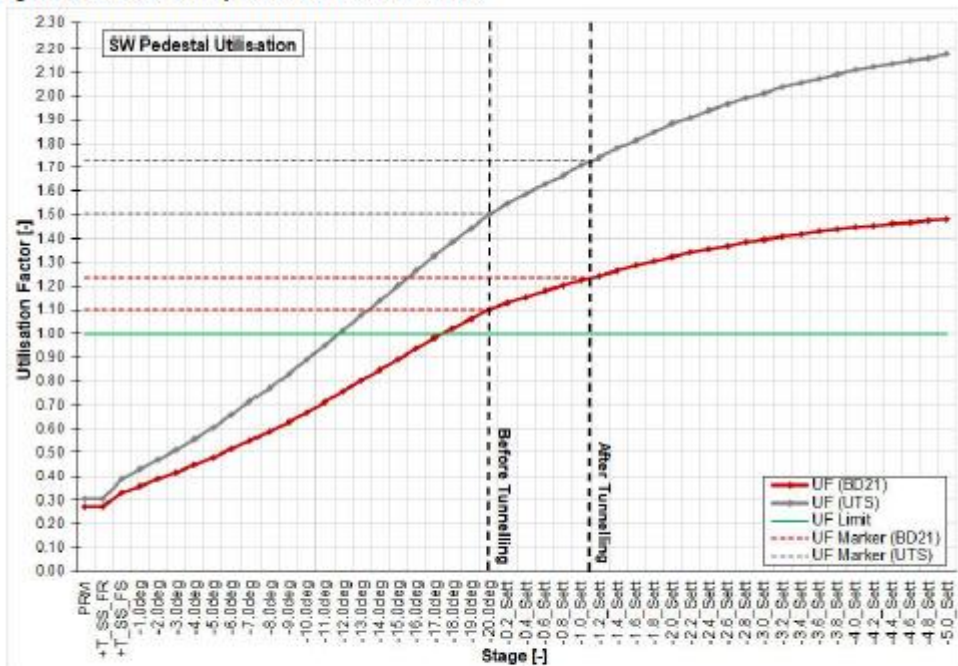
Figure 4.2: Extracts from MM report showing Utilisation Factors

In Figure 4.2, which is an extract from the MM report, it shows the UF for the SW pedestal much lower as 1.10, increasing to 1.24 after the effects of TTT are included. Adding 0.18 from pedestrian loading takes the UF up to 1.42.

Stage	UF (BD21)	UF (UTS)
Before tunnelling	1.10	1.50
After tunnelling	1.24	1.73
Impact from tunnelling works	+12.4%	+14.7%

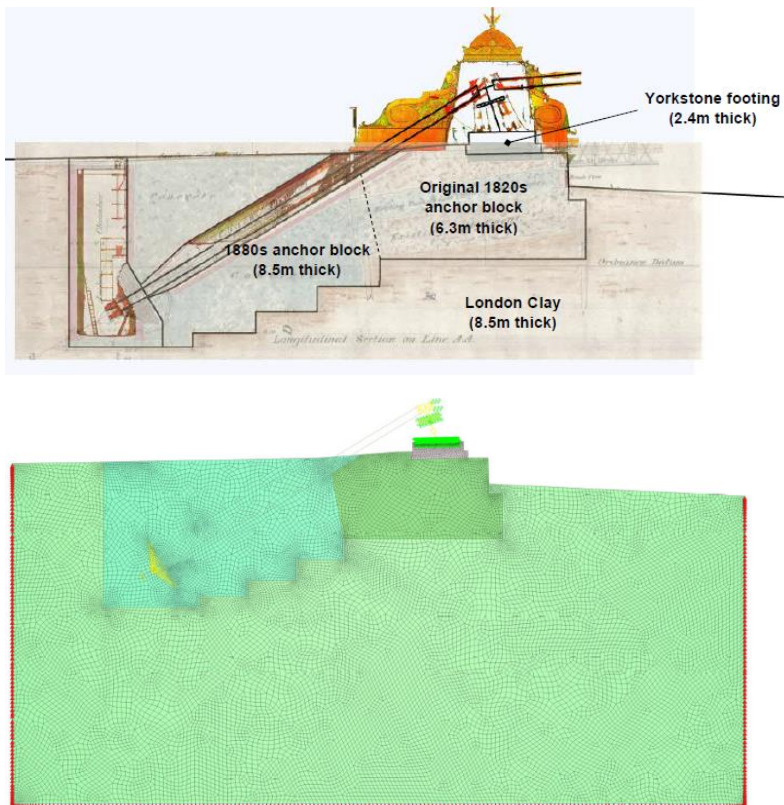
Figure 4.3: MM Soil-structure interaction model

- It has been established through discussion and comments sheets AECOM understands that the presence of the previous chain tunnel has been included in the analysis of the ground conditions. It is likely that the softer ground may help to dissipate the restraining force. The extracts in Figure 4.3 below show the geometry and the subsequent model used for the 2D analysis of the anchorage and ground.

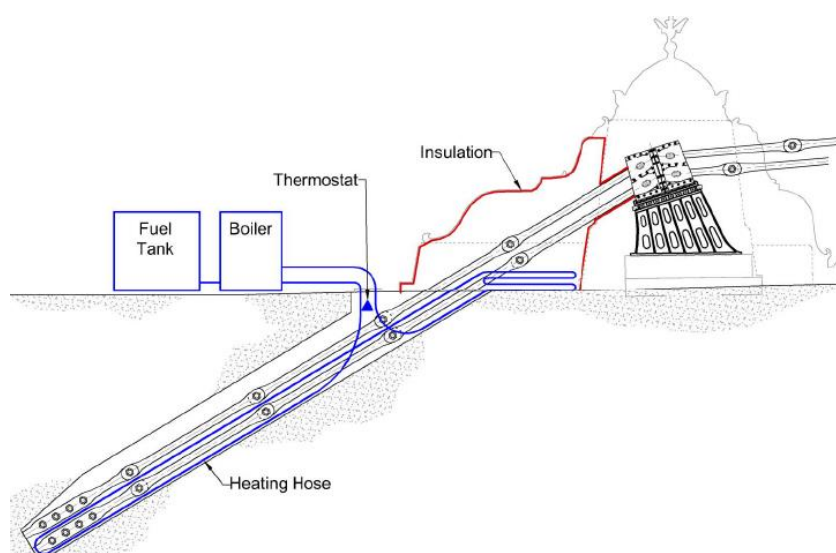
Figure 4.4 – Schematic of Heating System (Source: MM)

The heating system was installed over 3 days starting Monday 2<sup>nd</sup> March and was commissioned fully on Monday 16<sup>th</sup> March. The system was a water based one with pipes installed down the anchorage chamber with a boiler on the ground intended to achieve an average temperature of 13.5°C over the length of the anchorage. An extract showing the schematic of the heating system is shown in Figure 4.4 below:

The system managed to maintain a temperature between 11°C and 16°C during the passage of the tunnel.

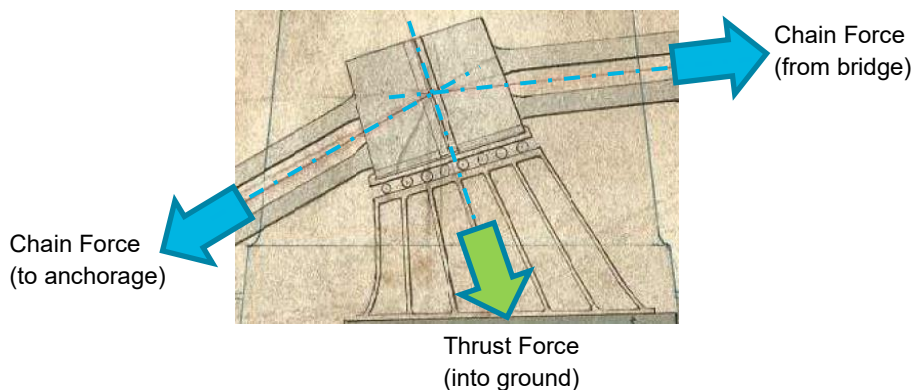
Fig 6.1: Pedestal force diagram (rollers free)

The pedestals were designed to withstand a force normal to the top surface applied via the rollers from the saddle. This force is the resultant due to the change in angle of the chains as they pass from the side spans into the chain tunnels. If the rollers are able to move freely (as it was originally designed) the magnitude of the chain force is balanced on either side of the saddle, and the resultant force from change in direction is directed through the rollers into the pedestal as a simple thrust, as shown in Figure 6.1.

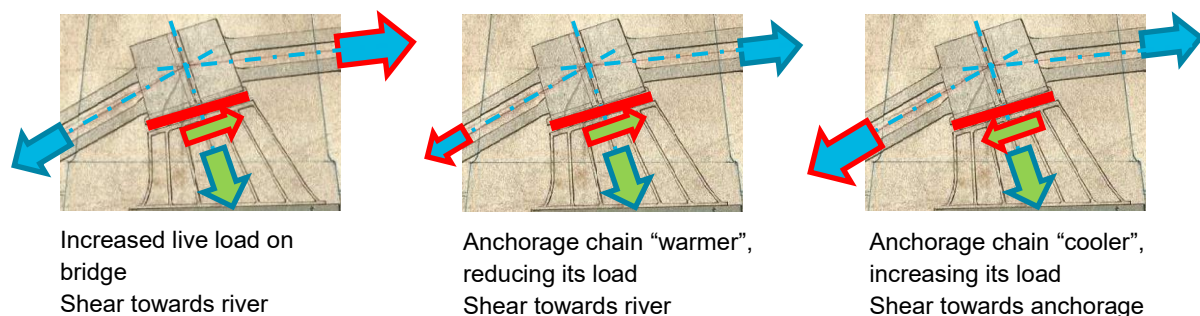
Fig 6.3: Seized rollers – shear forces from differential chain loads

Given that the rollers have seized, there is now an additional tangential (shear) force applied to the top surface. With the bridge in normal operation carrying traffic and pedestrians the resultant shear force will always be towards the river. Now that the bridge is closed to the public the dominant effect will be due to temperature changes to the length of chain between the pedestal and the anchorage, which can produce shear loads either towards or away from the river, as shown in Figure 6.3.

Forces due to temperature changes can be large but they are associated with very small strains of a few millimetres, so if there is any "give" anywhere the forces can dissipate rapidly. The flexibility of the soil below the pedestals is particularly significant and is something that MM has included in their analyses. However, using standard properties of London clay rather than from test samples at the bridge. AECOM understand that ground investigation (GI) has been carried out on or near the site on

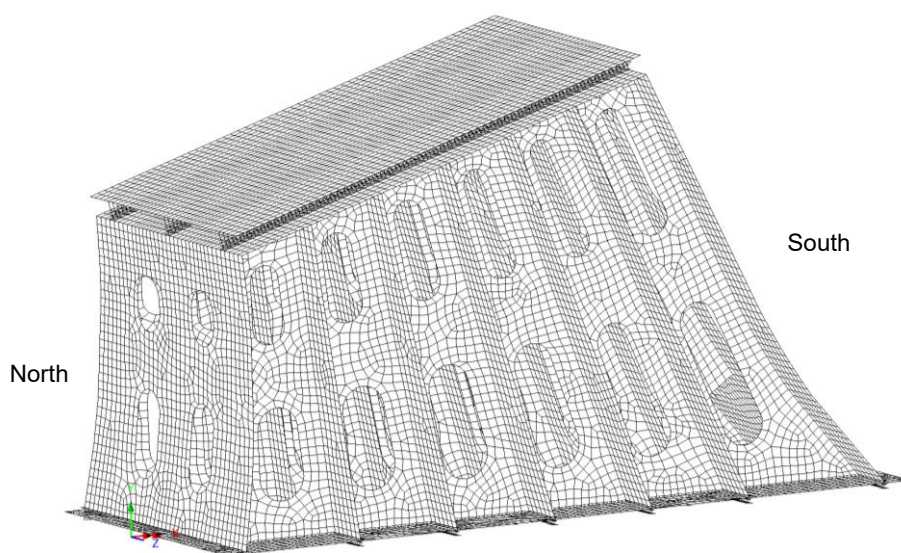
Fig 6.4: 3-D model of NE Pedestal by AECOM

The mesh comprised thick shell elements, located on the mid-planes of the plates represented. The geometry was taken from the record drawings from the original construction and all plates, stiffeners diaphragms and openings therein shown on the drawings were represented in the model. A non-linear material model approximating the brittle behaviour of cast-iron was assigned to all elements of the pedestal. The elastic modulus was assumed to be 114GPa – the value in Network Rail assessment standard NR/GN/CIV/025 and middle of the range given in BD 21/01. The non-linear material model allowed for rapid strain-softening of the cast-iron at tensile strains greater than that at which the maximum tensile stress is reached but did not model the formation of individual cracks.

The pedestal was modelled initially as uncracked, with no pre-existing cracks. The analysis was then repeated with the cracks recorded in the NE pedestal included in the analysis. The crack position was estimated from the sketches in Figure 2.12 and the data in Table 2.1 of the “Post-blast inspection report” (Document Reference 417457 MMD-HSB-REP-PBI-000001 01) by MM.

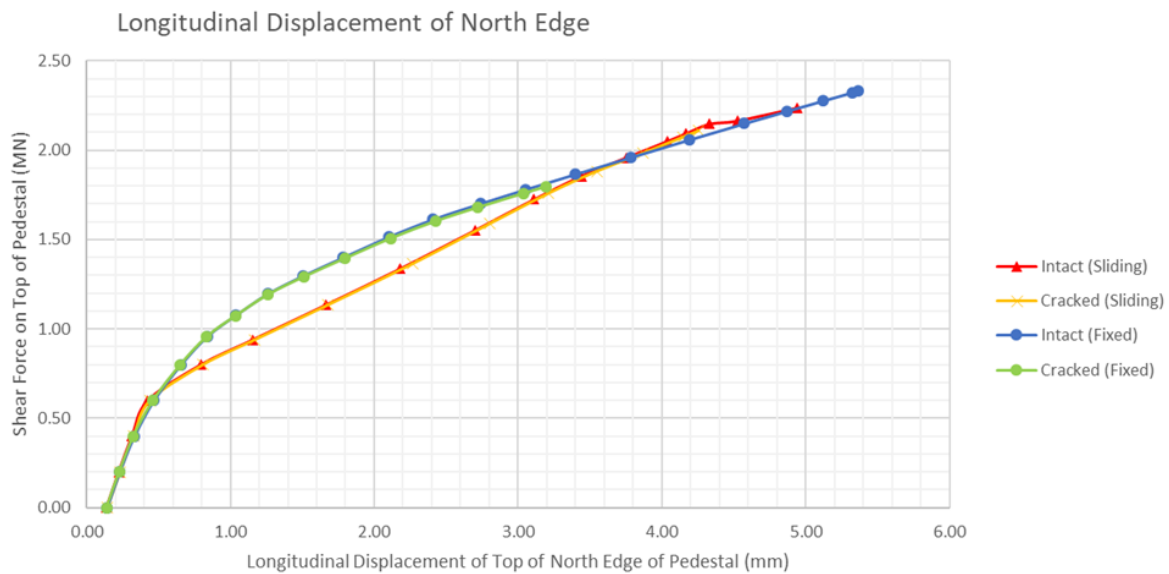
Figure 6.5: Longitudinal displacement against shear force for NE pedestal

The longitudinal displacement against shear force for the NE pedestal is shown in Figure 6.5 above.

The increase in the rate of deflection with load between 0.6MN and 0.8MN corresponds to the onset of slip on the base as the limiting friction force is reached. A zero gap between the base plate and the bolts is assumed – therefore the real displacement may be higher, with the consequence that the applied shear force, which arises from restraint of thermal movements, will be shed more effectively.

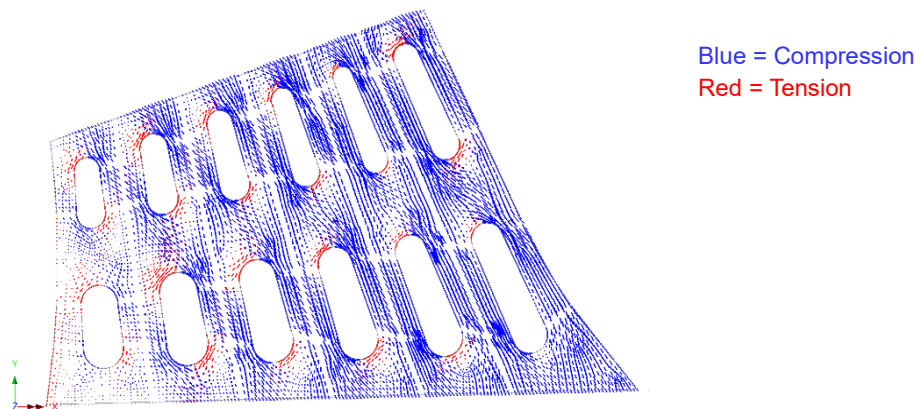
Figure 6.6: Principal Stress Trajectories with Shear Load of 0.80MN (uncracked model)

The principal stress trajectories with shear load of 0.80MN (uncracked model) is shown in Figure 6.6 below and the principal stress trajectories at final increment (Shear Load = 2.33MN) (uncracked model) is shown in Figure 6.7 below:

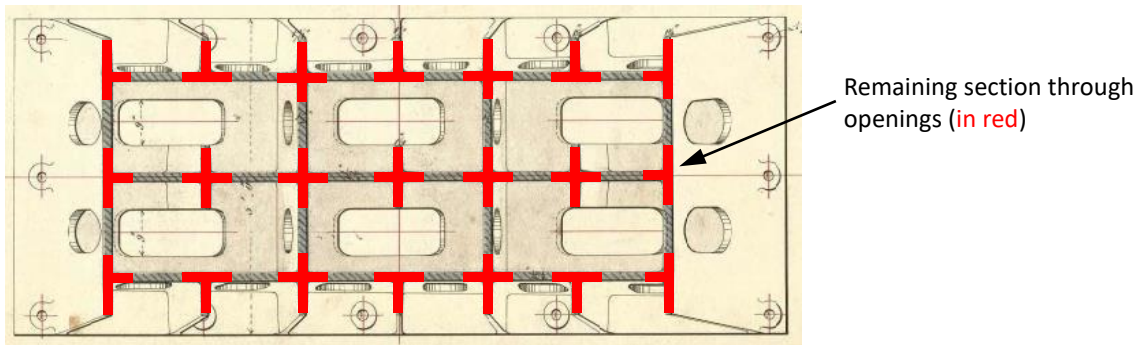
Figure 6.8: Plan on typical pedestal showing net section through openings

An important point to note is that if any crack was to propagate fully it would only locally fracture the pedestal as the perforations effectively divide it into 21 sections (either “T” or “+” shapes), see Figure 6.8 below:

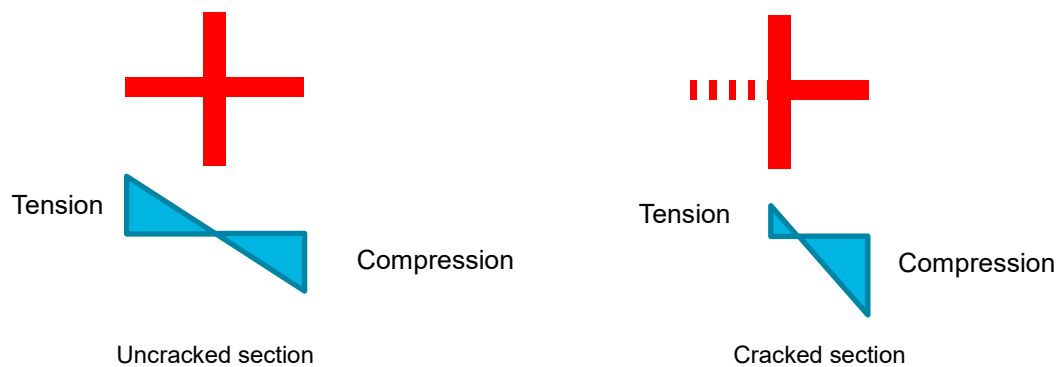
Figure 6.9: Illustrated difference in stress distribution between an uncracked and cracked section

Further, the stress on any of these sections will comprise a small compression from the normal component of chain force plus local bending from Vierendeel-type frame effect. So the stress variation (for an uncracked and cracked cruciform) will be approximately as shown in Figure 6.9 below:

For the uncracked section, the tensile and compressive stresses will be equal and opposite, but for the cracked section, the remaining “T” will have lower stresses (as it is less stiff) with the tensile stresses lower than the compressive stresses as the section is no longer symmetrical.

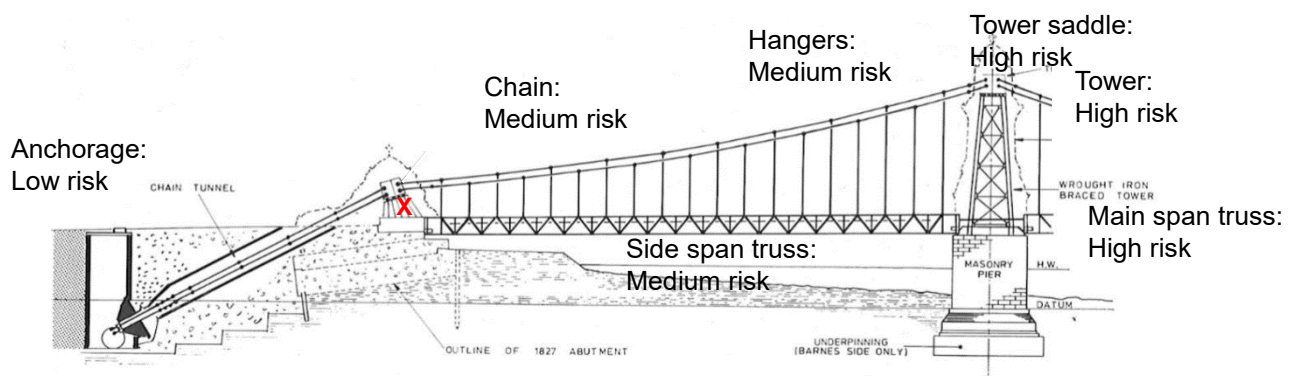
Figure 6.10 – Illustration showing relative risk rating for bridge elements if pedestal fails

If a pedestal were to somehow fail, there would be major ramifications for the bridge. The actual consequences are complex (and of course depend on what happens to the pedestal), but it is possible to apply broad risk ratings to parts of the bridge as shown in Figure 6.10 and Table 6.1 below.

Item	Risk rating	Comments
Anchorage	Low	Unlikely to be affected
Chain	Medium	Has good ductility and redundancy (2 chains)
Hangers	Medium	Likely to sustain damage if placed in compression but has redundancy
Side span truss	Medium	May span without hangers under dead load
Tower saddle	High	Vulnerable to excessive longitudinal movements
Tower	High	Displaced saddle could overload tower legs
Main span truss	High	Unable to span without hangers under dead load

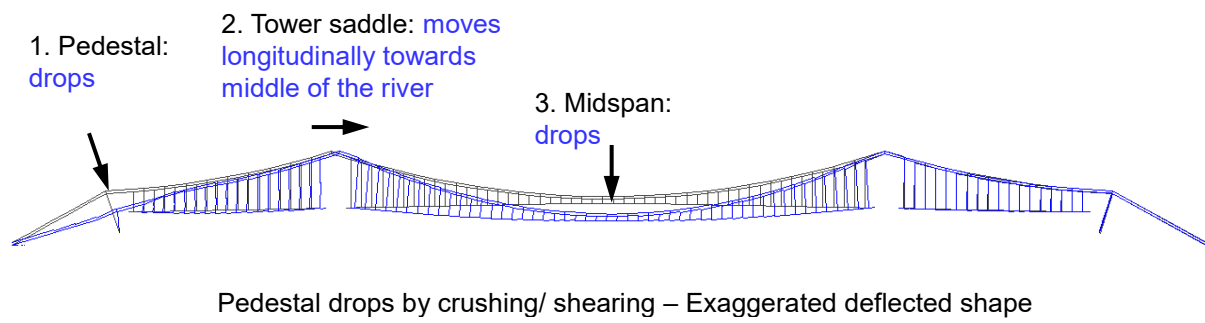
Figure 6.12: Illustration showing potential displacement of bridge if pedestal fails by crushing/ shearing

In Section 6.4.3 above, we highlight that failure by pure crushing or shearing of the pedestal is unlikely. But for the purposes of illustrating possible failure modes for the bridge, we have considered the failure mode arising from crushing of the pedestal. Although it is not seen as a logical failure mode, a simple 2-D analysis has been carried out to assess the effect of a pedestal and chain saddle dropping. As the bridge deck has a low torsional stiffness there is little load redistribution from one chain plane to the other. Two aspects have been noted – the longitudinal displacement of the tower saddle and the drop of the deck at mid main span as shown in Figure 6.12 below.
