# ***AAIB Bulletin***

# ***1/2021***

Published 14 January 2021

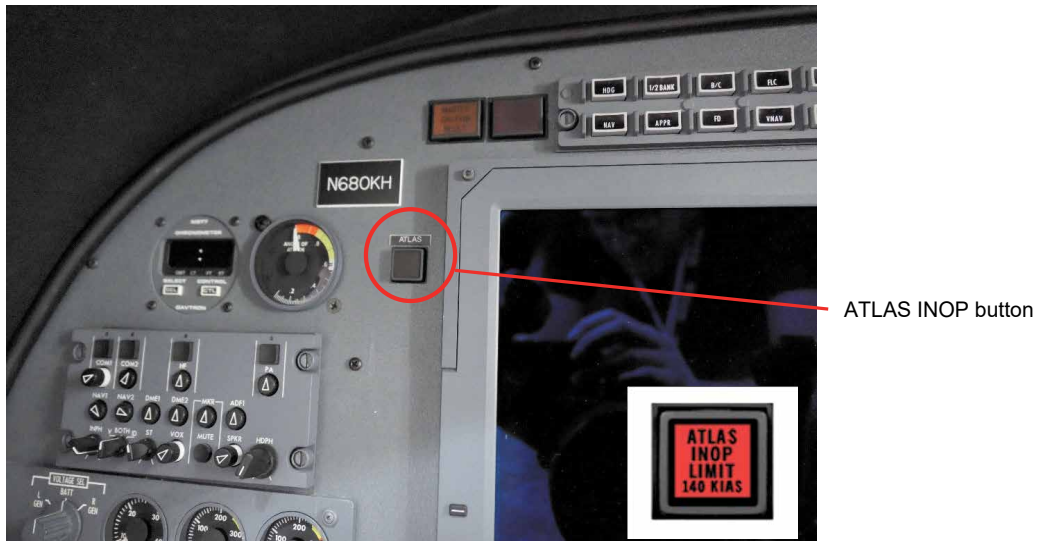
**Figure 2**

The pilot recalled feeling light vibration, then a button on the left of the instrument panel labelled 'ATLAS' illuminated (Figure 2), displaying the text 'ATLAS INOP LIMIT 140 KIAS' in red. At 1418:39 hrs, when the aircraft was around 6 nm east of the airport, at 3,000 ft amsl and 258 KIAS, the aircraft rolled left with a rate the pilot described as "very quick"<sup>4</sup>. ATC described N680KH turning "sharply... left and descending" (Figure 3)<sup>5</sup>. As it rolled through 45° the autopilot disengaged automatically.

ATLAS INOP button in N680KH, inset representation of button when illuminated

If there are any faults with the system, such as a LVDT mismatch, a fault latch within the ACU will be triggered and the instrument panel mounted ATLAS INOP push button will illuminate. When this is illuminated the actuators are de-powered. Pressing the ATLAS INOP button once clears the ACU fault latch and the system will resume normal operation. The light will go out if the reset is successful, if it is not, the light will remain on. Pressing it three times within three seconds will initiate a built-in test schedule to further attempt to rectify any faults.

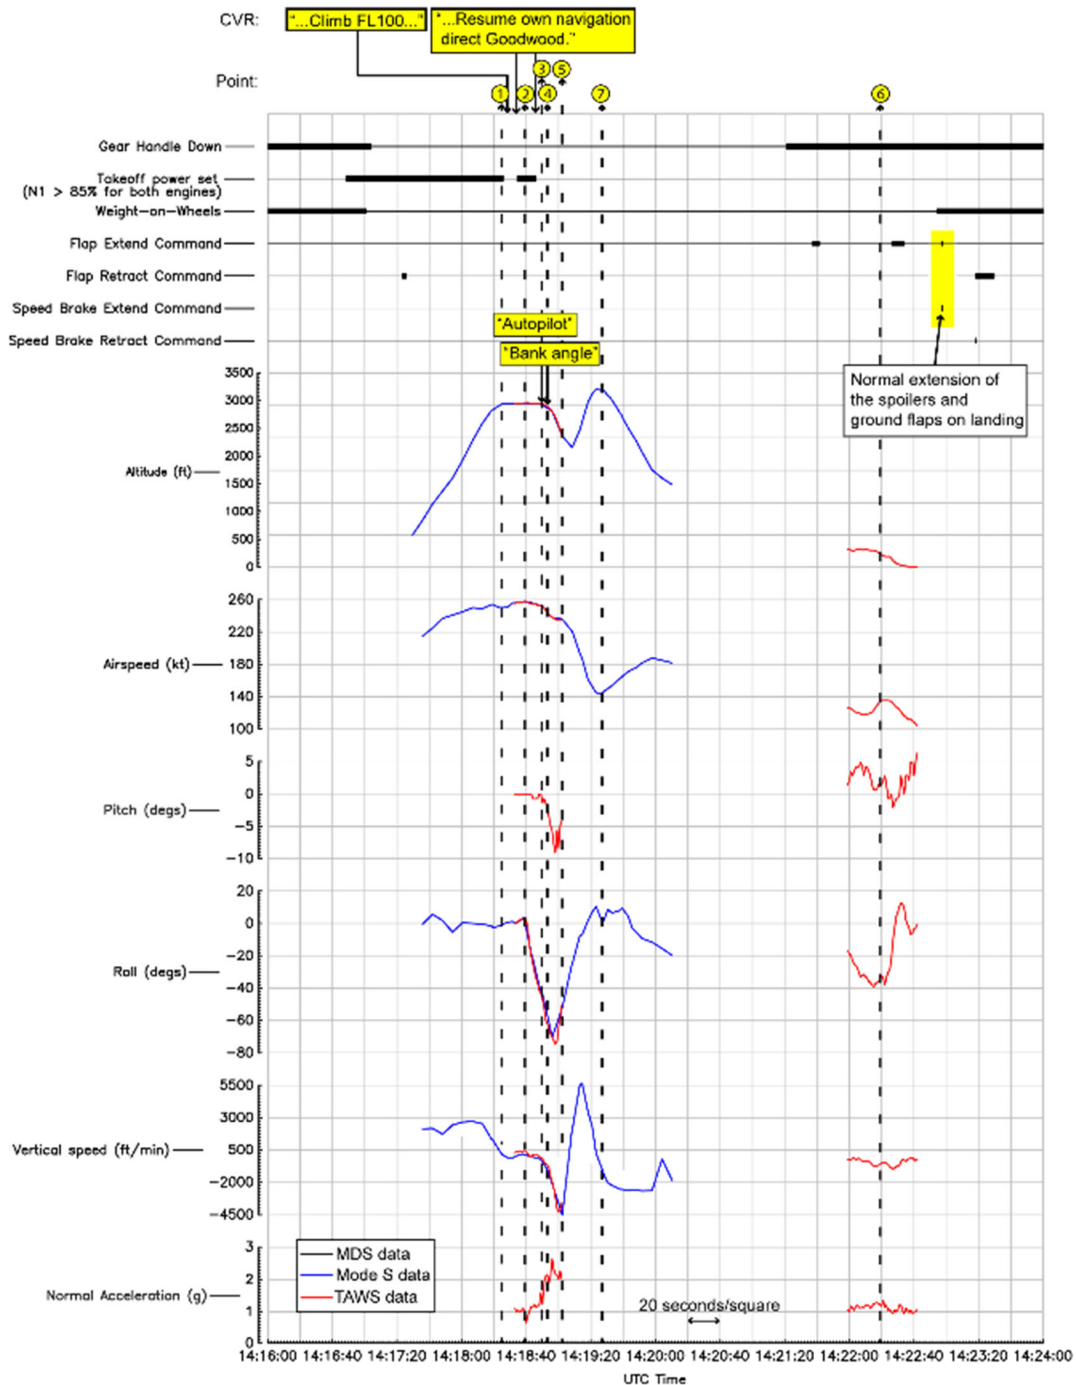
**Figure 5**  
Summary plot of recorded information

Data for the incident flight showed that after takeoff from Bournemouth the aircraft briefly levelled at approximately 3,000 ft<sup>13</sup>, with a pitch attitude of  $0^{\circ}$  at between 250 KIAS and 260 KIAS (between Point 1 and 2 on Figure 5). The aircraft then began to roll to the left at approximately  $4^{\circ}$  per second (Point 2 on Figure 5). Data from the CVR shows the pilot acknowledged an ATC clearance shortly afterwards and recorded data shows the revised climb altitude being selected. Eleven seconds later, the aircraft rolled through approximately  $45^{\circ}$ . The excessive roll caused the autopilot to disconnect automatically and was accompanied by an aural disconnect warning that was audible on the CVR. At this time the recorded pitch angle markedly decreased to  $9^{\circ}$  nose down (Point 3 on Figure 5). As bank angle exceeded  $60^{\circ}$  a bank angle alert<sup>14</sup> was generated (Point 4 on Figure 5) and a sharp increase in normal acceleration was recorded which reached +2.65 g. The bank angle reached a maximum of  $75^{\circ}$  left wing down, 19 seconds after the onset of the roll (between Point 4 and 5 on Figure 5), although the rate of descent

continued to increase and reached 4,500 ft/min (Point 5 on Figure 5), when the aircraft's airspeed was 235 kt.

A 'TOO LOW – FLAPS' alert occurred when the aircraft was on short final at approximately 230 ft radio altitude, indicating that landing flap was not selected, followed immediately by a second bank angle alert (Point 6 on Figure 5). This was triggered because the bank angle had reached 40° left wing down, 3 seconds earlier, at 260 ft radio altitude.

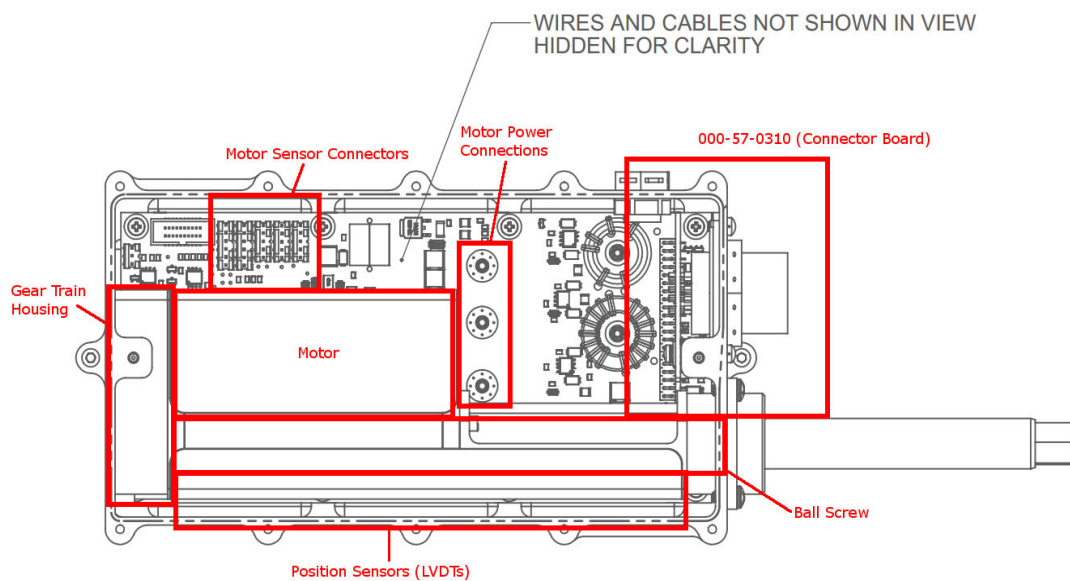
**Figure 7**

A TACS Control Unit (TCU) is mounted in each wing. The TCU comprises analogue control circuitry, an electric motor, gearing and a ball screw actuator module (Figure 7). This drives each TACS mechanically as shown in Figure 8. The TCUs are controlled by an ATLAS Control Unit (ACU), which is mounted close to the aircraft centre of gravity. The ACU houses two accelerometers which monitor the aircraft's movement in the vertical axis. When aircraft vertical acceleration exceeds specified positive or negative values, the ACU activates both TCUs symmetrically to aerodynamically unload the wings.

Internal layout of TCU

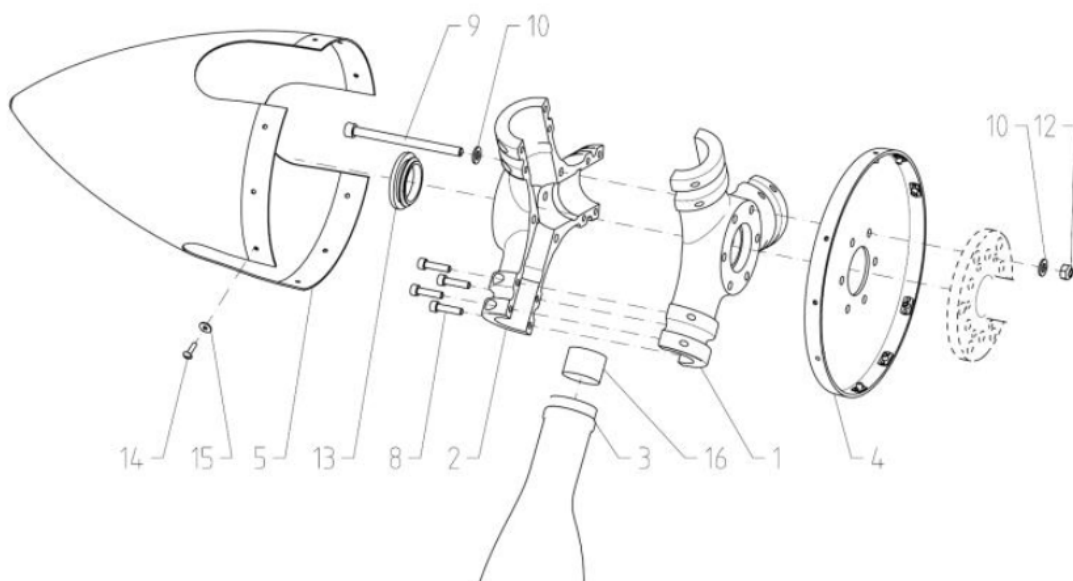
**Figure 2**

The aircraft was fitted with a three-bladed Woodcomp Klassic 170/3/R propeller and the blades were numbered 1, 2 and 3, with Blade 2 being the blade which failed in flight. The propeller blades are moulded from carbon and glass fibres embedded in a polymer matrix and are clamped between two aluminium alloy half-hubs to form the propeller assembly (Figure 2). The blade pitch may be adjusted by rotating the blade roots within the hub, when the hub screws are suitably loosened. The propeller is attached to the engine reduction gearbox drive flange by six bolts.

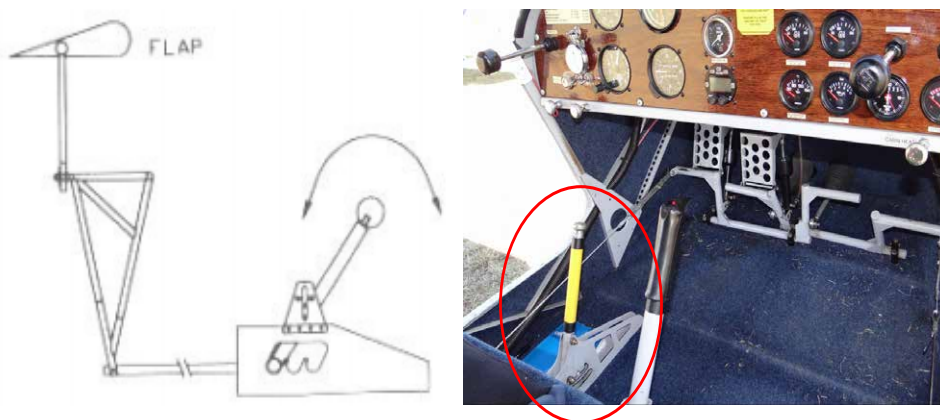
**Figure 2**  
Flap system – lever and linkage

The Savannah VG is fitted with full wingspan trailing edge flaperons with 0°, 20° or 40° settings. They are operated by a lever on the cockpit floor between the legs of the left seat pilot (Figure 2). The lever has a locking button on the top which engages with a detent for each setting. The Pilot's Operating Handbook (POH) states that with the standard take off procedure with flaps 20° the aircraft lifts off between 26 to 30 kt and the Take Off Distance Required (TODR) to clear a 50 ft obstacle is 228 m. The pilot had practiced a full-flap take off once before with an instructor and in the POH is noted: "*The short take off procedure [Flaps 40°] is a very delicate maneuver [sic]. It is suggested to practice it with an instructor before attempting it.*" The stall speed is 26 kt with flaps fully extended and 30 kt with flaps retracted. The pilot stated that in flight when extending the flaps, it is necessary to overcome the aerodynamic loads, however on ground, the flaps will fully extend under their own weight.

During the takeoff ground roll with the aircraft approaching flying speed, the pilot stated that the aircraft struck a bump and he inadvertently moved the flap lever. No defect was identified in the flap mechanism and due to the low aerodynamic loads, they deployed to flaps 40°. This would have created a sudden increase in lift and drag and reduced the stall speed. The manufacturer has highlighted in the POH that taking off with flaps 40° should be handled delicately and that the lift off and stall speeds are very similar. The pilot had practiced rejected takeoff manoeuvres to the right and straight ahead, but not to the left. The sensation of a left-wing stall resulted in the pilot turning to the left and he realised he would strike the hay bales or the farm buildings (Figure 3).

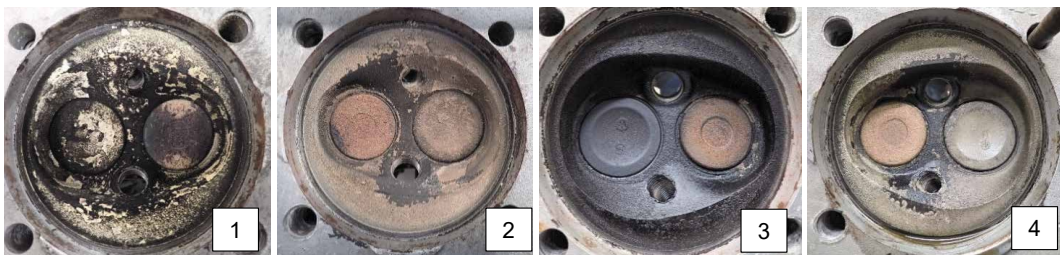
**Figure 9**  
Cylinder heads

After publication it was noted that the captions for figures 9 and 10 were incorrectly assigned.
