SERIOUS INCIDENT

Aircraft Type and Registration:	DJI Matrice 210 (UAS, registration n/a)	
No & Type of Engines:	4 electric motors	
Year of Manufacture:	2019 (Serial no: 17TDG350020016)	
Date & Time (UTC):	6 October 2019 at 1150 hrs	
Location:	Danbury, Essex	
Type of Flight:	Emergency services operations	
Persons on Board:	Crew - N/A	Passengers - N/A
Injuries	Crew - N/A	Passengers - N/A
Nature of Damage:	None	
Commander's Licence:	Other	
Commander's Age:	38 years	
Commander's Flying Experience:	262 hours (of which 5 were on type) Last 90 days - 28 hours Last 28 days - 16 hours	
Information Source:	Aircraft Accident Report Form submitted by the pilot and additional AAIB enquiries

Synopsis

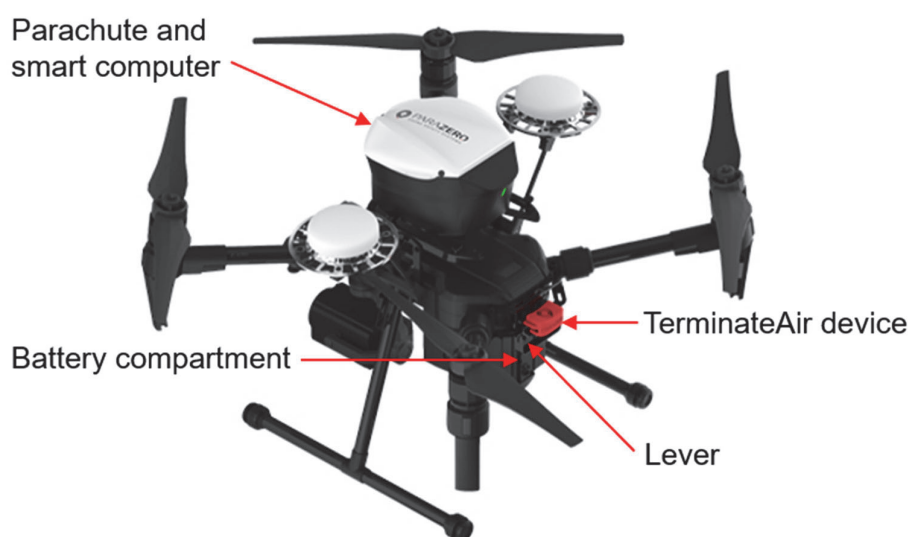
Figure 1

The parachute and the system's internal electronics are mounted on a plate which is fitted on top of the aircraft (Figure 1). It is attached to two parachute mounting legs, which are connected to the aircraft's landing leg joints. A flight termination device, known as TerminateAir, is mounted above the aircraft's battery compartment. A cable connects it to the rest of the parachute system.

Parazero SafeAir M200 installed on a DJI Matrice 210 RTK unmanned aircraft
(Source: Parazero)
