# ***AAIB Bulletin***

# ***2/2021***

Pitts S-2A Pitts Special	G-ODDS	24-Aug-19	3
--------------------------	--------	-----------	---

<b>Aircraft Type and Registration:</b>	Pitts S-2A Pitts Special, G-ODDS	
<b>No &amp; Type of Engines:</b>	1 Lycoming AEIO-360-A1E piston engine	
<b>Year of Manufacture:</b>	1980 (Serial no: 2225)	
<b>Date &amp; Time (UTC):</b>	24 August 2019 at 1304 hrs	
<b>Location:</b>	Stonor, Oxfordshire	
<b>Type of Flight:</b>	Training	
<b>Persons on Board:</b>	Crew - 2	Passengers - None
<b>Injuries:</b>	Crew - 2 (Fatal)	Passengers - N/A
<b>Nature of Damage:</b>	Aircraft destroyed	
<b>Commander's Licence:</b>	Private Pilot's Licence (Class Rating Instructor)	
<b>Commander's Age:</b>	35 years	
<b>Commander's Flying Experience:</b>	Approximately 710 hours (of which about 172 hours were on type) Last 90 days - 35 hours Last 28 days - 12 hours	
<b>Student's Flying Experience:</b>	197 hours (of which 1 hour 25 minutes were on type) Last 90 days - 34 hours Last 28 days - 8 hours	
<b>Information Source:</b>	AAIB Field Investigation

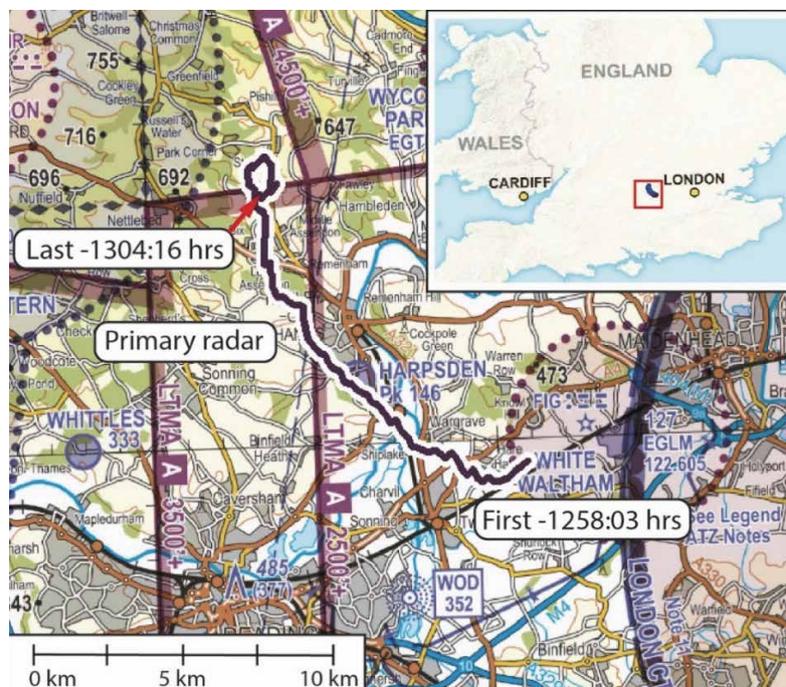
**Figure 2**  
Radar data

The only sources of data relating to the flight were primary radar recordings (Figure 2). This provided the aircraft flight path but no altitude information. Radar contact was lost at 1304 hrs.

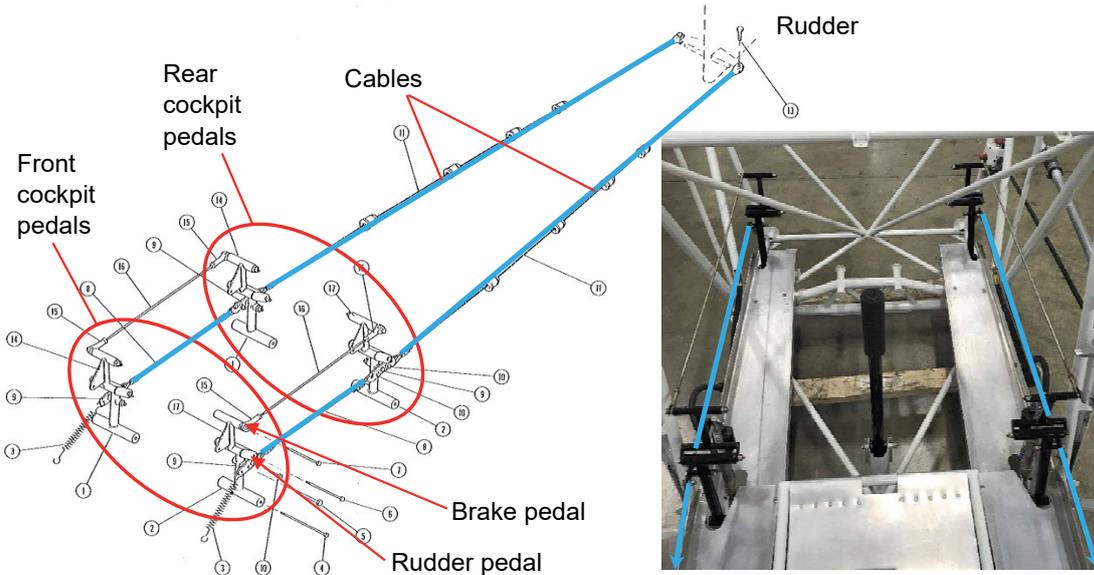
**Figure 4**

The rudder is operated by two steel cables running the length of the aircraft, which are connected to two sets of pedals, one set in each cockpit. When the left pedal is pushed forward, the cable pulls on a lever attached to the rudder and moves the rudder to the left, and visa-versa. As the left pedal is pushed forwards, the right pedal will be pulled backwards, with the pedals in both cockpits moving simultaneously. Figure 4 shows the system with an inset view, looking forward on the front cockpit, from an exemplar aircraft.

Rudder control system schematic and cockpit view looking forward in an exemplar aircraft

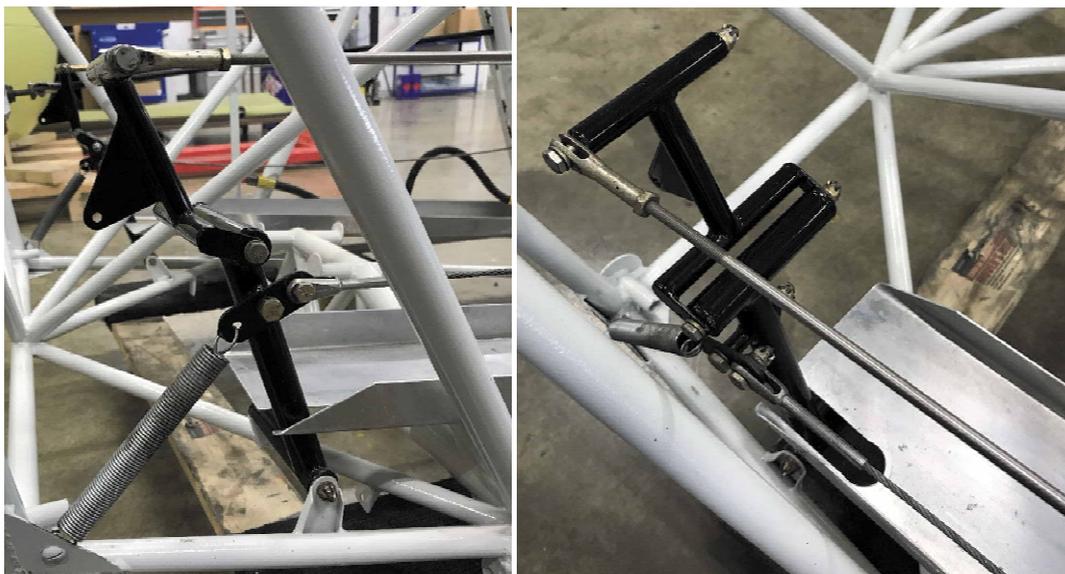
**Figure 5**

The airframe is a welded tubular steel construction with a fabric covering and sheet aluminium trays in the cockpits for the pilot's feet to rest upon. The rudder pedal hinges are welded to the frame and there are cut-outs in the trays to allow for pedal movement (Figure 5). The cut-outs in the trays allow for the full movement of the pedals and the rudder of +/- 30° without restriction. The brake pedals, which actuate the hydraulic brake system, are mounted on top of the rudder pedals. No adjustment of the pedal position or seat position to suit the pilot is possible.

Front rudder and brake pedal and heel tray cut-out (side and top view of exemplar aircraft)

A change of more than 30 mm in the front pedal neutral position when using the devices, caused the retreating pedal to come into contact with the end of the heel tray cut-out, thus preventing full pedal and rudder deflection. In the accident flight configuration (B2+B2), this interference restricted rudder movement by 3° (ie reduced the rudder movement from +/- 30° to +/-27°) and the maximum device setting restricted the rudder by 10° (from +/- 30° to +/-20°). In April 2019, the aircraft had a 50-hour maintenance check and, during the check, the devices were found already fitted to the rudder cables. While inspecting the rudder travel, the engineer noticed that there was a 6 mm gap between the rudder lever and the fuselage stop when the pedals were at the limit of their travel. This 6 mm gap at the rudder stop equated to approximately 3° of rudder travel. The devices were removed, and it was noted in the maintenance documentation that '*Non-approved rudder cable devices found fitted. Once removed rudder travel then is satisfactory*'. There was no discussion about this note between the operator and the maintenance organisation.

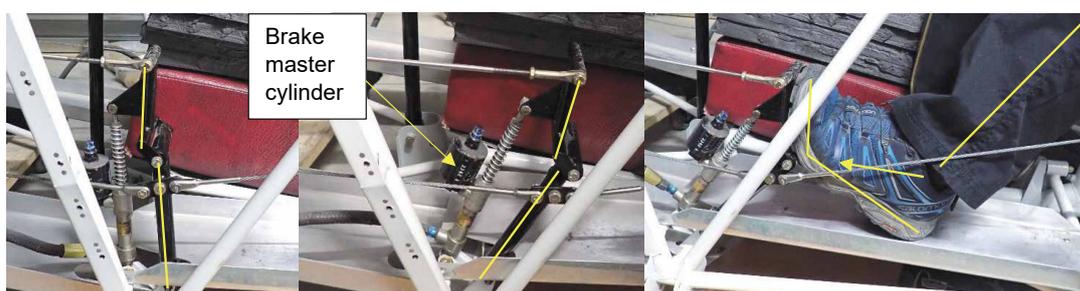
**Figure 8**

The geometry of the brake master cylinder and pedal connecting linkages means that, as the rudder pedal moves towards the rear of the aircraft, the brake pedal does not move as much (Figure 8 left and middle). The brake pedal position influences the pilot's foot posture and, with soft soled shoes as both pilots were wearing, extension of the toes would result in an optimal direction of force applied to the rudder pedal (Figure 8 right) with minimal force applied to the brake pedal. However, it has been stated that, whilst flying aerobatic manoeuvres, it is not uncommon for pilots to inadvertently apply the wheel brakes. Despite this small application of the brakes, the main application of force is through the rudder pedal.

Rudder / brake pedal relative movement and foot posture

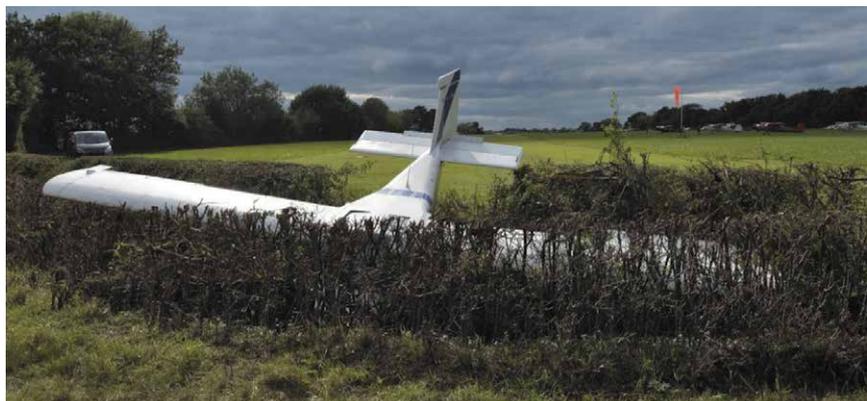
**Figure 2**

Approaching the end of the runway it became evident that the aircraft would overrun into the boundary hedge beyond. The pilot was not aware that the hedge line contained a ditch and assumed the safest course of action was to go through it. The pilot stated that if he had known of the ditch he would have tried to turn away before impact. G-MPAC left the runway at approximately 15 kt and penetrated the hedge before tipping forward and coming to an abrupt halt (Figure 1 and Figure 2).

View looking down Runway 26  
(image © Leicestershire Police)

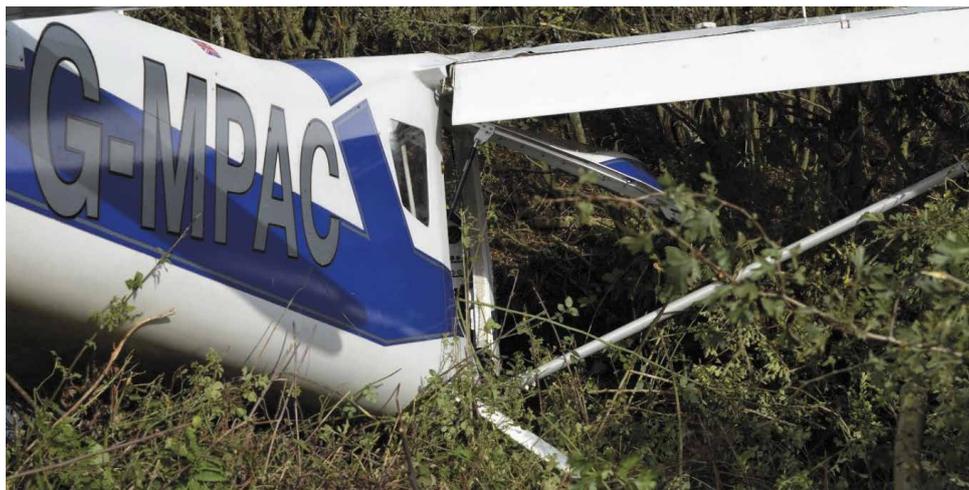
**Figure 4**

The occupants were able to exit the aircraft using the door on the right side of the aircraft, although progress was hindered by the hedge's thorny branches. Bystanders were quickly on scene to assist.

Photograph showing exit route through the right cockpit door  
(image © Leicestershire Police)

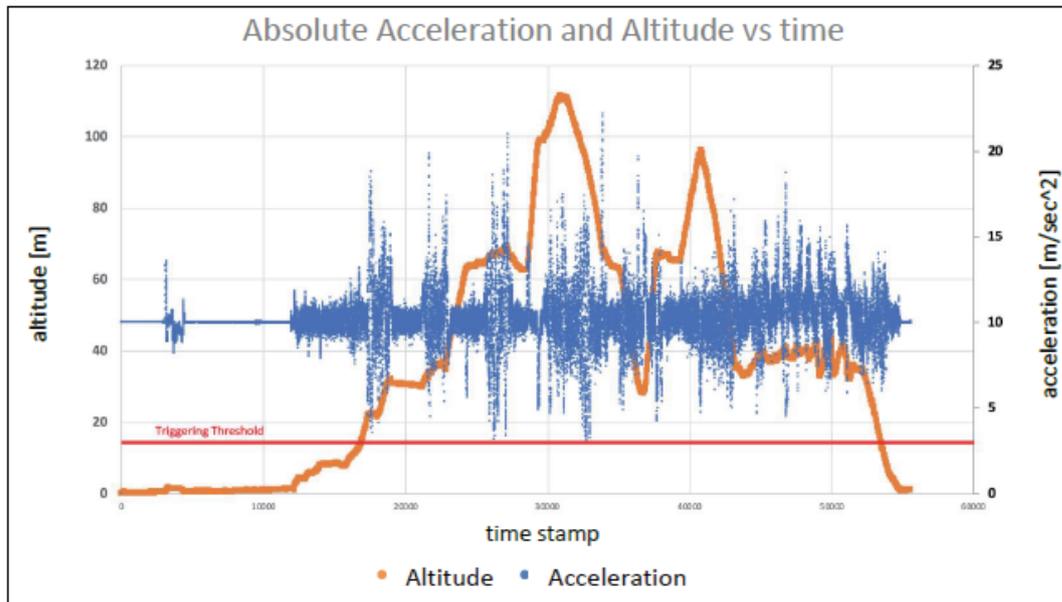
**Figure 3**

The Matrice 200 with the SafeAir unit fitted was then flight tested to assess the behaviour of the parachute system during flight. A flight profile similar to that of the accident flight was used and additional, more extreme, manoeuvres were flown. No abnormal events were recorded during the flight test. The parachute system did not trigger, nor did the acceleration cross the triggering threshold (Figure 3).

SafeAir recorded data for the test flight  
(Source ParaZero)

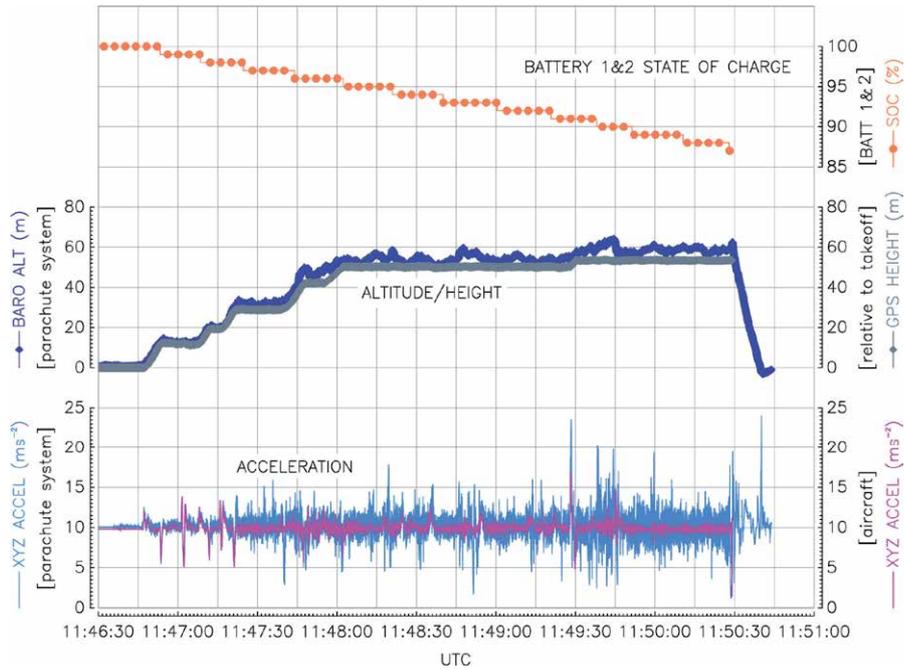
Figure 4

A review of the aircraft's on-board recorded data by the AAIB confirmed that the recording ended abruptly after 220 seconds, when the aircraft was hovering at a height of 53.5 m (recorded resolution is 0.5 m), having travelled 390 m from the takeoff point. The energy level (state of charge) of the aircraft's two batteries was 87% (Figure 4). The figure also compares the aircraft's altitude and acceleration data with the equivalent data from the SafeAir log file and shows that as the flight progressed, the acceleration recorded by the SafeAir system grew in amplitude compared to that recorded by the aircraft.

Flight log data from the aircraft and SafeAir system for the accident flight

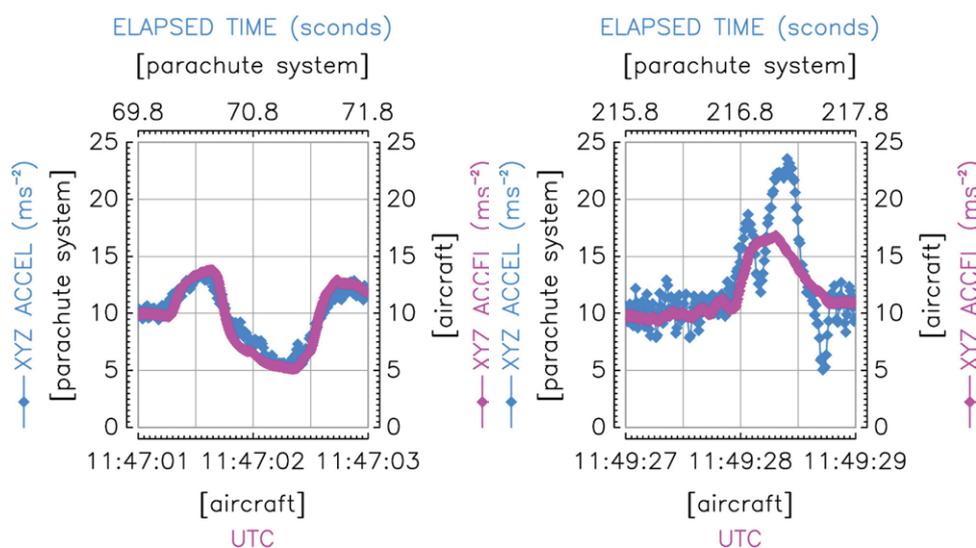
**Figure 6**

The two acceleration data sets in Figure 5 appear misaligned; however, given that the aircraft logged data at about 200 Hz and timestamped each line of data in the log file with a UTC time, these should be accurate to within 5 ms. Similarly, the parachute system logged data at about 100 Hz so should be accurate to within 10 ms. It is also time stamped data but relative to the start of logging. The alignment of these data sets, therefore, relies on matching accelerations during a couple of portions of the flight, ideally at the start and then as near to the end as possible where a match in acceleration can be found to confirm the alignment. Figure 6 does this by comparing accelerations shortly after takeoff and then 150 seconds later (about 60 seconds before parachute deployment). Note that each square on the x-axis is 500 ms so any misalignment more than say 50 ms would be noticeable.

Comparison of accelerations to time align aircraft and parachute system datasets
