# DESIGN AND OPERATION OF TRASH SCREENS CASE STUDY

## LEEN SYPHON

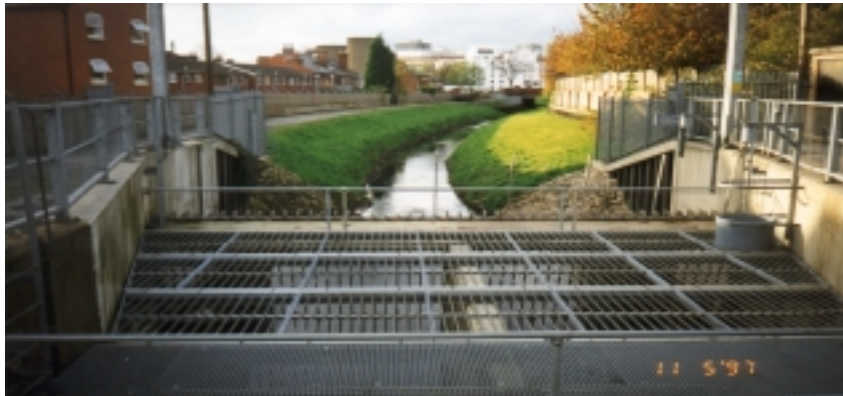
**Figure 1.1 View of the canalised river looking directly upstream. The access road is on the left of the river.**

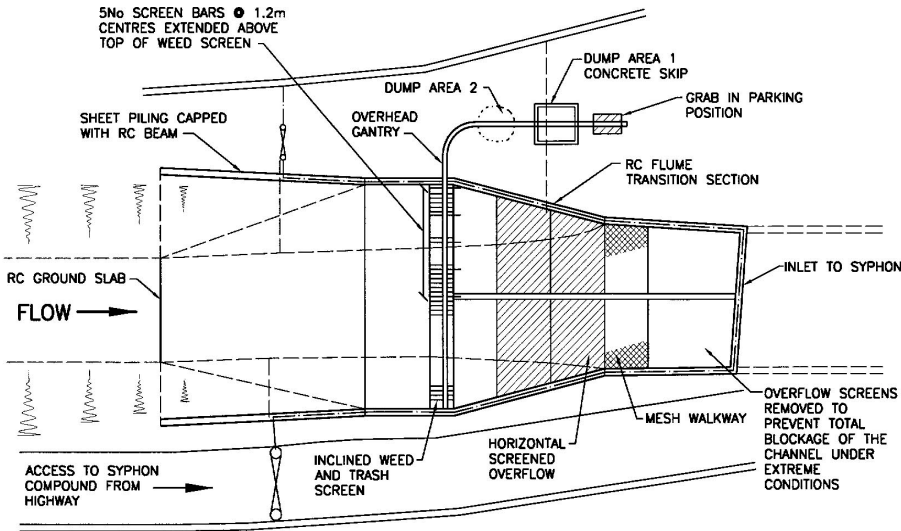
Figure 2.3 Screen Layout

The screen face is some 29m<sup>2</sup> and set at an angle of 73 degrees to the horizontal. The plan above shows the horizontal layout of the screen, which is regarded as the overflow area. (*Manual, Section 3.3.4 details screen sizing*).
