# DESIGN AND OPERATION OF TRASH SCREENS CASE STUDY

## LUSTRUM BECK

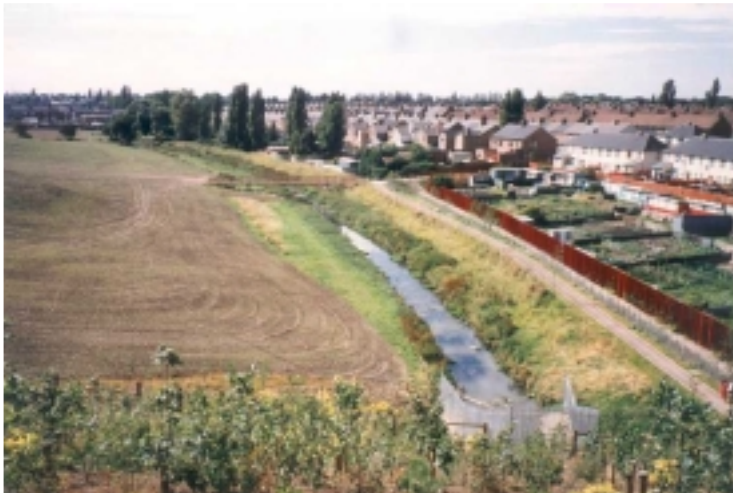
**Figure 1.1 View of the area prior to construction of the screen but after the installation of the culvert.**

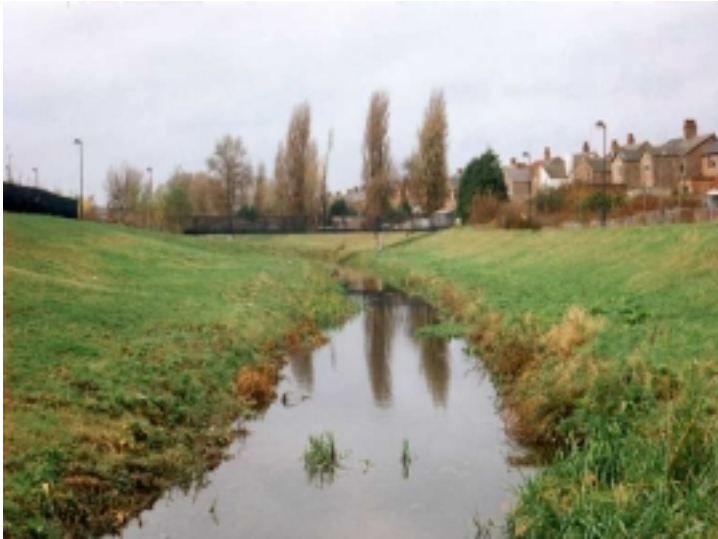
**Figure 2.2 View of the Lustrum Beck immediately upstream of the trash screen site. To the right are allotments gardens and to the left is the new public park and play area.**
