AAIB Bulletin: 3/2021

Alauda Airspeeder Mk II

#### ACCIDENT

Aircraft Type and Registration:	Alauda Airspeeder M	lk II, (UAS, registration n/a)
No & Type of Engines:	4 brushless DC elect	ric motors
Year of Manufacture:	2019	
Date & Time (UTC):	4 July 2019 at 1140 I	nrs
Location:	Goodwood Aerodron	ne, West Sussex
Type of Flight:	Demonstration flight	
Persons on Board:	Crew - None	Passengers - None
Injuries:	Crew - N/A	Passengers - N/A
Nature of Damage:	Destroyed	
Commander's Licence:	Remote Pilot Licence	9 <sup>1</sup>
Commander's Age:	22 years	
Commander's Flying Experience:	20 hours (of which 1 Last 90 days - 3 hou Last 28 days - 1 hou	8 were on type) rs r
Information Source:	AAIB Field Investigat	tion

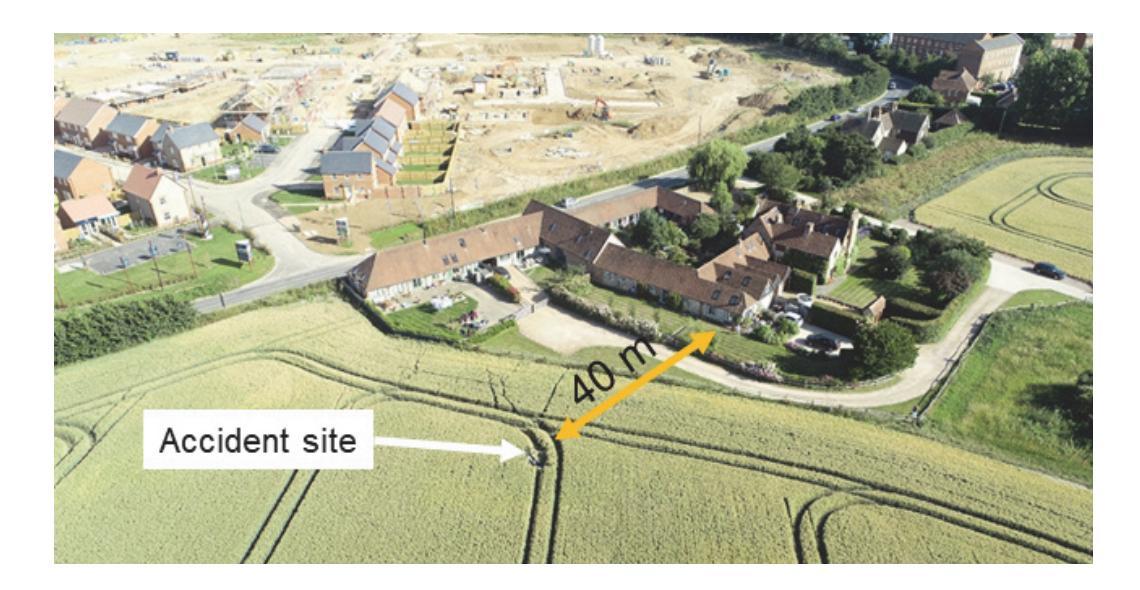
The UA came to rest inverted in a field of wheat, 875 m south-south-west of the takeoff point. The crop was dry and there was no post-impact fire. The accident site was 40 m from the nearest building which was in a group of houses on the north-eastern edge of Chichester, (Figure 4).

Figure 4 Accident site, looking south

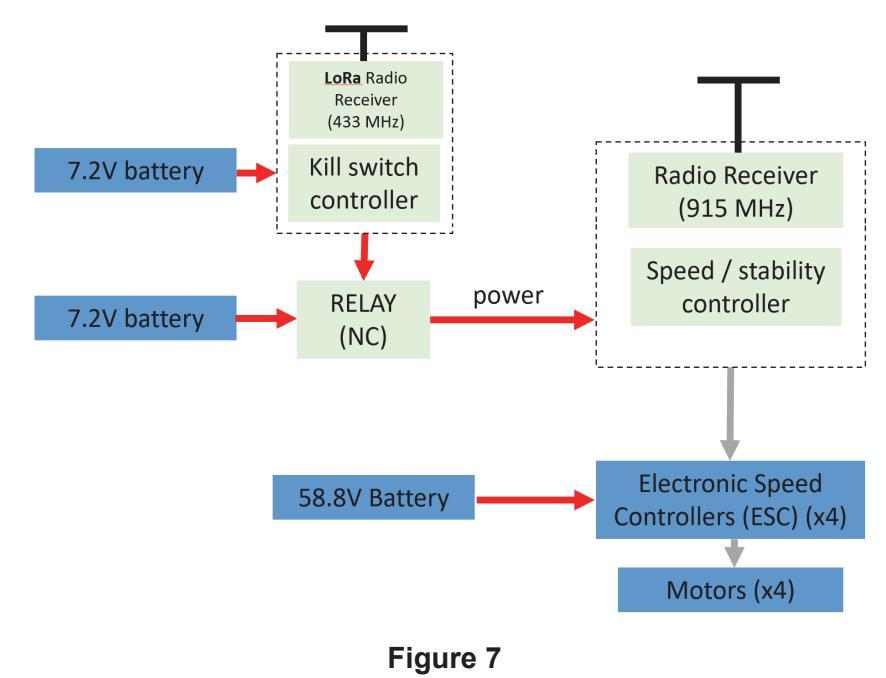
The flight controller power supply was routed through a relay, which was controlled by a kill switch. This relay was wired in the 'Normally Closed (NC)' position meaning that if the kill switch was unpowered, power was still available to the flight controller (Figure 7). When activated, the kill switch opened the relay, cutting the power to the flight controller. With the control system unpowered, the ESCs would receive no command and the motors would stop.

On-board control system schematic

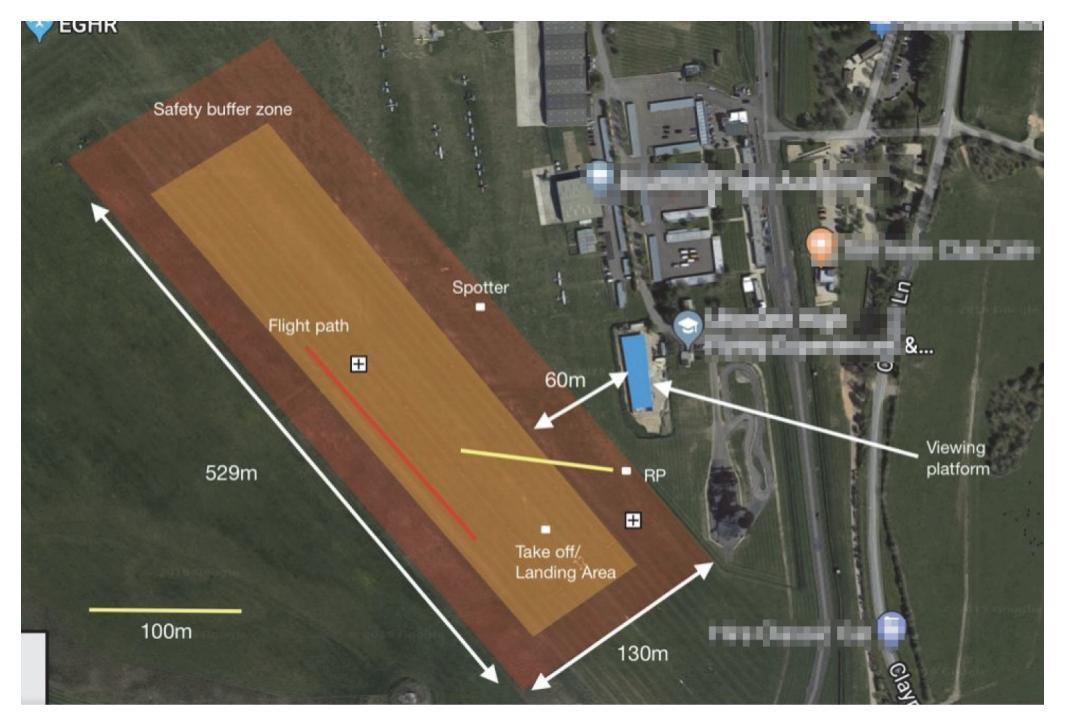
Invited guests were to be located on the viewing platform. The area in orange in Figure 13 is the flight area where the operator was to perform the display. The area shaded red is the safety buffer zone which the OSC stated that if flown in '*will require a response from spotter to alert the RP* [Remote Pilot] *of the perimeter breach and initiate redirection procedures*'.

**Figure 13** Operating area detail from Flight Approval Form in OSC Volume 1

The display area dimensions (orange area in Figure 14) defined in the OSC were approximately 90 m x 450 m, with the safety buffer zone extending towards the viewing platform by 45 m. The viewing platform was 30 m from the edge of the red safety buffer zone (Figure 13).

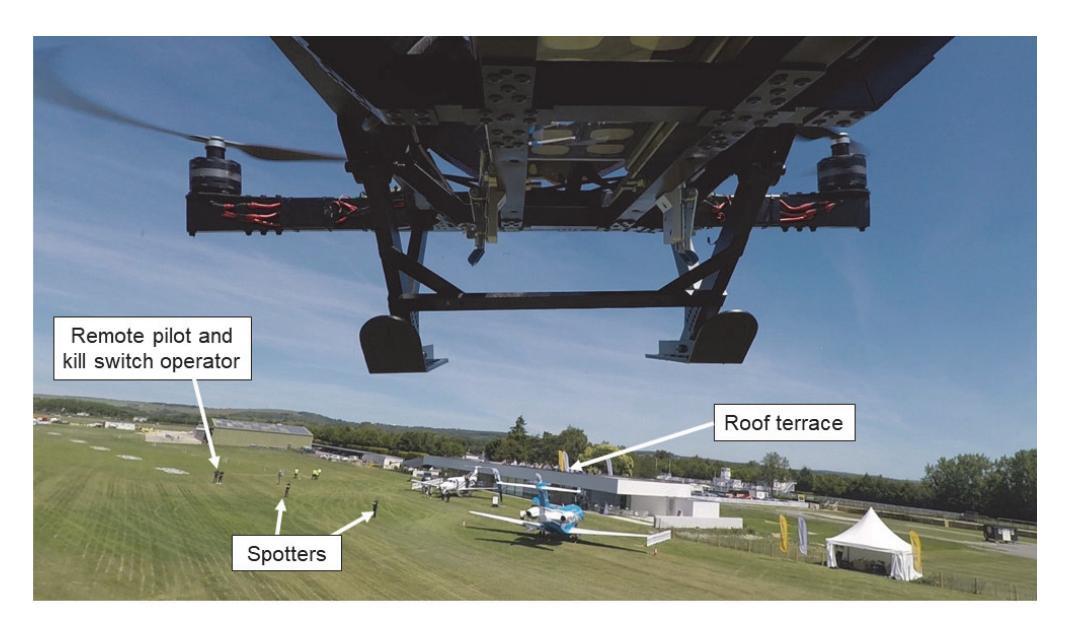
# Figure 15

Video footage was reviewed to compare requirements of the CAA exemption and the operation of the aircraft. The review confirmed that, within the camera's field of view, the UA remained intact for the display with no visible failures of the motors, propellers, ESCs, airframe and battery. The footage also revealed a number of items including aircraft parked in front of the aerodrome building (Figure 15) and two fuel bowsers parked within the safety buffer zone. At times, during low-speed turns, the aircraft was pointed directly towards the aerodrome building.

View from bottom rearward-facing camera towards the aerodrome building, just after takeoff
