Soil piping tests on Thorngumbald flood embankment

Keywords: Flood embankments, soil piping, mode of failure,
internal erosion

Science Report FD2411/TR3. This short investigation was
part-funded by EA Science as part of Defra project FD2411.

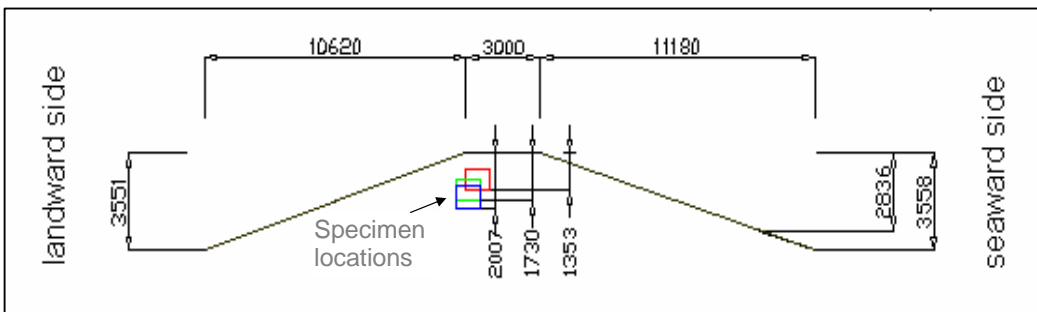
Figure 3: Location of Samples within the Embankment

Samples were obtained from the embankment from location 'x' shown on the plan in Figure 1 and in section in Figure 3. The three samples were taken from the middle of the proposed breach area from the landward side of the embankment so as not to expose the embankment to a possibility of breaching by the sea. Sampling locations are shown in Figure 3.

The elevation of the base of the specimens in terms of 'Ordnance Datum Newlyn' (ODN) was: Specimen 1 - +4.25 m ODN, Specimen 2 - +3.87ODN and Specimen 3 - +2.79m ODN. Mean sea level and high water (spring) are approximately +0.3m ODN and +3.4m ODN respectively. Thus part of the embankment from which the lowest specimen (Specimen 3) was obtained would be subjected to some hydraulic loading. [In terms of extreme water levels, 1 year and 100 year extreme water levels (not taking account of

During specimen recovery, it was found that up to a depth of about 1.3m, upper layer of the embankment comprised blocky, firm to stiff, brown silty clay with some voids and sometimes approximately orthogonal fissures resulting in small blocks of soil. The degree of fissuring was variable both on plan and with depth. The largest voids were about 20mm wide and were discontinuous. In general, fissuring and the degree of voids decreased with depth. As such deeper specimen comprised of more homogeneous material, with a fewer voids and fissures. It is possible that the embankment was formed without adequate compaction and it is most likely that the lower parts were compacted due to overburden pressure.

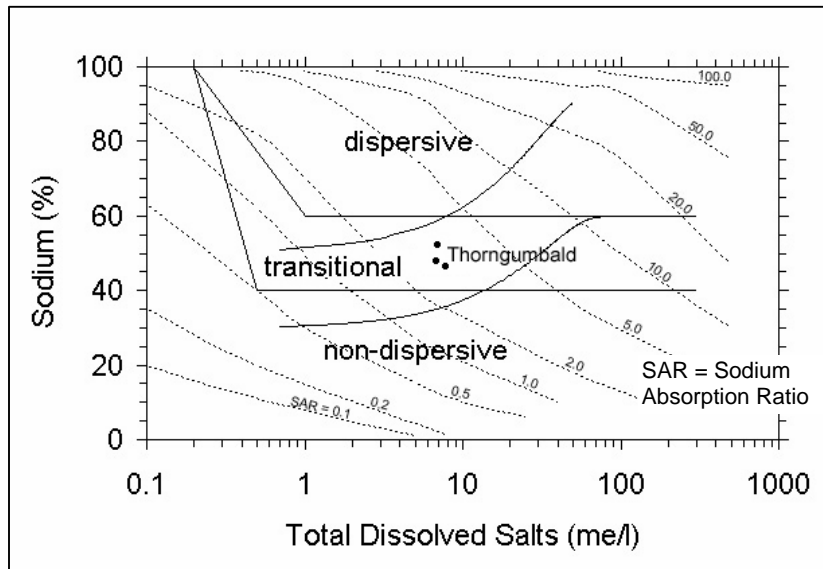
Figure 5: Dispersive character of the Thorngumbald Clay Based on Sodium Absorption Ratio (after Sherard et al., 1976)

Previous research (Arulanandan *et al.*, 1975) has shown that salt content, in particular the sodium salt to total salt ratio of the soil, may have a significant effect on the erodibility of soils. Therefore, total salt and sodium salt content determinations were made. These results summarised in Figure 5, show that the Thorngumbald material was on the boundary between dispersive and non-dispersive clays based on the recommendations by Sherard *et al.* (1976). Atomic absorption technique was used to determine the salt content by measuring the concentrations of ions in the pore water extract. Sodium, potassium, magnesium and calcium ions were the four most abundant and the sum of their concentrations was considered to make up the total dissolved salt concentration.

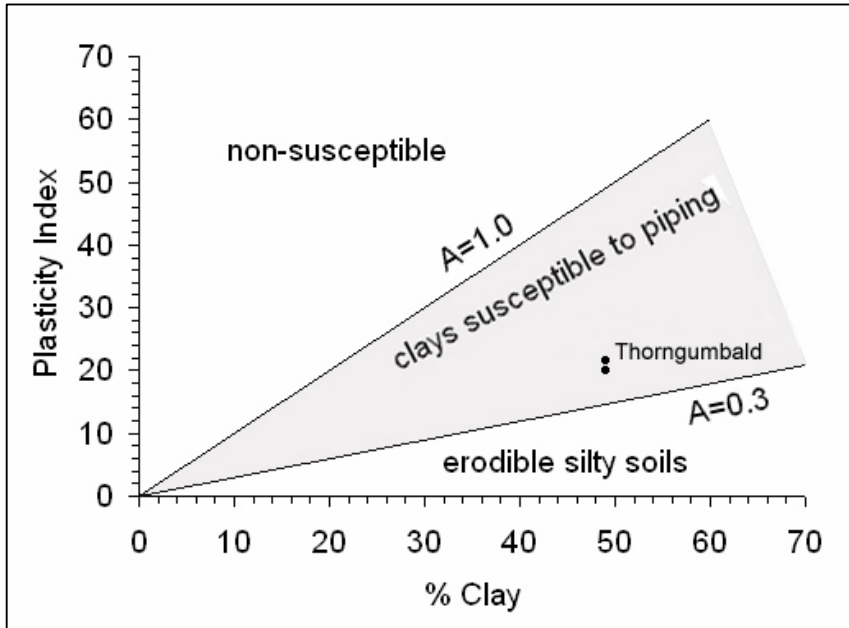
Figure 6: Clay Activity and Susceptibility to Piping (Resendiz, 1977)

Activity of a soil is the ratio of its Plasticity Index (Liquid Limit – Plastic Limit) and the clay content and can be used to assess susceptibility of a soil to piping (Resendiz, 1977). Plasticity Index and percentage clay fines for the Thorngumbald embankment clay, shown in Figure 6, suggest that it is susceptible to piping.

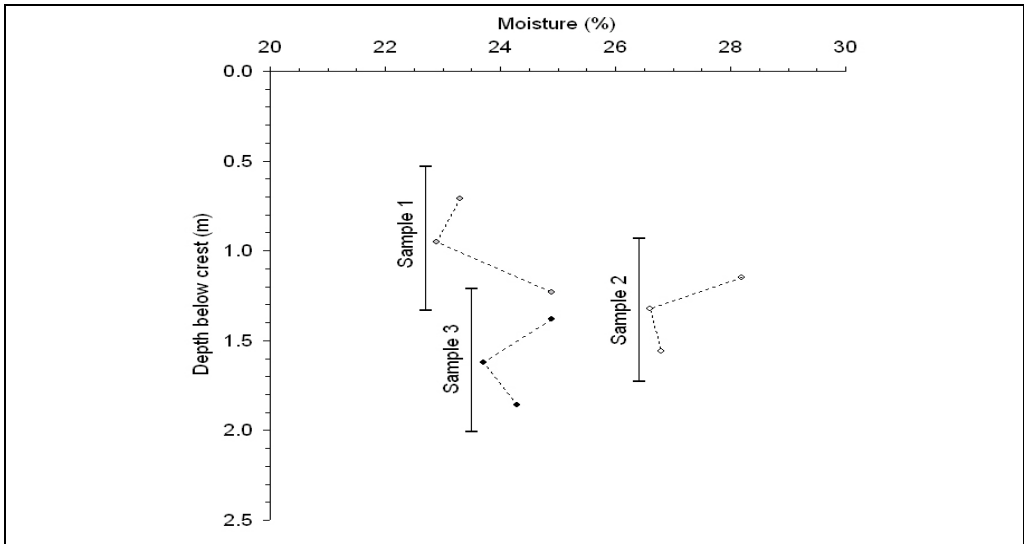
Figure 7: Variation of Natural Moisture Content with Height

Moisture content distribution in the embankment with depth is shown in Figure 7. Although there was an overlap in the depths from which samples were taken, there was up to 3% difference in moisture content from similar elevations. The reduced moisture content of the mid-depth specimens for each of the specimens is thought to be a coincidence and reflects variability within the embankment.

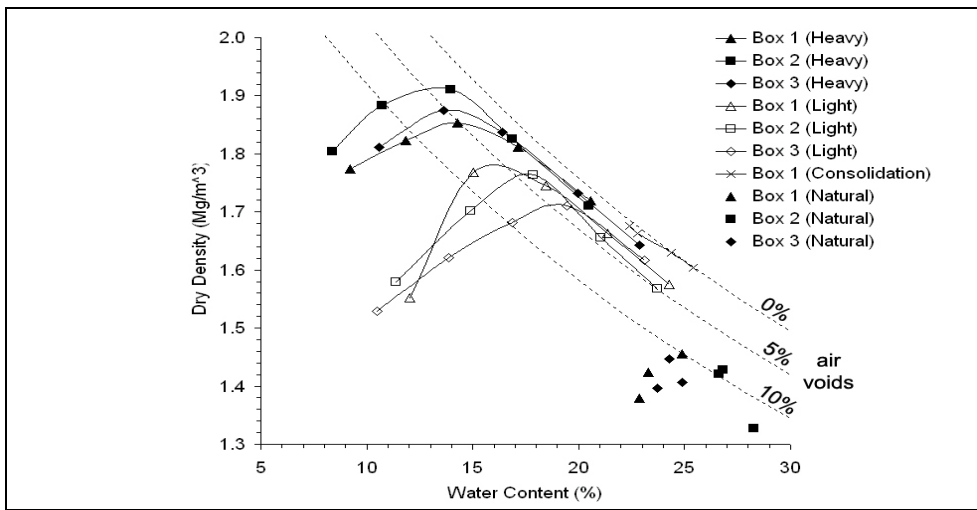
Figure 8: Compaction Characteristics

A comparison of measured density and density determined from compaction tests (both heavy and light) is shown in Figure 8. The dry density of the embankment material was about 15% and 22% lower than the maximum dry density measured in the laboratory investigation for both the light and heavy compactions respectively. However, the field moisture content was about 6% and 10% respectively higher than the optimum moisture content determined respectively from the light and heavy compaction tests. At the higher moisture contents measured in the field it is estimated that the dry density of the in-place embankment material was only about 5% to 7% below that determined from both the compaction tests. It is not possible to comment on the implications of this without knowing the design to which the embankment was constructed. [It has clearly been stable for numerous decades. So perhaps it has met its requirements in terms of strength.] It is however worth noting that the field moisture contents were higher than the optimum moisture contents ascertained from compaction tests and the field density was much lower than the maximum dry density. Thus it is not possible to pin down the cause of fissuring since in each case moisture content was higher than the Plastic Limit of the soil. The field density was considered to be particularly low for a long standing flood embankment. Many such embankments are known to be constructed with relatively poor quality control by modern standards.

For the laboratory pipe erosion tests, specimens were reconstituted from slurry made from the recovered specimens. The densities achieved for these tests are also shown as “Box 1 (consolidated)” in Figure 8. Field densities were about 10% lower than those of the reconstituted specimens. Lower densities were expected since the in situ embankment material contained many voids.

The embankment is constructed from “poorly” compacted material as it has a dry density that was at least 15% lower than maximum dry density ascertained from laboratory compaction tests. The in situ moisture content of the soil was also about 6% greater than that determined from a laboratory compaction test.

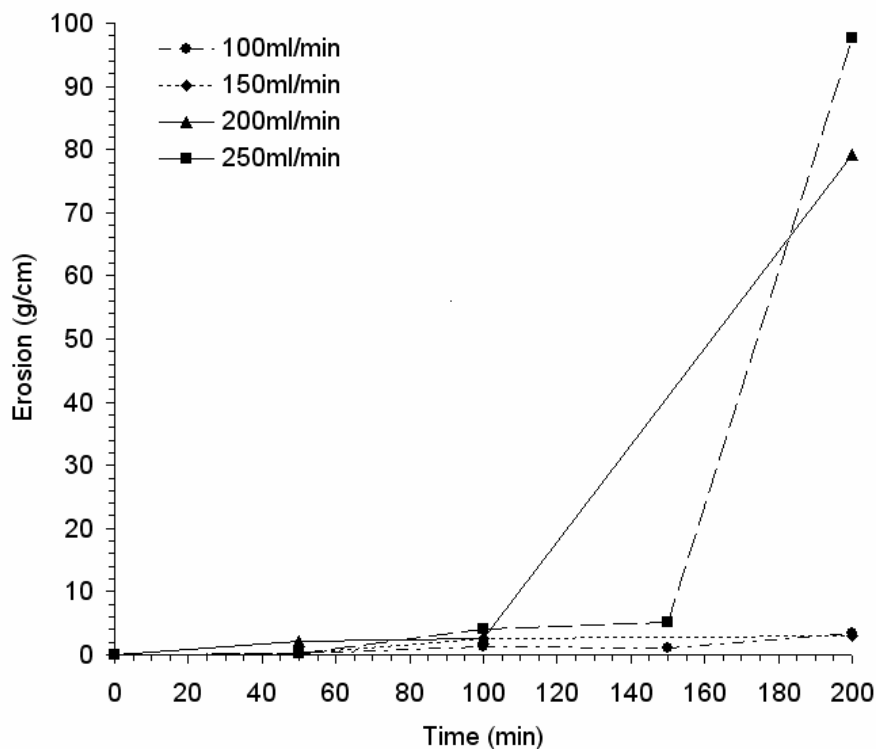
Figure 11: Internal Erosion Rates for Thorngumbald Clay (at its natural moisture content and density) Against Time of Applied Flow

The rate of erosion of re-formed Thorngumbald clay (at its natural moisture content and density) against time of applied flow is shown in Figure 11. The erosion rate is normalised in terms of volume of material eroded (g) per unit length (cm) of the pipe. For flow rates of below 150ml/min and below there was no significant erosion, suggesting formation of a stable pipe. For flow of greater than 200ml/minute there was a rapid increase in erosion after about 100minutes. For lesser period the pipe seems to be stable. This perhaps suggests that excessive exposure to high flow rate may lead to increased shear stress on the particles, which lead to their dislodgement. Once particles start to dislodge, turbulent flow may develop that may lead to very rapid increase in erosion. This excessive erosion can be seen in Figure 10 flow above 200ml/minute for duration of 200 minutes.

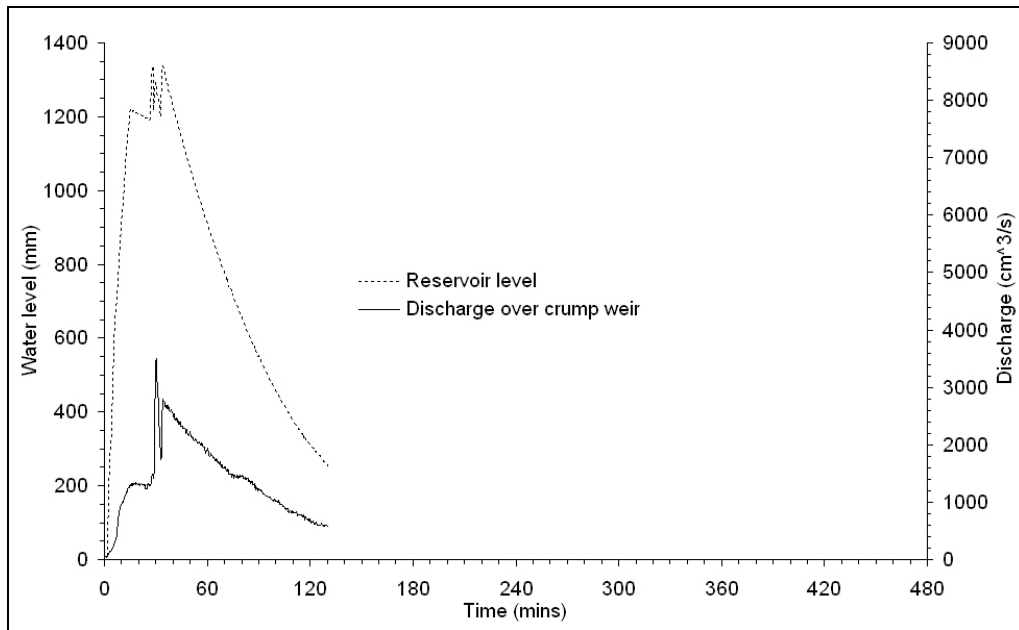
Figure 15: Water Level and Discharge Hydrograph for Pipe Test No. 1

The first sample to be tested was Box 1, which was taken near to the top of the embankment with its base being at 1.33m for the embankment crest. Test 1 was run twice due to complications. The upstream water level and discharge through the pipe against pipe are shown Figure 15. The results show that the upstream head of water was not constant. This was because during the first run a major leak appeared in the side of the flume, just as peak water level was achieved. The test therefore had to be abandoned so that repairs could be carried out. The second run also ran into difficulties shortly after peak water level was reached. This time large leakage was observed between the upstream face and the weir. It was not possible to control this leakage and the force to the water caused the soil block to be moved out from within the box. The test was abandoned, as the specimen was unusable. The upstream and downstream faces of the sample block are shown in Figures 16 and 17 respectively. Over the 22 minutes of variable head, both the upstream and downstream faces of the pipe did not show signs of erosion.

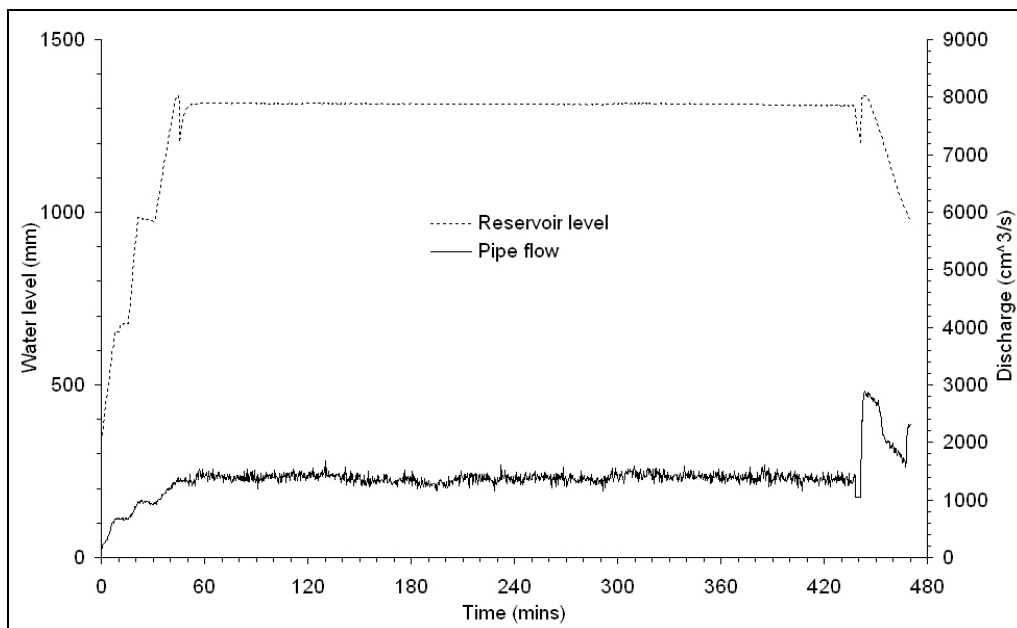
Figure 18: Water Level and Discharge Hydrograph for Pipe Test No. 2

Test 2 used the sample from Box 2. The sample was inspected before the start of the test and a crack was noticed along the top and continuing down the downstream face. The degree to which this crack developed during transport or simply reflected a wider existing network of fissures within the sample was unclear. Given the care taken to transport undisturbed samples, it is thought more likely to reflect an existing fault or fissure line within the sample. At the beginning of the test the crack was estimated to be approximately 1mm in width, but it was not possible to ascertain its depth. During the test this crack was monitored. Under cutting of the downstream face was also observed and approximately 38 minutes after start of the test a small block failure occurred essentially below the level of the pipe (see second photograph in Figure 20) This was considered to have occurred due to ingress of water into fissures in the sample. Subsequent to this failure, the vertical crack started to widen and large block failure of the downstream face occurred about 58 minutes after the start of the test. The presence of voids and fissures are considered to have been the main cause of block failures.

After this the test was run for a further 6 hours with no notable signs of block failure or significant erosion occurring. The upstream water level and discharge through the pipe

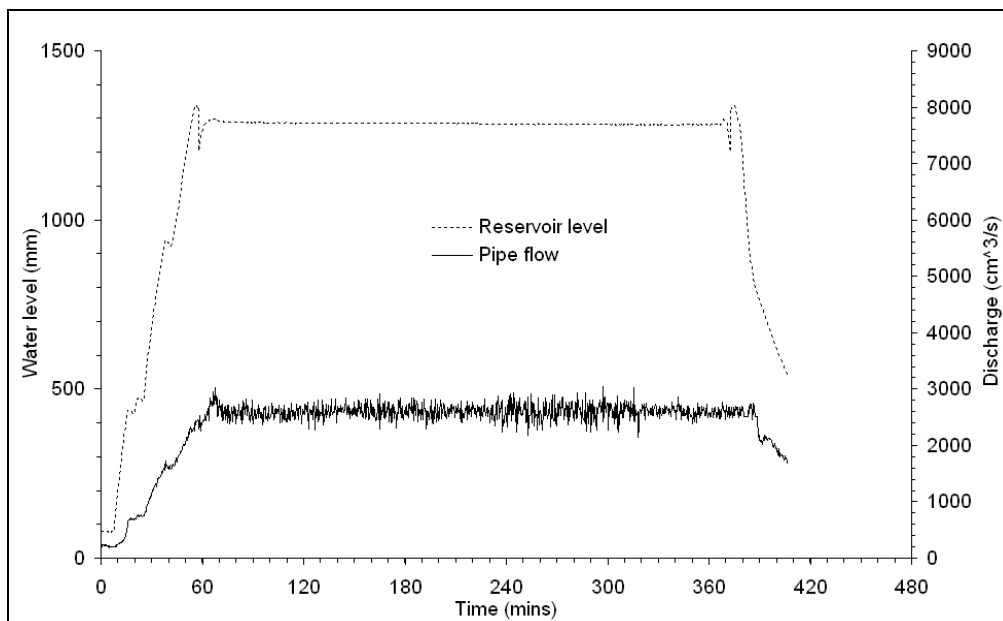
Figure 21: Water Level and Discharge Hydrograph for Pipe Test No. 3

Box 3 was used for this test. The sample was the deepest of the three with its base at 2.01m below the crest. Erosion was again seen below the level of the pipe outlet. In this case erosion was directly under the outlet and then spread to either side. There was also some erosion above the outlet and into the specimen along the roof of the pipe to a distance of approximately 180mm into the specimen. Approximately 2 hours after the start of the test a large block failure occurred on the downstream face. Increased seepage was noted in the area of the crack. After approximately 5 hours, another large block failure occurred on the opposite side of the previous failure. This caused material on the roof of the pipe to fail. The upstream water level and discharge through the pipe are shown Figure 21. The upstream and downstream faces of the test specimen are shown in Figures 22 and 23 respectively. It was clear in this instance that voids and fissures were the main contributing factors.

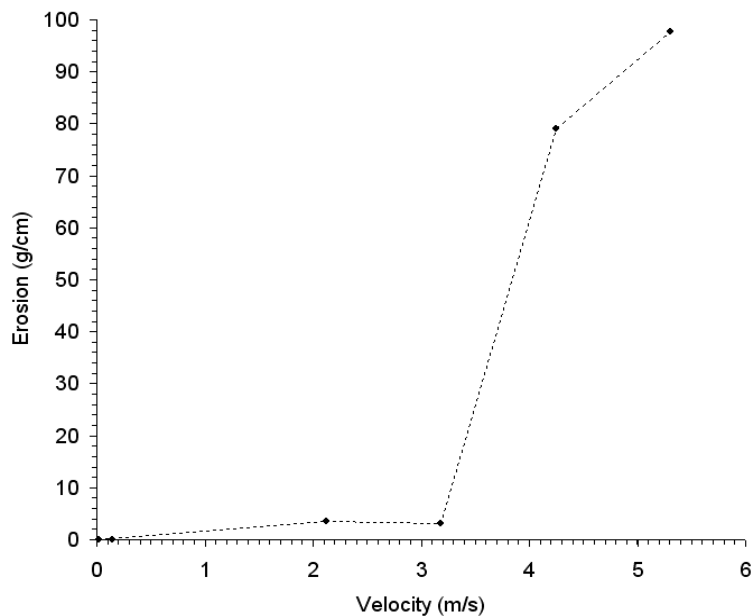
Figure 24. Erosion of embankment clay at 200 minutes in terms of initial velocity.

The relationship between initial velocity in the pipe and erosion per unit length for the small scale are shown in Figure 24. Results show that there was little erosion below an initial velocity of about 3.2m/s. Erosion increased rapidly beyond this velocity.

Results of all the tests in terms of pipe diameter, discharge, hydraulic head (h_i), initial velocity and erosion in terms of unit length of pipe are given in Table 3. Whilst there is no overlap between the discharge rates, it seems that velocity is the key variable in terms of

erosion. Thus, in this instance, it is tentatively suggested that provided the velocity of flow can be limited to below about 3.2m/s a stable pipe may exit provided also that failure due to other modes is not initiated.
