SERIOUS INCIDENT

Aircraft Type and Registration:	1) Boeing 737-8AS, EI-DPC 2) Boeing 737-8Z9, G-GDFR 3) Boeing 757-28A, G-OOBA
No & Type of Engines:	1) 2 CFM56-7B27 turbofan engines 2) 2 CFM56-7B26 turbofan engines 3) 2 Rolls-Royce RB211-535E4-37 turbofan engines
Year of Manufacture:	1) 2006 (Serial no: 33604) 2) 2003 (Serial no: 30421) 3) 2000 (Serial no: 32446)
Date & Time (UTC):	8 September 2020 at 2227 hrs
Location:	Birmingham Airport
Type of Flight:	1) Commercial Air Transport (Passenger) 2) Commercial Air Transport (Passenger) 3) Commercial Air Transport (Passenger)
Persons on Board:	1) Crew - 6 Passengers - 35 2) Crew - 6 Passengers - 181 3) Crew - 8 Passengers - 190
Injuries:	1) Crew - None Passengers - None 2) Crew - None Passengers - None 3) Crew - None Passengers - None
Nature of Damage:	1) None reported 2) None reported 3) None reported
Commander's Licence:	1) Airline Transport Pilot's Licence 2) Airline Transport Pilot's Licence 3) Airline Transport Pilot's Licence

Synopsis

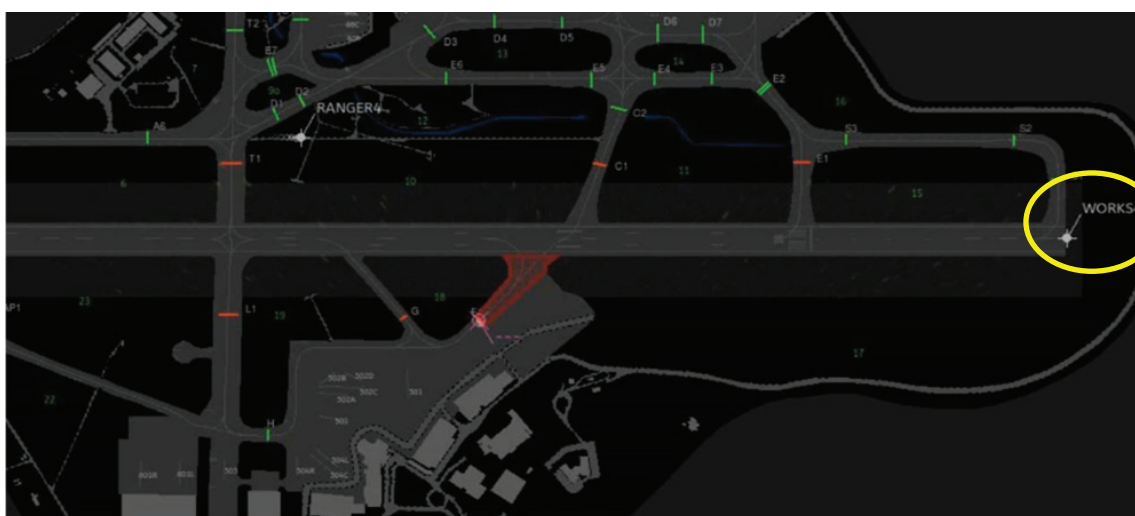
**Figure 9**

At 2135 hrs WV4, having gained permission from ATC, entered Runway 33 from holding point S1. The vehicle then parked at the edge of the grass in the undershoot of the runway. Figure 9 shows part of the SMR picture with WV4 (highlighted) parked at the beginning of Runway 33.

WV4 at the beginning of Runway 33
