ACCIDENT

Aircraft Type and Registration:	DJI Matrice 200 V1, (UAS, registration n/a)
No & Type of Engines:	4 electric motors
Year of Manufacture:	2018 (Serial no: 0FZDF7U0P30222)
Date & Time (UTC):	1) 21 September 2019 at 1318 hrs 2) 29 November 2019 at 1022 hrs
Location:	1) Near Raigmore Hospital, Inverness 2) Montrose, Angus
Type of Flight:	Commercial operation
Persons on Board:	Crew - N/A Passengers - N/A
Injuries:	Crew - N/A Passengers - N/A
Nature of Damage:	1) Landing gear, lower cowl, rear antennas and forward camera damaged 2) Landing gear and rear control link antenna damaged
Commander's Licence:	Other
Commander's Age:	39 years
Commander's Flying Experience:	1) 86 hours (of which 27 were on type) Last 90 days - 9 hours Last 28 days - 4 hours 2) 88 hours (of which 29 were on type) Last 90 days - 11 hours Last 28 days - 2 hours
Information Source:	AAIB Field Investigation

Synopsis

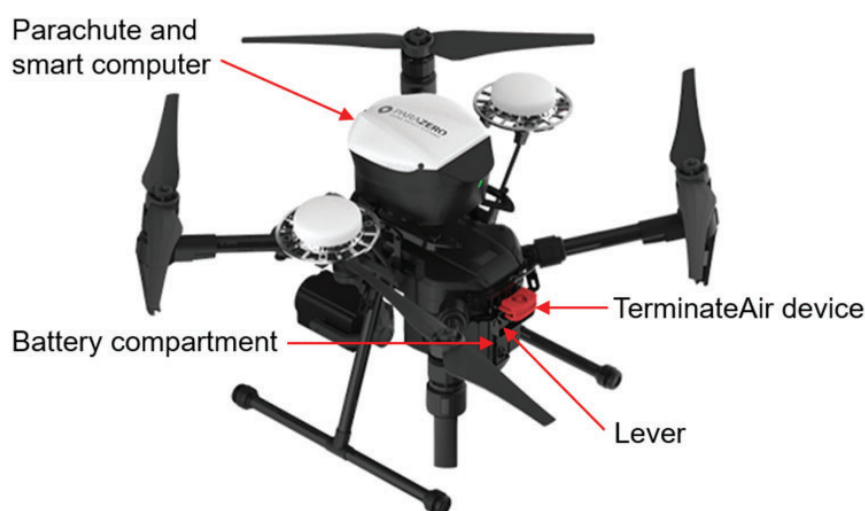
Figure 2

The parachute and the system's internal electronics are mounted on a plate which is fitted on top of the aircraft (Figure 2). A flight termination device, known as TerminateAir, is mounted above the aircraft's battery compartment. A cable connects it to the rest of the parachute system.

Parazero SafeAir M200 installed on a DJI Matrice 210 RTK unmanned aircraft
(Used with permission of ParaZero Ltd.)

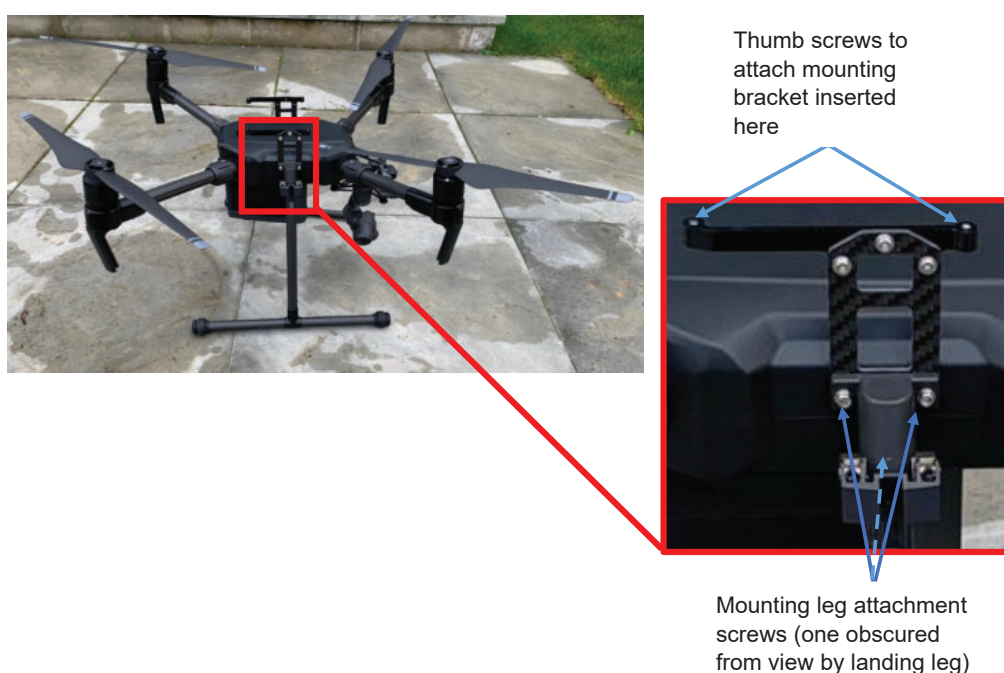
Figure 3

To allow rapid installation and removal of the parachute, the integral mounting plate attaches to two parachute mounting legs via four thumb screws, one in each corner of the mounting plate. The parachute mounting legs are fitted to the aircraft's landing leg joints by removing the existing three landing leg attachment screws and replacing them with three longer screws (Figure 3). A spring washer and plain washer are also installed at each mounting screw. The parachute mounting legs can remain attached to the aircraft between flights.

DJI Matrice 210 with mounting legs for SafeAir M200 parachute system attached

When the aircraft was returned to the operator in November 2019, following repair by the aircraft manufacturer, the operator inspected the SafeAir mounting legs and noted that the attachment screws were loose and had not been installed in accordance with the SafeAir

installation guide. Spring washers were missing from four of the screws and flat washers were missing from the other two screws. It was highly likely the mounting legs had been removed during the repair at the aircraft manufacturer's facility and so the post-repair condition of mounting leg attachment screws and washers did not provide an indication of their pre-accident condition.
