AAIB Bulletin

3/2021

Published 11 March 2021.

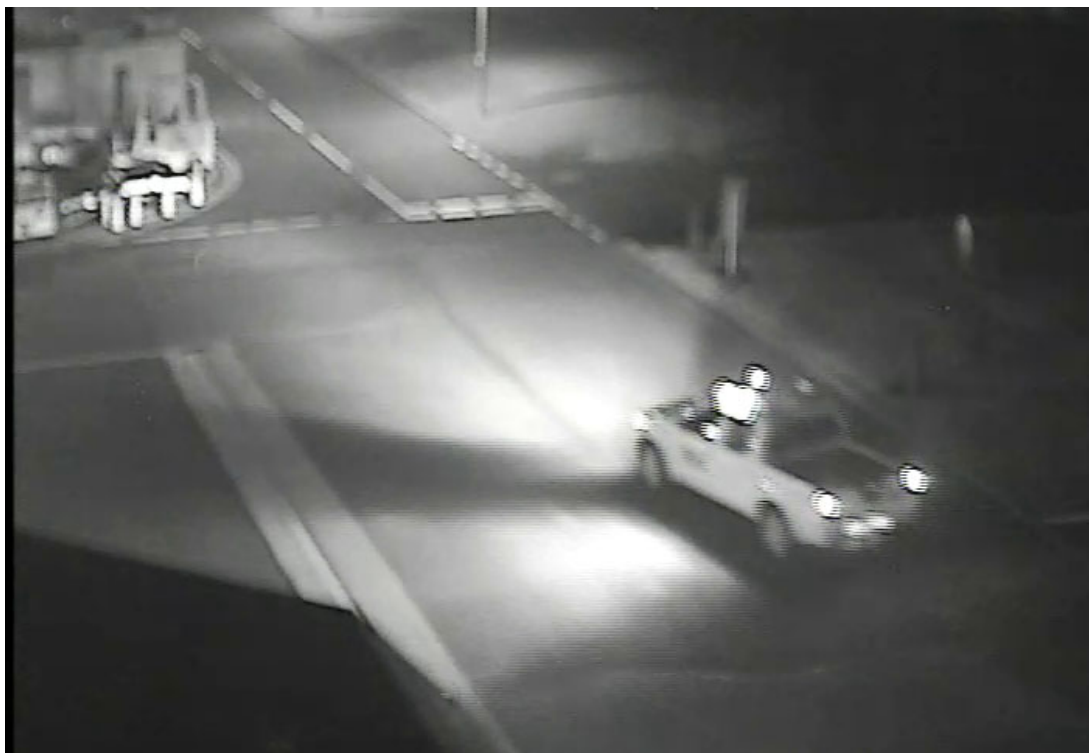
Figure 12

At 2218 hrs Technician 1 was informed by ATC that the first inbound aircraft was 20 nm from touchdown. This was acknowledged by Technician 1, and Technician 2 got back into the vehicle before they vacated the runway via Taxiway B. The vehicle again passed the fire station at 2220 hrs as shown at Figure 12. Note, the tailgate of the truck is up, and the ladder is not present.

WV4 passing the fire station at 2220 hrs

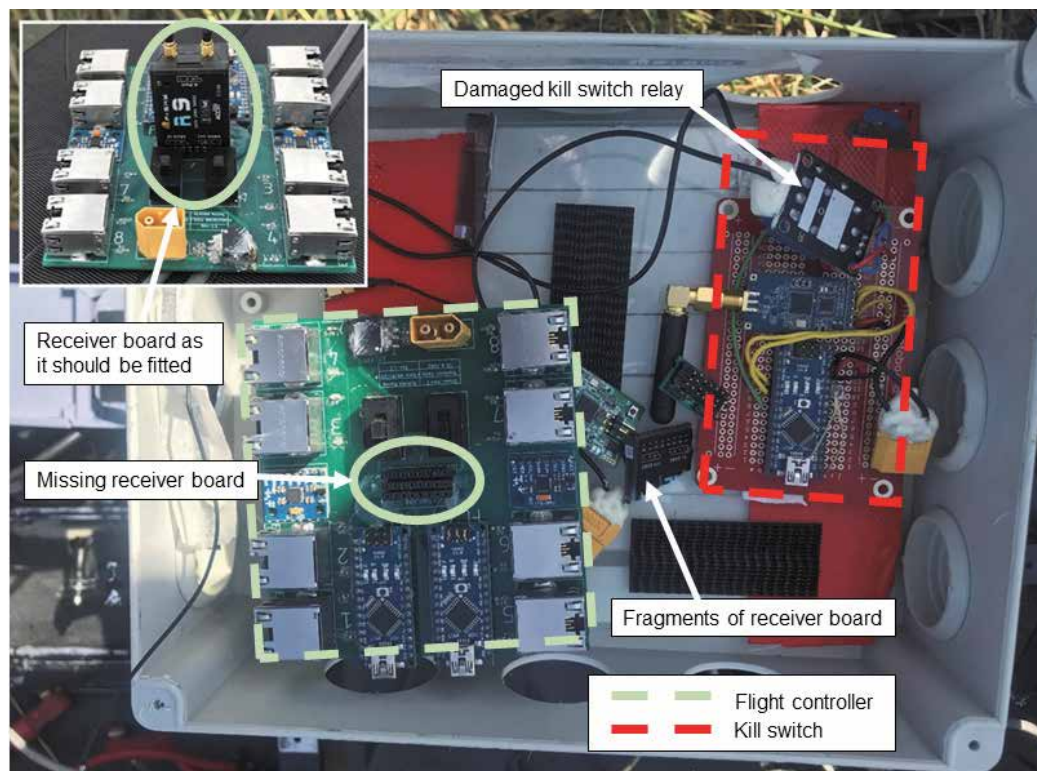
Figure 9

The flight control circuit board was present, but the operator had disconnected the ESC connection wires prior to AAIB arrival. The radio receiver, which was normally slotted into the circuit board, had detached and broken into several pieces (Figure 9). This damage was likely caused in the impact. Failure or loss of this component would lead to loss of link between the UA and pilot.

Initial examination of the on-board kill switch circuit board showed that the relay and one of the battery power supply leads had detached from the board. Loss of either of these components would render the kill switch inoperative. The antenna and the rest of the components all appeared to be in place.

Flight controls box at accident site

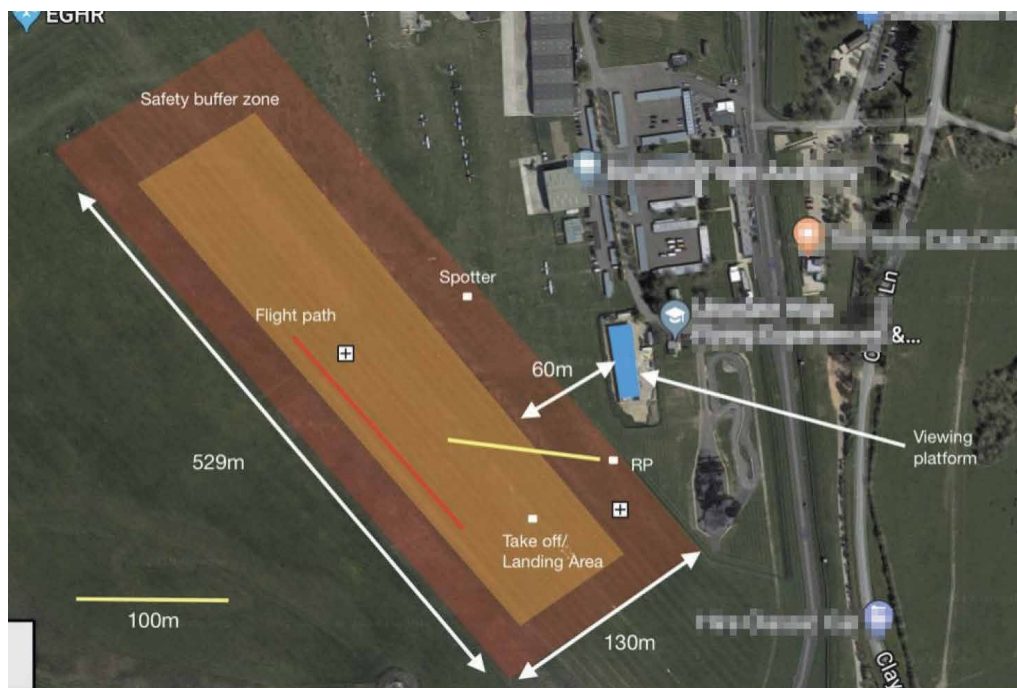
Figure 13

Operating area detail from Flight Approval Form in OSC Volume 1

The display area and safety buffer zone defined in the OSC were generated using the eastern edge of Runway 32 as the edge of the display area. This display area was drawn using a Google Earth image from 2015. In August 2017, the aerodrome modified Runway 14/32 by reducing its width from 45 m to 30 m by reducing the eastern edge by 15 m. This meant the display area defined in the OSC did not represent the correct runway geometry on the day of the accident. If the pilot was using the edge of Runway 14/32 as the edge of display area, the width would be 15 m less than that defined in the OSC. The AIP entry at the time of the application contained up to date information.

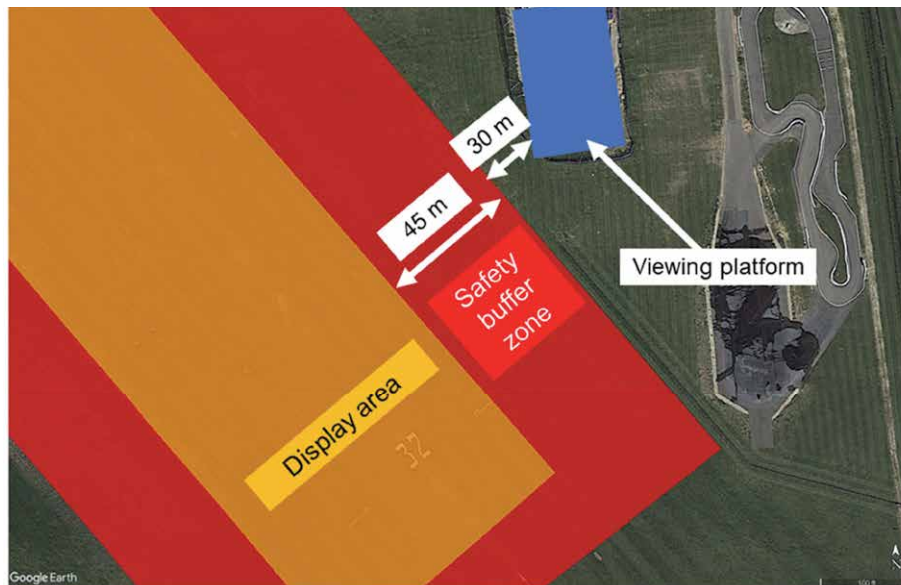
Figure 14

The display area dimensions (orange area in Figure 14) defined in the OSC were approximately 90 m x 450 m, with the safety buffer zone extending towards the viewing platform by 45 m. The viewing platform was 30 m from the edge of the red safety buffer zone (Figure 13).

Viewing platform distances from display area and safety buffer zone

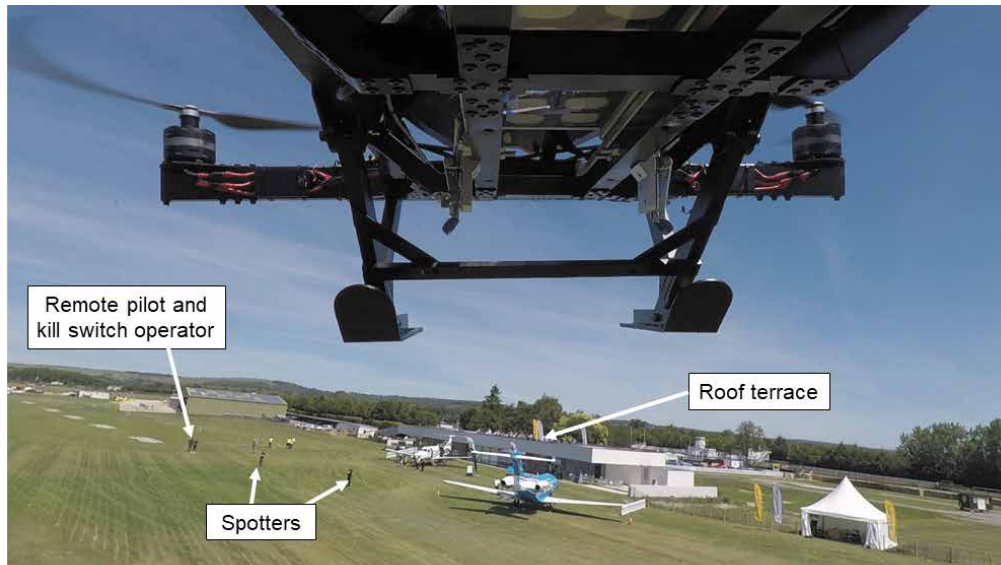
Figure 15

Video footage was reviewed to compare requirements of the CAA exemption and the operation of the aircraft. The review confirmed that, within the camera's field of view, the UA remained intact for the display with no visible failures of the motors, propellers, ESCs, airframe and battery. The footage also revealed a number of items including aircraft parked in front of the aerodrome building (Figure 15) and two fuel bowsers parked within the safety buffer zone. At times, during low-speed turns, the aircraft was pointed directly towards the aerodrome building.

View from bottom rearward-facing camera towards the aerodrome building, just after takeoff

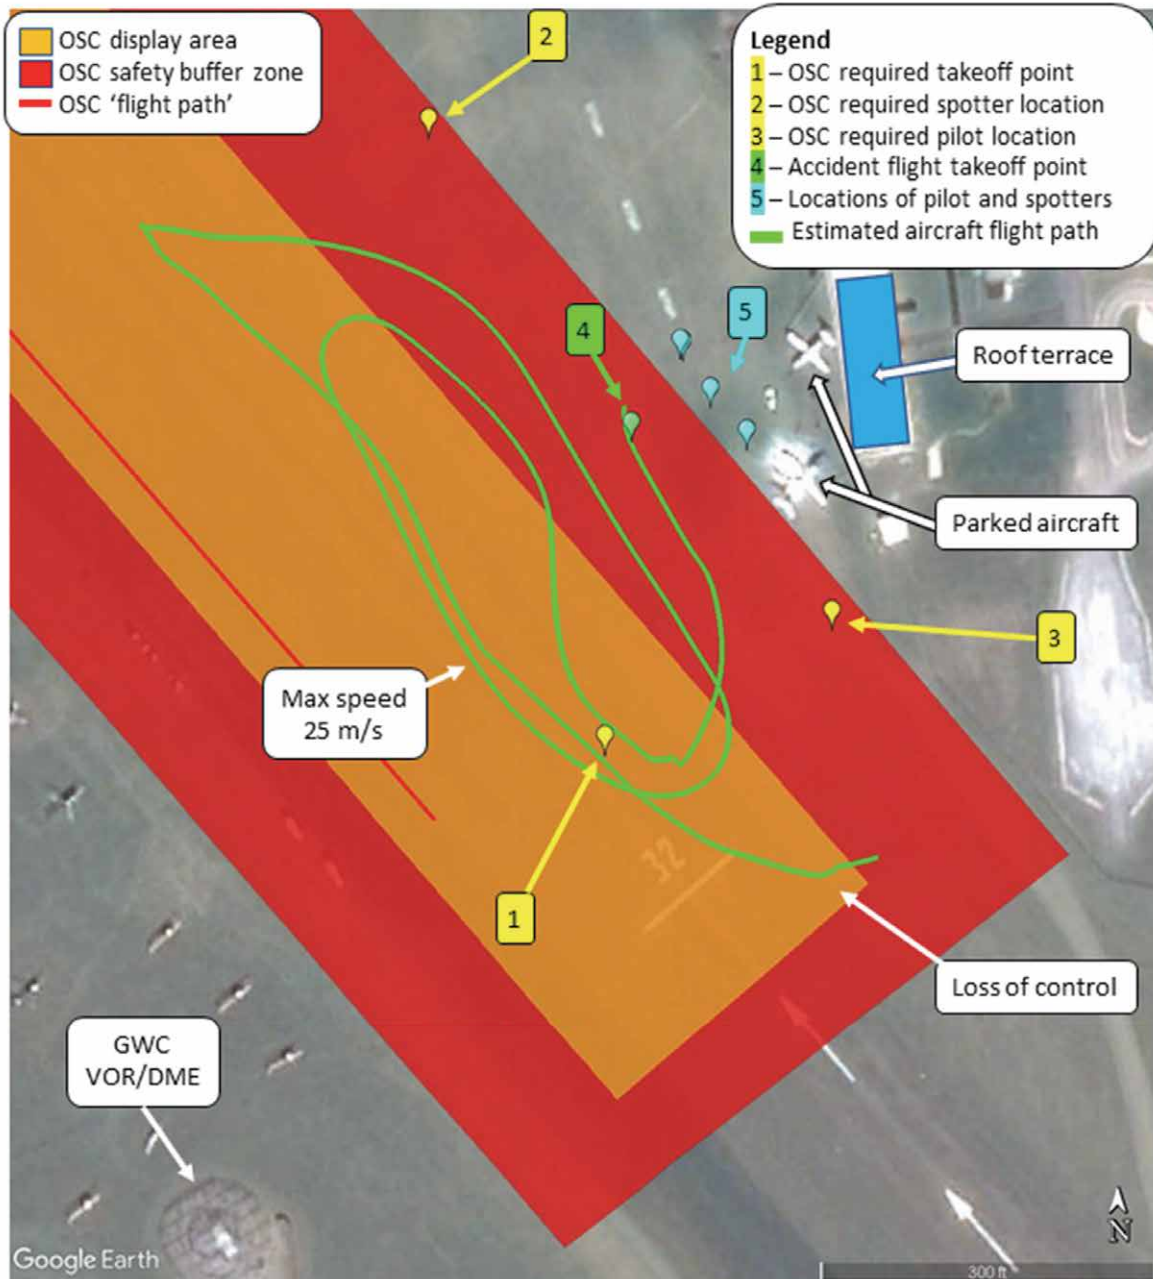
Figure 16 shows the takeoff location detailed in the OSC and the takeoff location ascertained from the video analysis. The aerial imagery is from a satellite image taken on the day of the accident. The aircraft took off 60 m from the aerodrome building and approximately 85 m from the designated takeoff / landing area.

Overhead view of Goodwood Aerodrome showing estimated aircraft flight path, location of personnel and their required locations.

Prior to takeoff the pilot completed the pre-flight checklist. This included a successful functional check of the kill switch. However, the takeoff was 85 m from the point specified in the OSC, Figure 16. Before moving away from the takeoff point, the OSC Volume 1 procedure was for the remote pilot to climb the UA to 1 to 1.5 m agl and carry out checks to confirm that it operated normally. However, video footage of the flight shows that soon after takeoff the UA was immediately manoeuvred towards the threshold of Runway 32 without any of the required checks as to the operability of the aircraft. Had the check been completed it may have identified an issue with the UA and allowed the flight to be aborted.

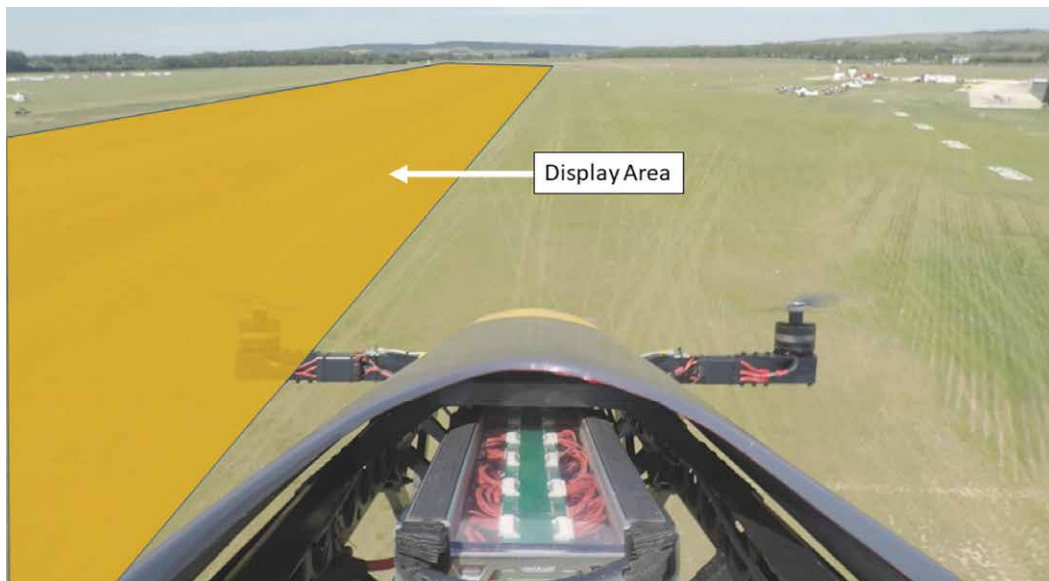
Figure 18

After takeoff, the aircraft tracked directly towards the threshold of Runway 32 at low speed, no post-takeoff control check was performed. The display then consisted of a number of runs past the aerodrome building where the aircraft initially pitched down to increased speed, before pitching up again to slow down prior to a turn. Parts of the first and third passes (left to right for the spectators) were performed within the safety buffer zone (Figure 18); the second and fourth passes were within the designated operating area (Figure 16).

Aircraft on first pass to the east of Runway 32 inside the safety buffer zone

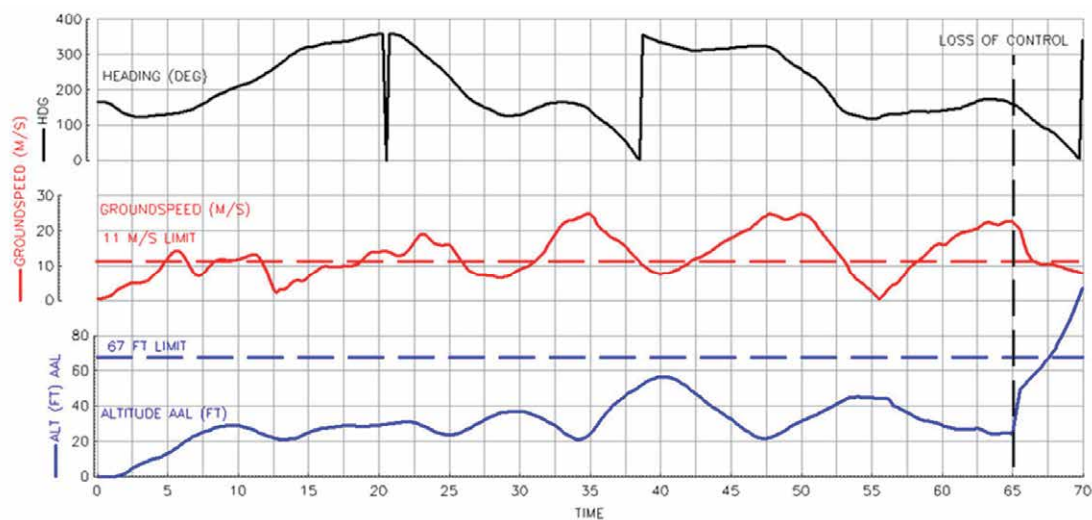
Figure 19

The calculated altitude during the display was within the CAA's exemption limit of 67 ft (20 m) but the groundspeed was in excess of 11 m/s on a number of occasions. The average groundspeed for the display was 12.9 m/s with a maximum of 25 m/s (Figure 19). With the aircraft at 20 m height and 25 m/s, using the CAA's calculations, the aircraft would travel 50 m if the kill switch was activated or power was lost.

Derived heading, groundspeed and altitude from video analysis

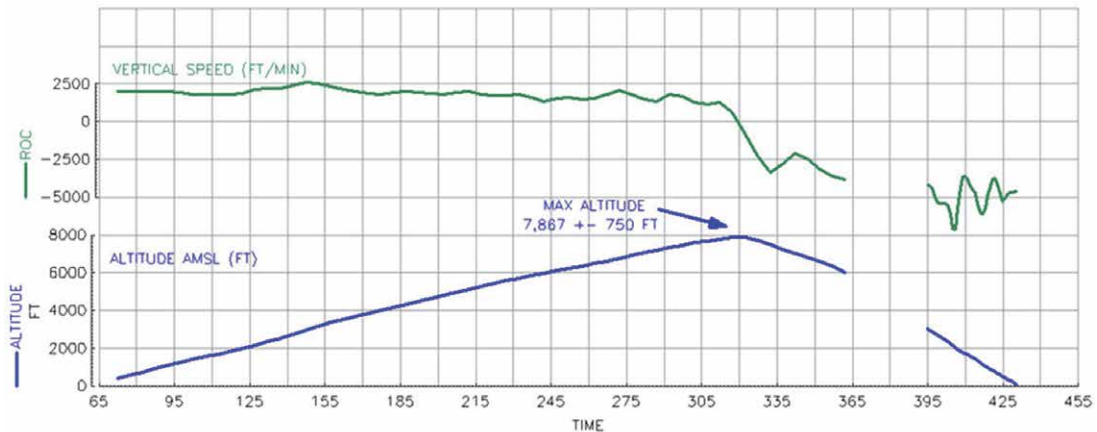
Figure 20

As per design, the aircraft continued at its previous throttle setting and with the self-levelling function, began a climb with a yaw rate of approximately 40°/sec. The aircraft climbed, uncontrolled, for 4 minutes 12 seconds, initially at around 2,000 ft/min. The rate reduced towards the top of the climb as the battery became depleted (Figure 20). The accuracy of the altitude estimation decreased as the altitude increased so a precise maximum altitude could not be established. The video analyst estimated this as 7,867 ft with an estimated error margin of ± 750 ft (see also below).

Altitude and vertical speed profiles.
Note gap in the data is where analysis was not performed.

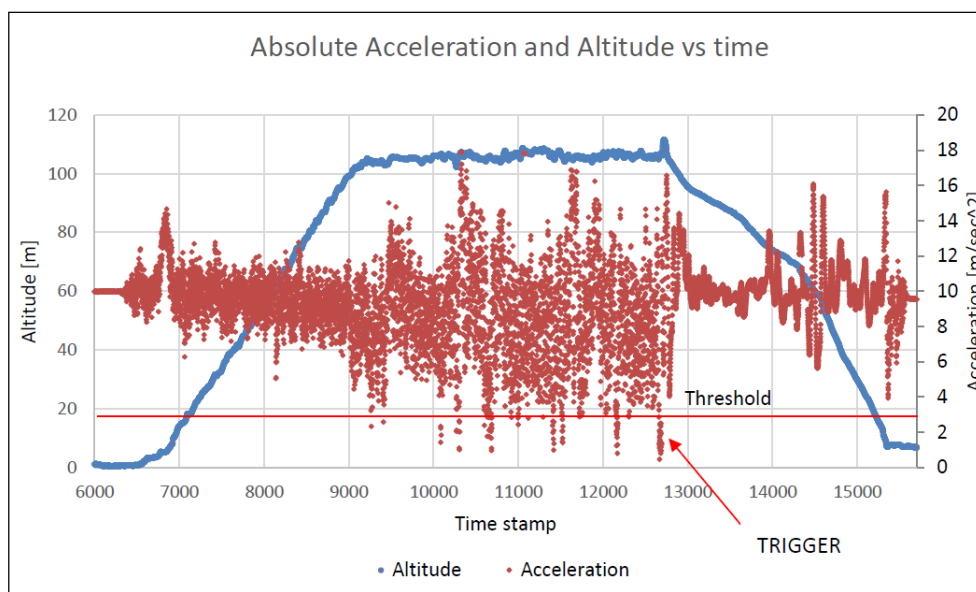
Figure 4

The parachute manufacturer analysed the log file from the parachute system. This showed an extensive vibration pattern after 9000 on the 'Time stamp' x-axis (Figure 4), which subsequently triggered the parachute deployment. The vibration pattern changed after deployment of the parachute as the power to the aircraft motors was cut by the TerminateAir system.

Plot showing salient recorded data from SafeAir for the accident flight

The parachute manufacturer concluded that it was highly probable that the cause of the parachute deployment on the 21 September 2019 accident flight was induced vibration due to loose attachment of the SafeAir unit to the aircraft.

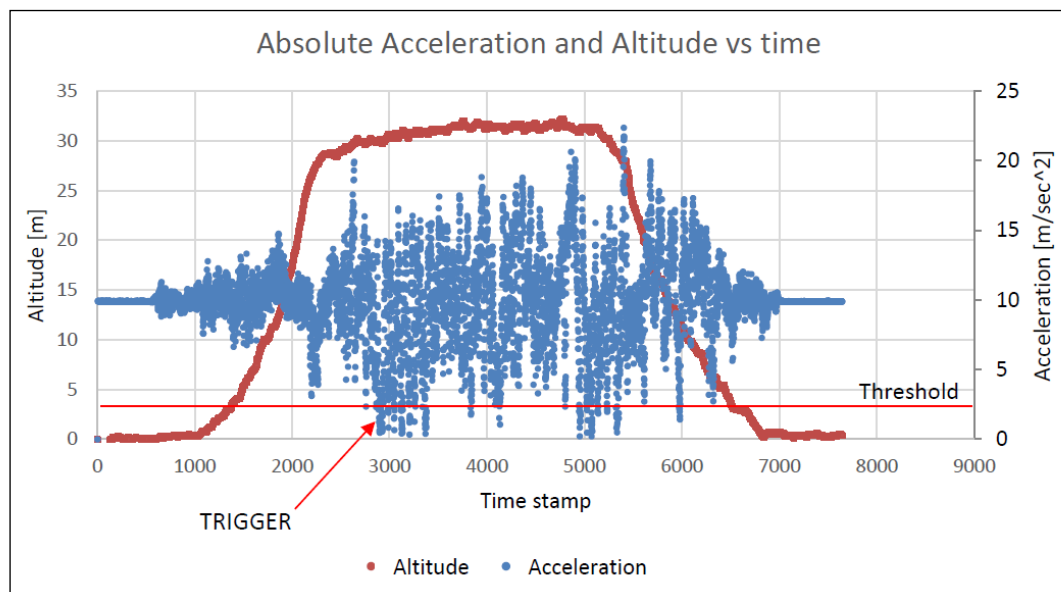
Figure 5

The parachute manufacturer advised that vibration can arise due to an attachment problem between the SafeAir system and the UAS. To try and replicate the unusual vibration pattern seen during the accident flight, a second test flight was performed. For this flight, the four thumb screws which connect the parachute to its mounting legs, were intentionally loosened. This produced an extensive vibration pattern which triggered a parachute deployment signal (Figure 5). Unlike the accident flight, the vibration pattern continued after the parachute trigger, as the dummy pyrotechnic device prevented the parachute from deploying.

Plot showing salient recorded data from SafeAir for the second test flight

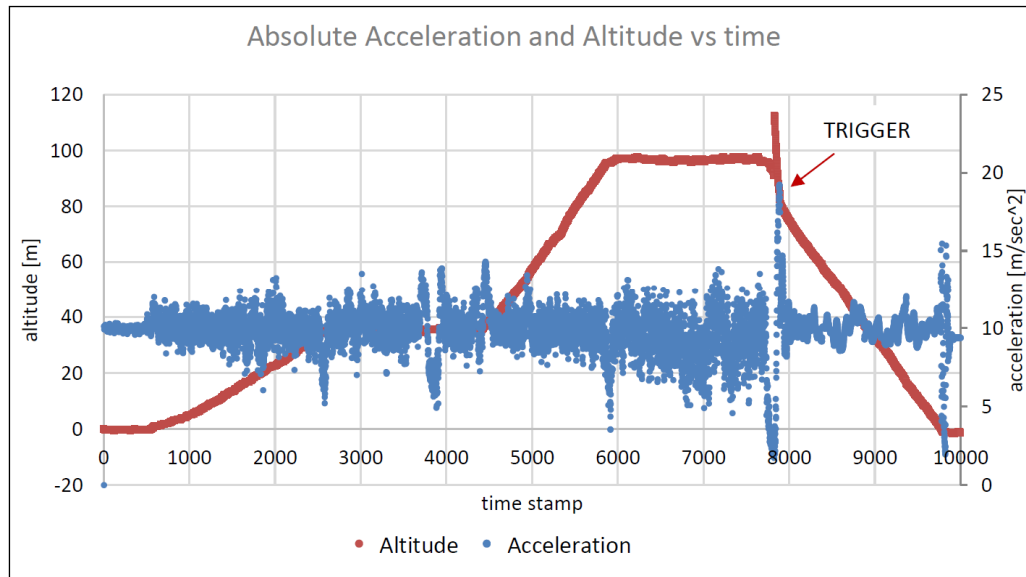
Figure 6

The parachute manufacturer analysed the log files from the parachute system and the aircraft and stated that both files were similar, with identical altitude and acceleration, until the point of parachute deployment. The aircraft's data log ended at cruise altitude, while the parachute system log (Figure 6) continued to record a fall in altitude, followed by the parachute deployment, which was characterised by erratic altitude and acceleration readings, before a constant rate descent to the ground.

The parachute manufacturer noted several warnings/errors in the aircraft's flight log and it considered that the sudden end of the aircraft's data log could be explained by a total aircraft power failure. It therefore did not examine the SafeAir system and no test flights were performed.

Plot showing salient recorded data from SafeAir for the second parachute deployment

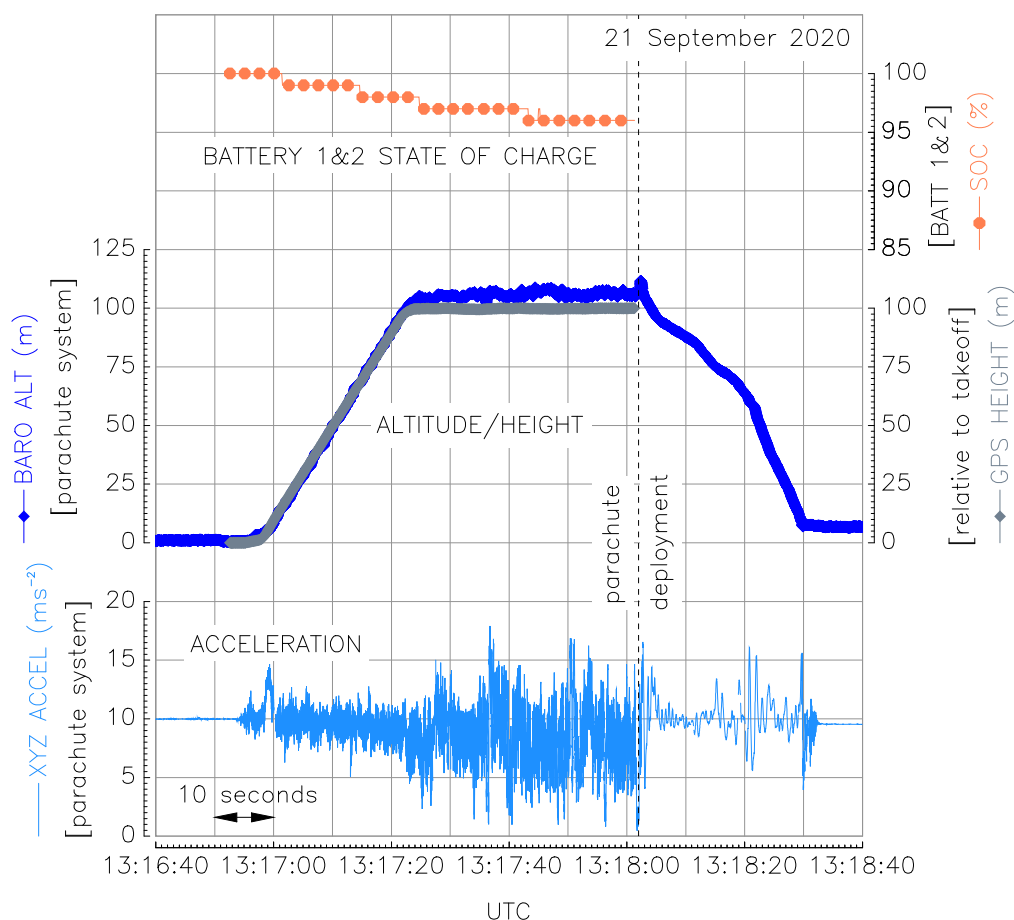
The recorded aircraft data confirmed that the recording ended abruptly after about 65 seconds of flight with the aircraft in the hover about 100 m above the ground, and at which point the energy level (state of charge (SOC)) of the aircraft's batteries was 96% (Figure 7). Not shown in Figure 7 is the aircraft's vertical velocity which changes from zero (whilst the aircraft is hovering) to 0.4 m/s in a downward direction over the last 0.2 s of recording. No warnings were recorded in the aircraft's controller log file.

The acceleration recorded by the parachute system is also plotted in Figure 7 and shows that the amplitude of the oscillations in acceleration appear in places to be biased below 9.81 m/sec² (1g) and dropping briefly below the 3 m/sec² trigger threshold about 20 times.

Flight data from the aircraft's controller and the parachute system for the 21 September 2019 accident flight

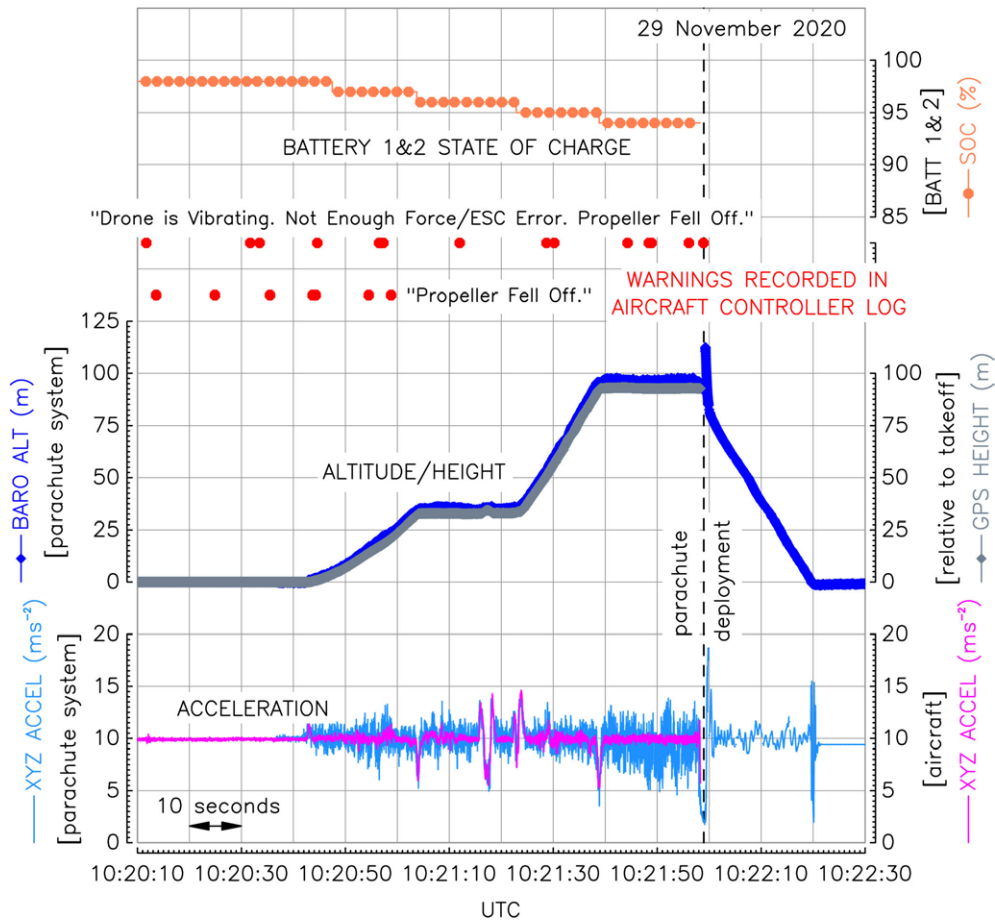
The recorded aircraft data confirmed that the recording ended abruptly after about 75 seconds of flight with the aircraft in the hover about 93 m above the ground, and at which point the energy level (state of charge(SOC)) of the aircraft's batteries was 94% (Figure 8).

Figure 8 also shows some of the warnings recorded in the aircraft controller log³. These included seven 'Propeller Fell Off' warnings, prior to takeoff, three of which also contained the message 'Drone is Vibrating. Not Enough Force/ESC Error.' After takeoff there were another 15 'Propeller Fell Off' warnings, 12 of which contained the message 'Drone is Vibrating. Not Enough Force/ESC Error'. Some of these also contained the message 'Barometer is Dead in Air. Motor is Blocked'.

Flight data from the aircraft and controller and the parachute system for the 29 November 2019 accident flight

Figure 8 also compares the aircraft's altitude and acceleration data with the equivalent data from the SafeAir log file. It shows that as the flight progressed, the acceleration recorded by the SafeAir system grew in amplitude compared to that recorded by the aircraft. The two data sets were aligned to within 10 ms at the start and throughout most of the recording, by matching the acceleration peaks and troughs associated with level changes in altitude. The accelerations throughout the flight were generally smaller in amplitude than those of the 21 September 2019 accident flight shown in Figure 7 and did not suggest the presence of excessive vibration

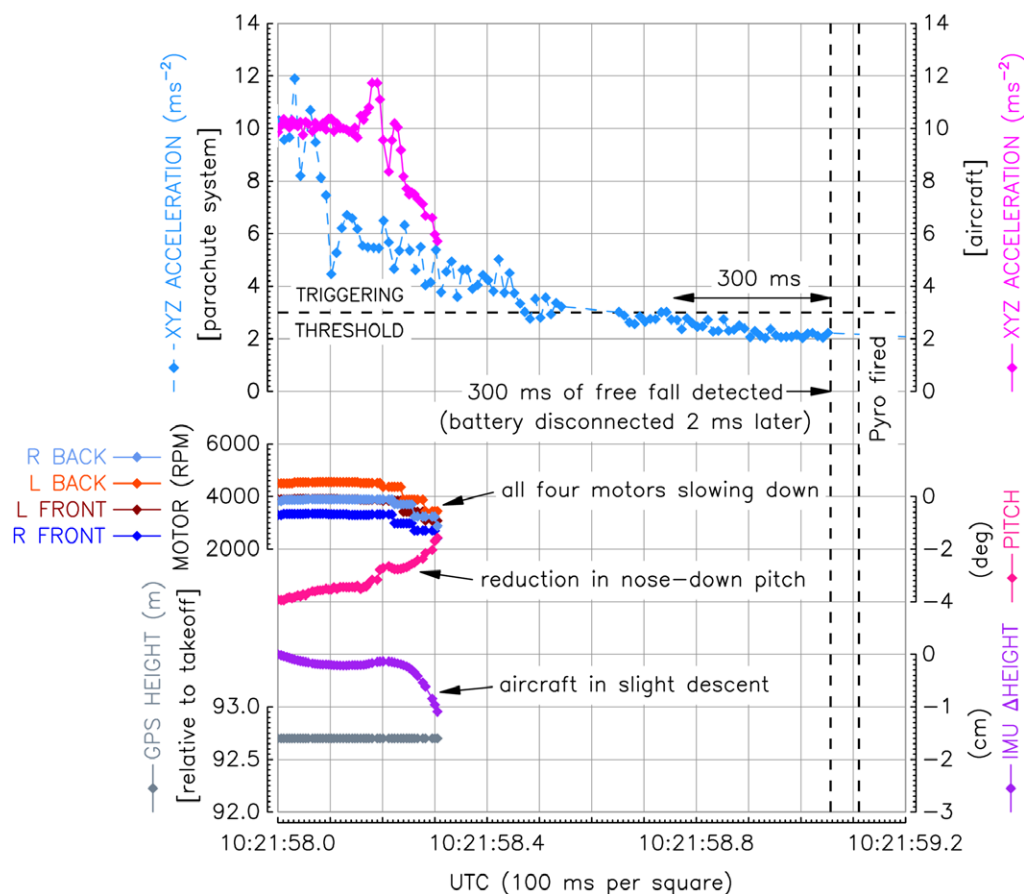
Figure 9 is a close up of the end of the aircraft data and when the parachute was deployed. The aircraft data shows that all four motors started to slow down over the last 0.1 s of recording with a corresponding decrease in the height and acceleration. The drop in the aircraft's acceleration is similar to that recorded by the parachute system; however, they are misaligned by about 150 ms. The parachute system's acceleration continued the fall below the parachute trigger threshold where it remained for 300 ms before triggering the TerminateAir and then deploying the parachute 50 ms later.

Comparison of acceleration prior to parachute deployment

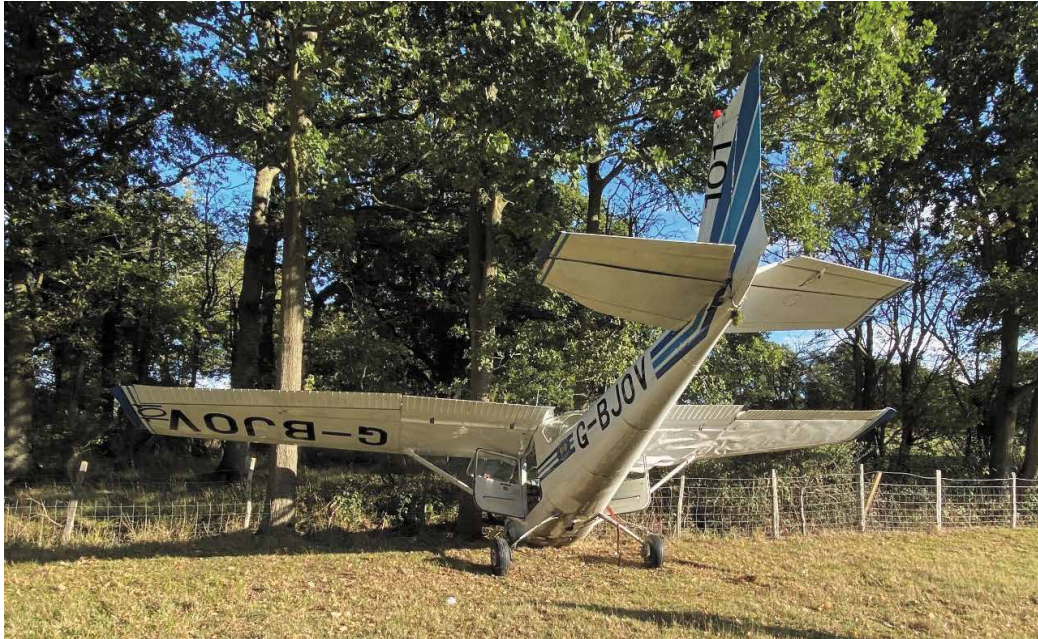
Figure 2

landing in the field. At touchdown, the nosewheel collapsed and the aircraft slid to a halt at the edge of the field (Figure 2).

G-BJOV in the treeline
(image courtesy of PIC)

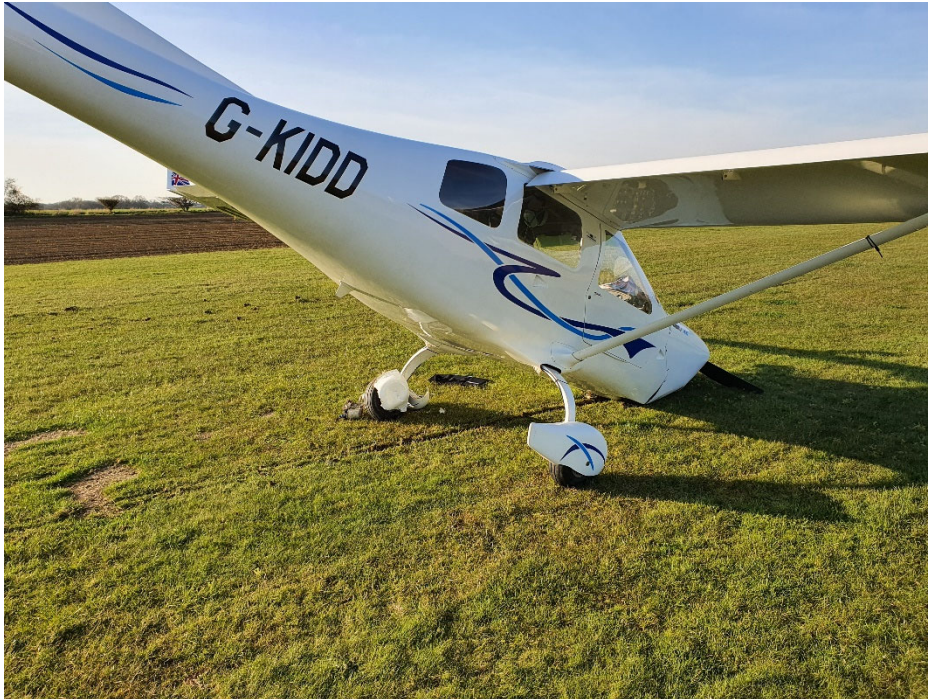
Figure 1

Whilst in an orbit the engine started to run roughly. The pilot throttled back the engine, checked the indications, selected carburettor heat ON and turned back towards the airstrip. The engine then “spluttered” and stopped; a restart was unsuccessful. Appreciating he was committed to a forced landing, the pilot selected best glide speed and continued towards the airstrip from the south-west. Realising he was too low to make an approach to Runway 23, he elected to land, with a tailwind, on Runway 05. Once over the runway the aircraft floated at about 8 to 10 feet. As the end of the runway was approaching, the pilot decided to pitch the aircraft's nose into the runway to stop the aircraft, during which the nose leg collapsed (Figure 1). The pilot vacated the aircraft uninjured.

G-KIDD after the accident
(Used with permission)

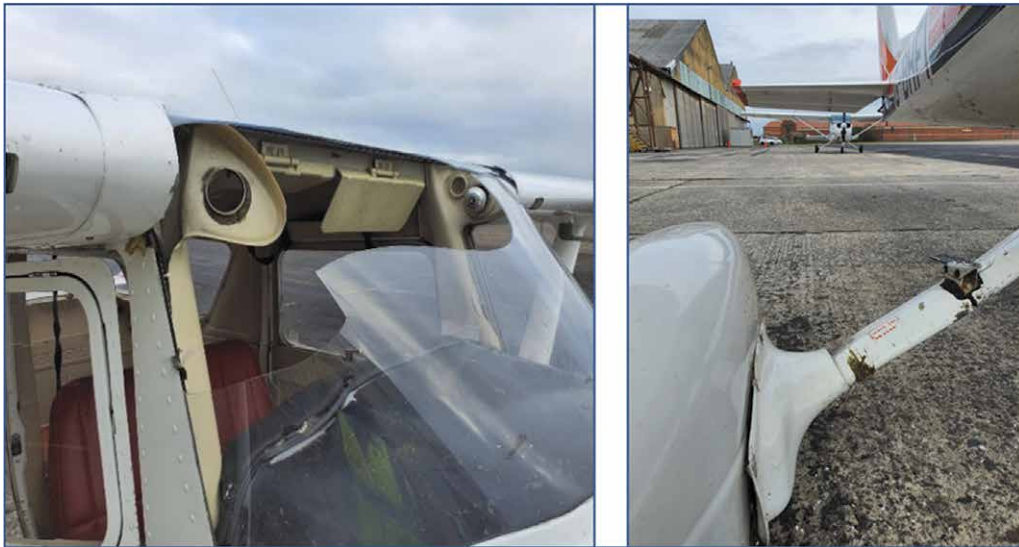
During the impact with the ground, the aircraft was damaged. The right main landing gear was disrupted and the top of the windscreen broke and detached. A significant increase in cabin noise made two-way radio communication almost impossible. The cabin noise was due to the wind caused by the combined effect of the damaged windscreen and the passenger door being blown open. The damage is shown at Figure 3 below.

Aircraft damage caused by the impact with the ground

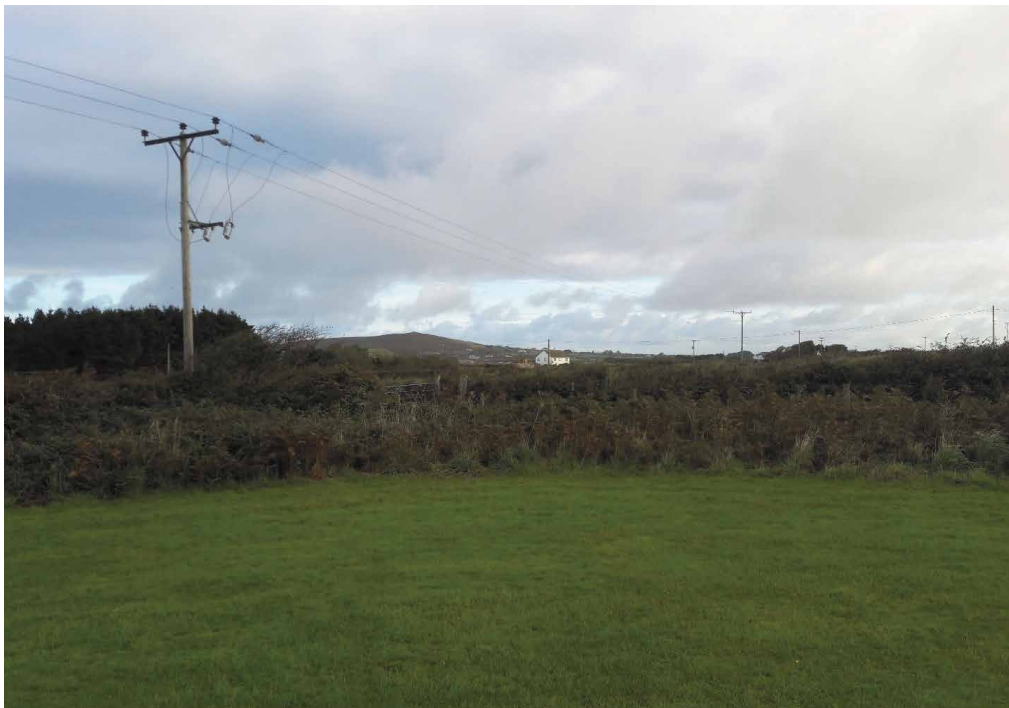
Figure 1

A set of domestic power cables runs past the threshold of Runway 22 (Figure 1) and these were at right angles to the aircraft’s into-wind track.

Power cables from approximately where the aircraft came to rest

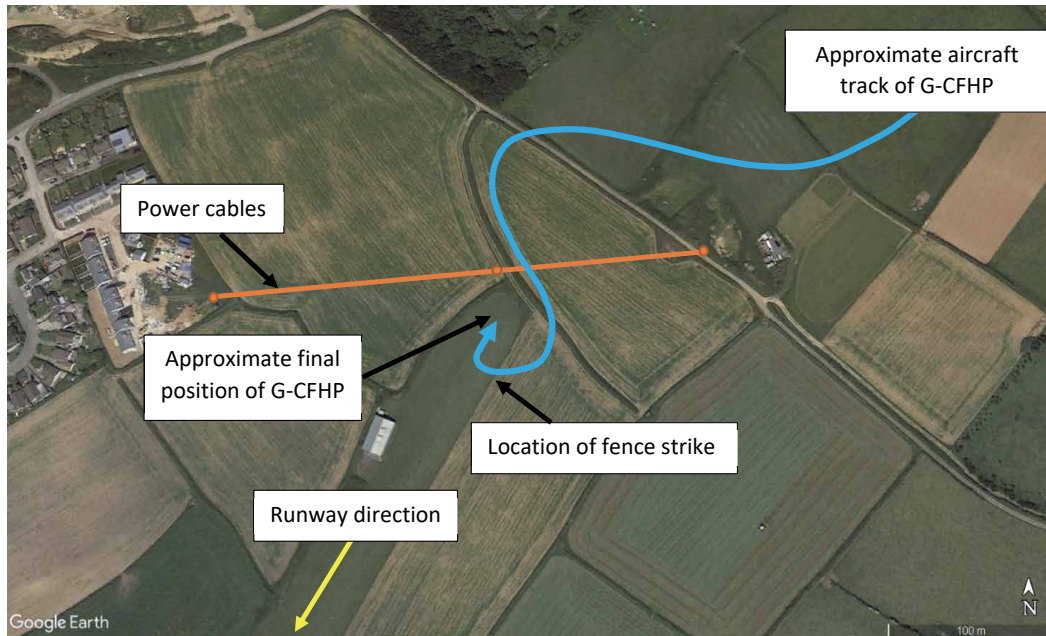
right through 90° and caused it to strike the ground heavily, damaging both wings, the engine cowling and the nose landing gear. Neither occupant was injured, and both were able to exit the aircraft unaided. The approximate aircraft track and aircraft final position is shown at Figure 2.

Figure 2
Approximate aircraft track

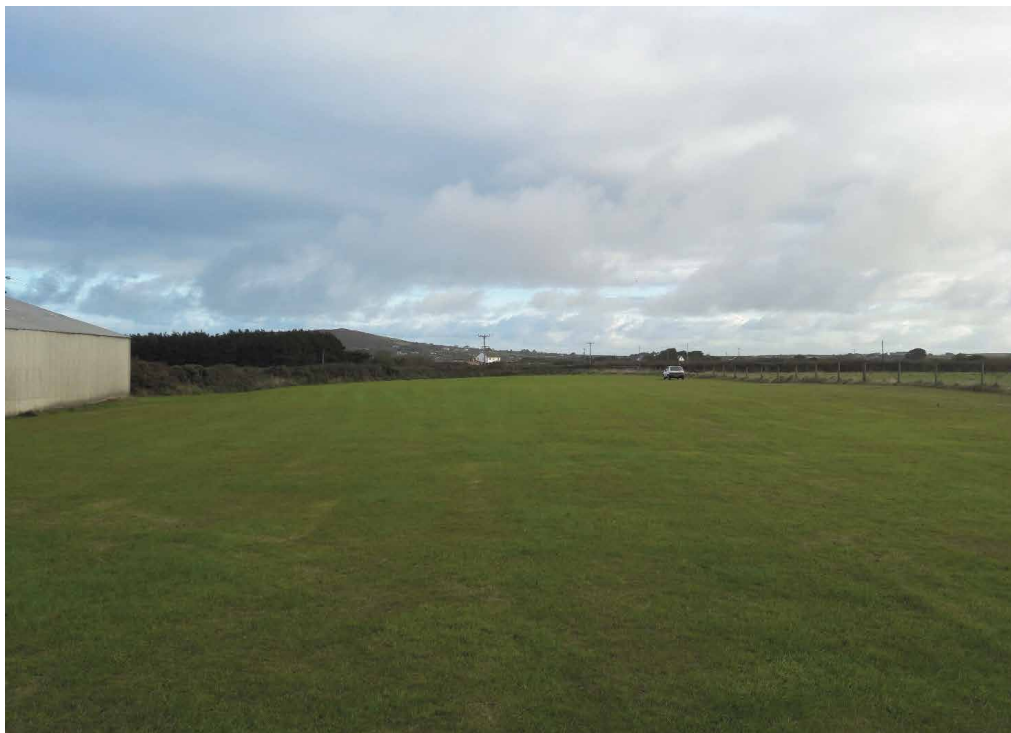
After clearing the wires, the commander made the right turn towards the airstrip using 30 to 35° angle of bank. During the turn the right landing gear struck a fence, approximately 5 ft tall, at the edge of the airstrip. The fence arrested the aircraft’s flight, turned it to the

Figure3
View along Runway 03 showing boundary fence
